NATURAL RESOURCE SOLUTIONS INC.

February 18, 2020

Project No. 2185Z

**Re: Romney Wind Energy Centre
Bald Eagle Nest Status and Requirements (BAL-001)**

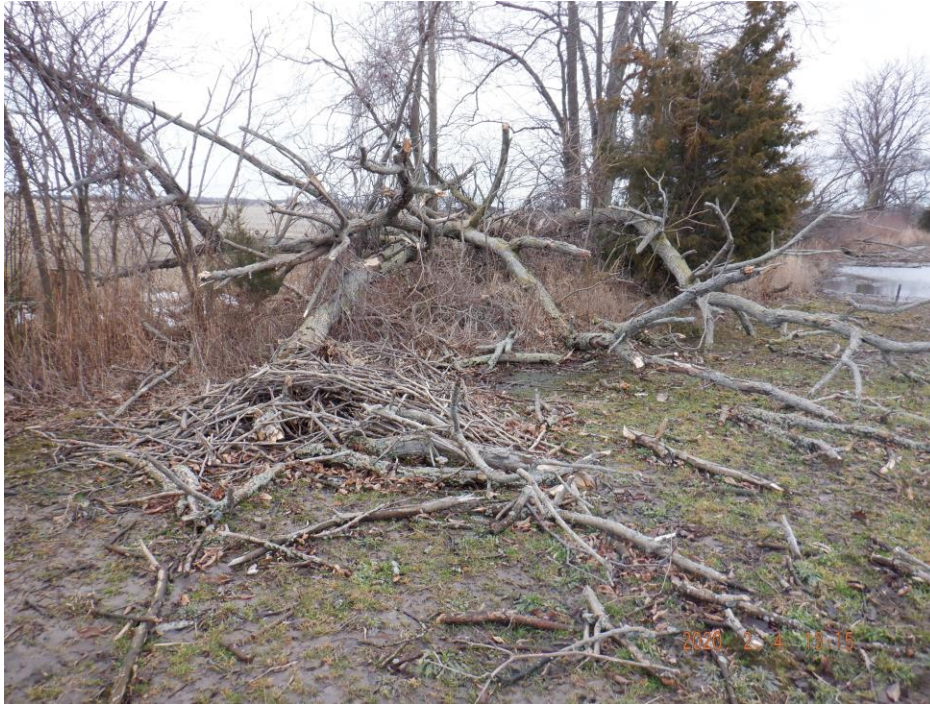
Photo 1

Following this initial observation made during construction monitoring indicating that the tree may no longer be standing, site access was gained and further investigation of the area near the tree was conducted on February 4, 2020. Photos taken during this inspection have been included in Appendix I. During the inspection, it was noted that the tree which had previously contained the Bald Eagle nest had fallen to the ground, along with the nest (Photo 1). No Bald Eagles had been observed in 2020 within the vicinity of the nest.

Description: The surrounding area where the tree and Bald Eagle nest fell to the ground.

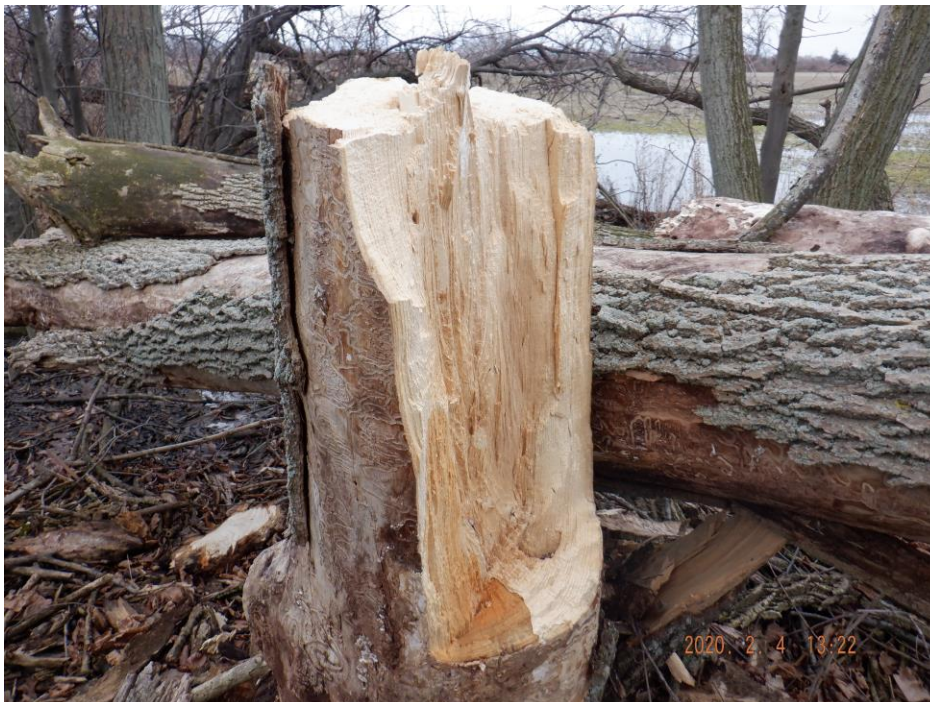
Photo 2

The tree was thoroughly examined to determine if the tree fell over naturally. During this examination, it was noted the area where the stem had broken off from the stump was uneven and jagged (Photos 2 to 4), as would occur when a tree naturally falls over. The tree appears to be an Ash (*Fraxinus*) species, which showed extensive signs of insect infestation, likely Emerald Ash Borer (*Agrilus planipennis*) (Photos 2 to 3). Loss of bark was also apparent along the stem (Photos 5 to 6). It was determined that the loss of bark and apparent insect infestation had contributed to degradation of the tree's health over time, which likely contributed to the tree falling over during a storm event. There were no signs of human interference noted during the inspection.

Description: The stump of the tree where the stem broke off. Note the uneven surface where the stem broke off, indicating the tree fell over naturally.

This photo also shows signs of insect infestation.

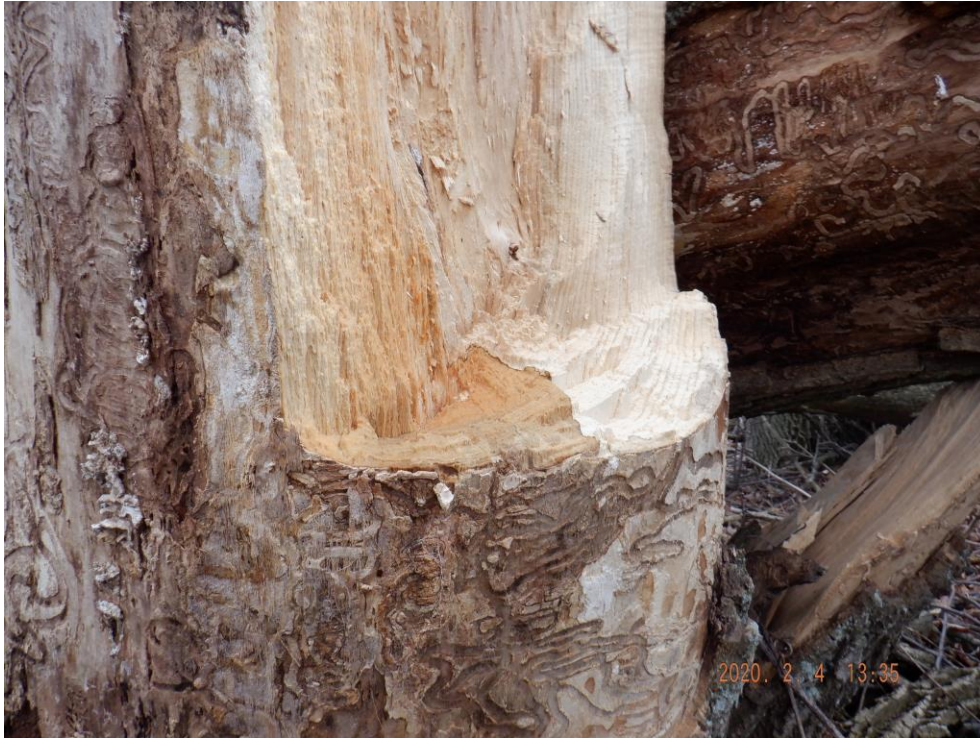
Photo 3

Close-up photo of the uneven surface where the stem broke off from the stump (lower portion).

This photo also shows signs of insect infestation.

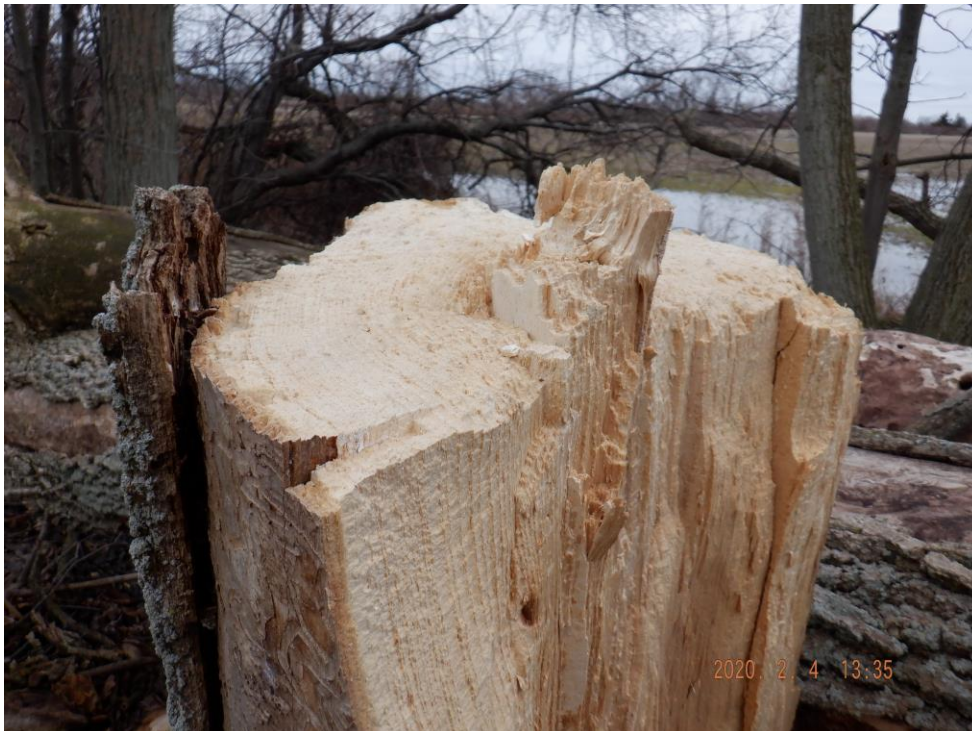
Photo 4

Close-up photo of the uneven surface where the stem broke off from the stump (upper portion).

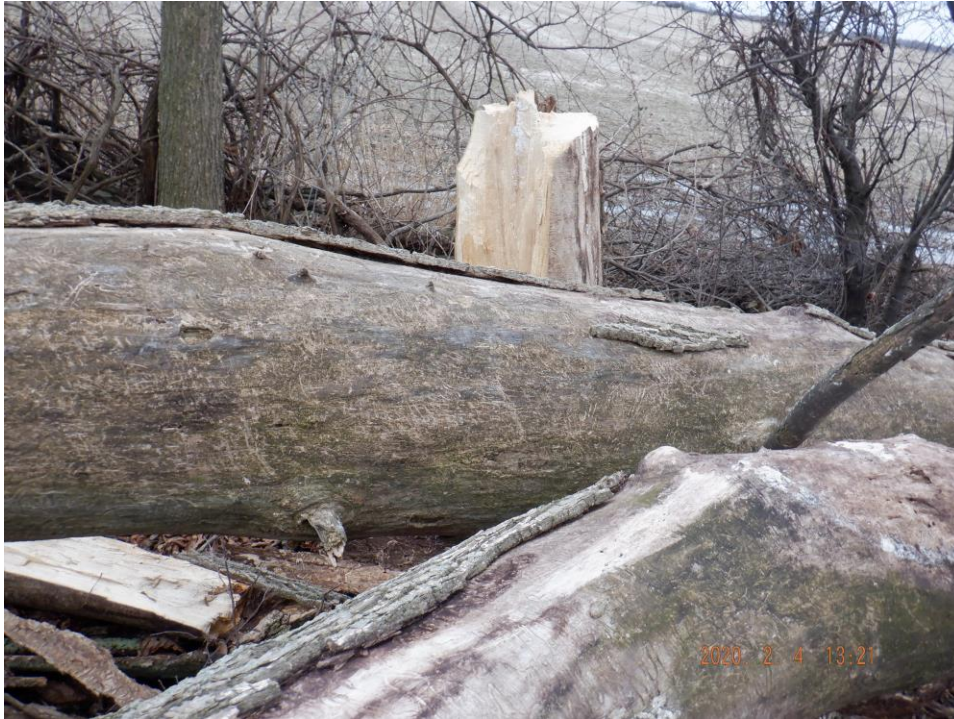
Photo 5

Description: Photo of the trunk showing bark loss along the stem.

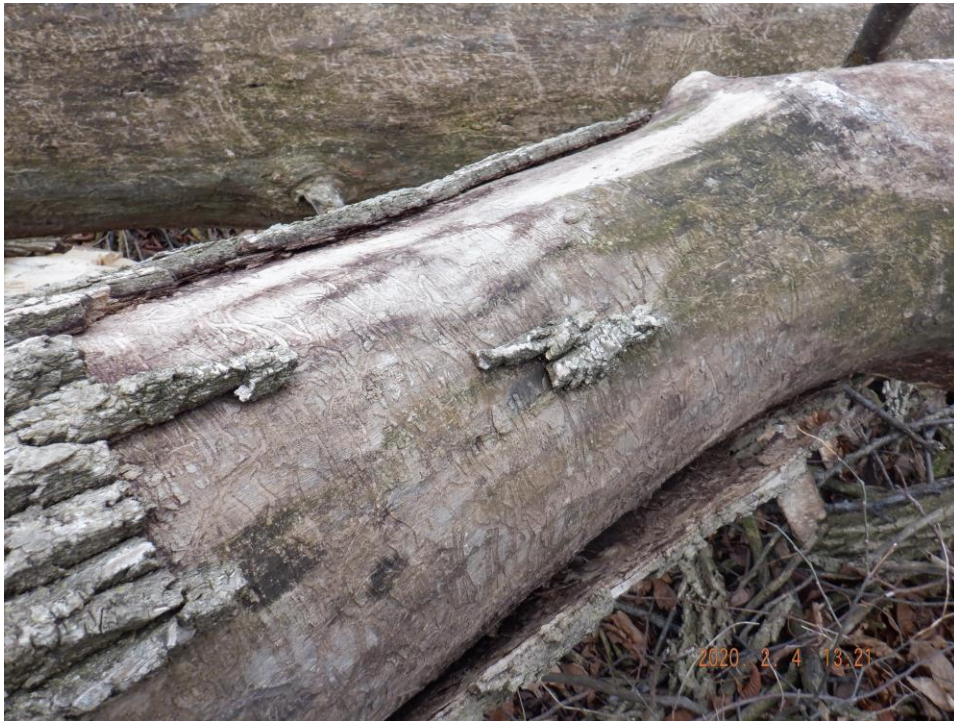
Photo 6

Description: Photo of the trunk showing bark loss along the stem.
