## ***Romney Wind Energy Centre Water Body Assessment***

Project No. 1736E | September 2017

***Romney Wind Energy Centre***  
**Water Body Assessment**

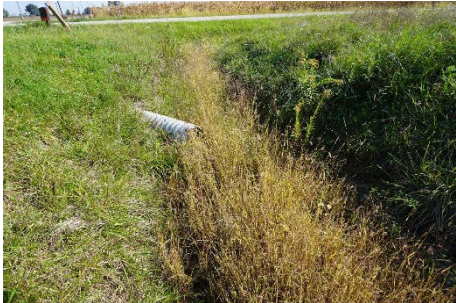
Drainage Feature	Water Body Point	Description	Photographs
Charles Simpson Drain	WB-017	Upstream, looking south-east

Cedar Creek	East Two Creeks	Charles Simpson Drain	WB-017	381069	4666064	5-Oct-16	0.4	4	25	23	None	Straight	Defined	L	Dry	1.5	0.1	Dry	0.5	Clay, Silt, Sand	Terrestrial grasses	High slope, moderate stability	L	None	100% terrestrial grasses	Dry	Dry	Dry	Clay, Silt, Sand	None	Saturated Soil	None	None	None	Y	Intermittent	Approx. 0.5M Csp Under Zion Rd.	Channelized roadside drain with terrestrial grasses on streambed which suggests periods of dry conditions. Tile drain outlets present throughout.	
		Charles Simpson Drain	WB-039	380283	4666971	5-Oct-16	0.4	4	30	25	None	Straight	Poorly Defined	L	2.3	7.5	0.1	0.1	1.5	Silt, Gravel	Sparse terrestrial grasses with areas of bare soil	Moderate slope, low stability	L	Terrestrial vegetation	100% terrestrial grasses	18	L	Brown	Clay, Silt, Sand	None	Saturated Soil	None	None	None	Y	Intermittent	None	Channelized roadside drain and low flow channel present with no instream vegetation. Terrestrial grasses present within bankfull channel and adjacent to low flow channel suggest periods of dry conditions

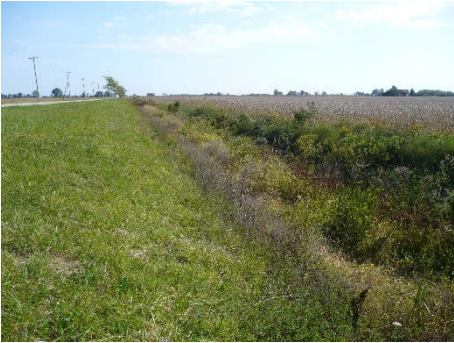
Charles Simpson Drain	WB-040	380738	4666448	5-Oct-16	0.4	4	30	25	None	Straight	Poorly Defined	L	2.5	7.5	0.1	0.1	1.5	Silt, Gravel	Sparse terrestrial grasses with areas of bare soil	Moderate slope, low stability	L	Terrestrial vegetation	80% terrestrial grasses 20% Broad Leaved Cattails	18	L	Brown	Clay, Silt, Sand	None	Saturated Soil	None	None	None	Y	Intermittent	None	Channelized roadside drain with cattails present on streambed. Terrestrial grasses present on streambed suggests periods of dry conditions. Evidence of bank erosion observed throughout.	
		Cottingham Drain A	NWB-011	380427	4671012	4-Oct-16	1.2	0	10	20	None	Straight	Poorly Defined	L	0.2	3.5	0.2	0.2	0.5	Silt, Gravel	Overhanging bank vegetation, mostly terrestrial grasses	Low slope, high stability	L	Terrestrial vegetation	100% terrestrial grasses	18	L	Brown	Clay, Silt, Sand, Gravel	None	Saturated Soil	None	None	None	N	Ephemeral	None	Roadside terrestrial grass lined drain. Feature not connected to downstream. No evidence of channel forming processes.

Drainage Feature	Water Body Point	Description	Photographs
Charles Simpson Drain	WB-040	Upstream, looking south-east

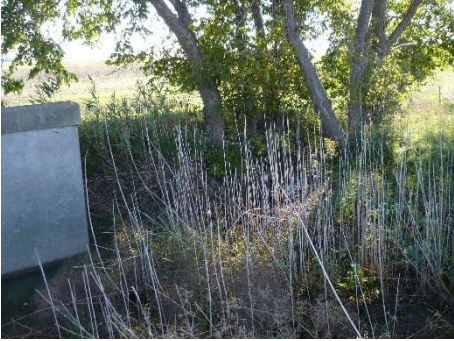
Drainage Feature	Water Body Point	Description	Photographs
Cottingham Drain A	WB-019	Upstream, looking north-east

Cottingham Drain A	WB-019	380195	4670779	4-Oct-16	1.2	0	10	20	None	Straight	Poorly Defined	L	2.0	3.5	0.5	0.4	0.7	Silt, Sand with some Gravel	Overhanging bank vegetation, mostly terrestrial grasses	Moderate slope, high stability	M	Terrestrial vegetation	50% terrestrial grasses 35% Phragmites 15% Duckweed Sp.	17	M	Brown	Clay, Silt, Sand, Gravel	None	Saturated Soil	None	None	None	Y	Intermittent	3 M Open Box Culvert At Road Crossing	Poorly defined channelized drain with terrestrial grasses on streambed which suggests periods of dry conditions. Duckweed present throughout suggests a degree of permanence.	
		Cottingham Drain A	WB-020	379755	4670365	4-Oct-16	1.2	0	10	20	None	Straight	Poorly Defined	L	0.8	4.2	0.2	0.1	0.7	Silt, Sand with some Gravel	Overhanging bank vegetation, mostly terrestrial grasses	Moderate slope, high stability	L	Terrestrial vegetation	75% terrestrial grasses 25% Phragmites	17	L	Brown	Clay, Silt, Sand, Gravel	None	Saturated Soil	None	None	None	Y	Intermittent	None	Poorly defined channelized drain with terrestrial grasses on streambed which suggests periods of dry conditions. Duckweed present upstream suggests a degree of permanence.

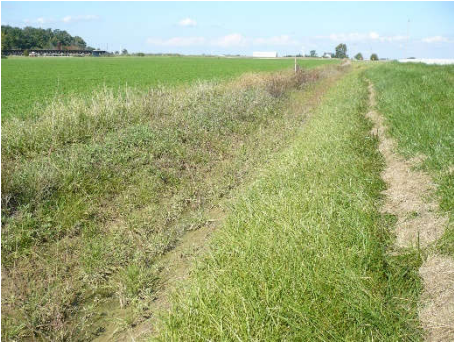
Drainage Feature	Water Body Point	Description	Photographs
Cottingham Drain A	WB-021	Upstream, looking north

Cottingham Drain A	WB-021	379628	4670059	4-Oct-16	1.2	0	10	20	None	Straight	Poorly Defined	L	0.1	2.5	0.1	0.1	0.7	Sand, Silt	Sparse terrestrial grasses	Moderate slope, moderate stability	L	Terrestrial grasses	100% terrestrial grasses	19	L	Brown	Clay, Silt, Sand, Gravel	None	None	None	None	Algae present	Y	Intermittent	None	Channelized roadside drain with sparse instream vegetation and algae present which suggests a degree of permanence. Patches of terrestrial grasses on streambed suggests periods of dry conditions.	
		Cottingham Drain A	WB-022	379589	4669175	4-Oct-16	1.2	0	10	20	None	Straight	Poorly Defined	L	1.5	2.8	0.2	0.1	0.7	Silt, Sand with some Gravel	Overhanging bank vegetation, mostly terrestrial grasses	Moderate slope, moderate stability	L	Terrestrial and aquatic vegetation	75% terrestrial 25% Broad Leaved Cattail	19	L	Brown	Clay, Silt, Sand, Gravel	None	Saturated Soil	None	None	None	Y	Intermittent	None	Channelized roadside drain . Cattails present on streambed suggests a degree of permanence, while terrestrial grasses on streambed suggests periods of dry conditions.

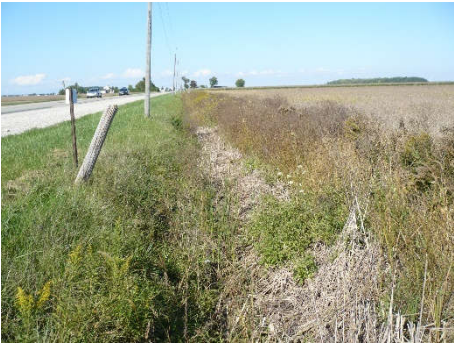
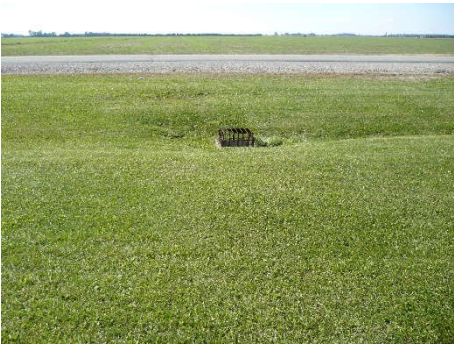
Drainage Feature	Water Body Point	Description	Photographs
Cottingham Drain A	WB-025	Upstream, looking north

Downstream, looking south

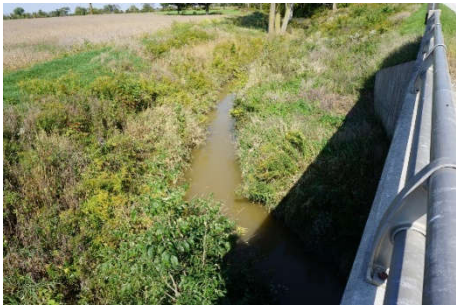
East Two Creeks	WB-016	Upstream, looking north-east

East Two Creeks	WB-016	379635	4664820	5-Oct-16	0.4	5	25	25	None	Straight	Defined	L	3.0	4.0	Unknown	0.2	1.5	Clay, Silt, Sand, Some Gravel, Cobble	Terrestrial grasses, forbs, Stinging Nettle	Low slope, moderate stability	L	Undercut banks and overhanging bank vegetation	None	19	H	Cloudy	Clay, Silt, Sand	None	Yes	Unknown	None	School of Yoy Cyprinids (Approx. 20) observed	Y	Permanent	Approx. 10M Concrete Box Culvert	Well defined natural channel incised into riparian corridor. Substantial flow observed during site investigation. Bank erosion and channel forming processes evident. Terrestrial grasses present along banks and on lumped material at toe of banks.

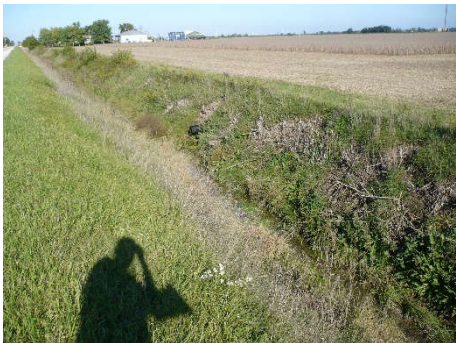
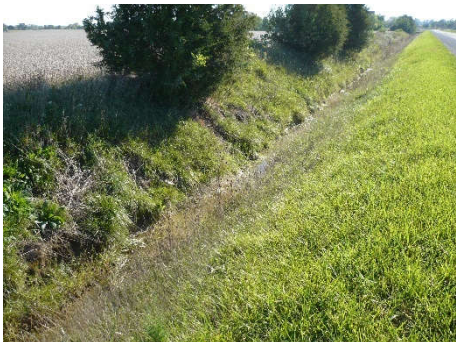
Gahan Drain	WB-032	380187	4667093	4-Oct-16	1.2	0	10	24	None	Straight	Poorly Defined	L	1.2	3.8	0.2	0.1	1.2	Silt, Gravel	Overhanging bank vegetation, mostly terrestrial grasses	High slope, moderate stability	L	Terrestrial vegetation	100% terrestrial grasseses	18	L	Brown	Clay, Silt, Sand, Gravel	None	Saturated Soil	None	None	None	Y	Intermittent	None	Channelized roadside drain and low flow channel with no instream vegetation present suggests a degree of permanence. Terrestrial grasses on streambed suggests periods of dry conditions.
		Gahan Drain	WB-036	382037	4668716	5-Oct-16	0.4	4	30	25	None	Straight	Poorly Defined	L	2.0	5.0	0.3	0.1	1.5	Silt, Sand	Overhanging bank vegetation, mostly terrestrial grasses	High slope, low stability	L	Terrestrial and aquatic vegetation	100% terrestrial grasseses	19	H	Brown	Clay, Silt, Sand	None	Saturated Soil	None	None	None	Y	Intermittent	None	Channelized drain and low flow channel with no instream vegetation. Evidence of bank erosion observed. Terrestrial grasses present within bankfull channel and adjacent to low flow channel suggests periods of dry conditions.

WB-032	Upstream, looking north-east

Downstream, looking south-west

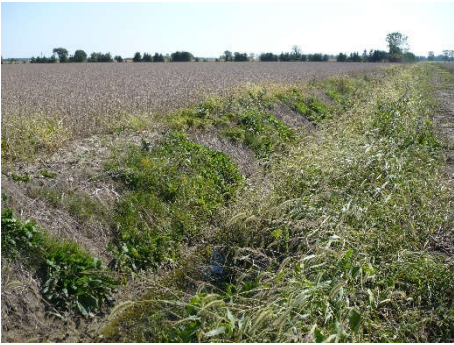
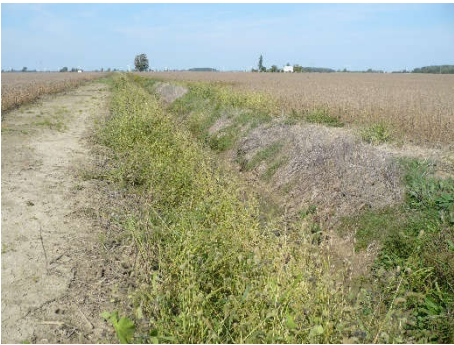
Jacobs Drain	WB-035	381186	4667355	5-Oct-16	0.4	4	30	25	None	Straight	Poorly Defined	L	0.7	3.5	0.1	0.1	0.9	Silt, Gravel	Very sparsely vegetated channel with patches Of overhanging bank vegetation	High slope, low stability	L	Patches of overhanging bank vegetation	100% terrestrial grasseses	18	L	Brown	Clay, Silt, Sand	None	Saturated Soil	None	None	Encrusting algae present	Y	Intermittent	None	Channelized drain with algae present and low flow channel with no instream vegetation. Evidence of bank erosion observed. Terrestrial grasses present within bankfull channel and adjacent to low flow channel suggests periods of dry conditions.
		Jacobs Drain	WB-042	381785	4666665	5-Oct-16	0.4	4	30	25	None	Straight	Poorly Defined	L	0.8	4.3	0.3	0.2	1.4	Silt, Sand with some Cobble	Overhanging bank vegetation, mostly terrestrial grasses	Moderate slope, moderate stability	L	Narrow Leaved Cattail	100% Narrow Leaved Cattail	19	L	Brown	Clay, Silt, Sand	None	Saturated Soil	None	None	None	Y	Intermittent	None	Channelized drain through hedgerow. Cattails present on streambed and evidence of bank erosion suggests a degree of permanence. Defined low flow channel present.

Drainage Feature	Water Body Point	Description	Photographs
Jacobs Drain	WB-035	Upstream looking north-west

Downstream looking south-east

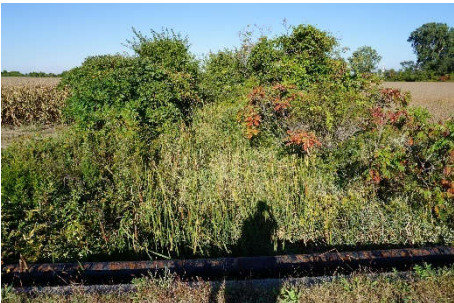
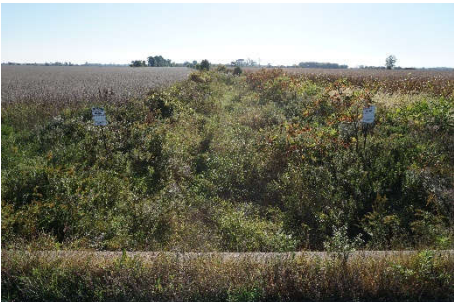
WB-010	Upstream, looking north-east

Stobbs Drain	WB-010	381482	4665617	4-Oct-16	1.2	5	0	22	None	Straight	Defined	L	1.5	2.5	0.3	0.1	1.0	Clay, Silt, Sand	Terrestrial grasses and forbs including Aster Sp., Goldenrod sp., Sumac sp., and shrubs	Low slope, moderate stability	L	Overhanging vegetation	50% terrestrial grasseses 50% Broad leaved cattails	18	L	Slightly Cloudy	Clay, Silt, Sand	None	Saturated Soil	None	None	None	Y	Intermittent	3M Concrete Box Culvert	Channelized drain with naturalized riparian corridor. Terrestrial grasses on streambed suggests periods of dry conditions and cattails present upstream suggests a degree of permanence. Bare low flow channel through drain suggests a degree of permanence. Standing water present during site investigation.
		Travis Drain	WB-026	379561	4668398	4-Oct-16	1.2	0	10	24	None	Straight	Poorly Defined	L	2.5	4.5	0.5	0.3	1.5	Silt, Sand with some Cobble	Overhanging bank vegetation	Moderate slope, moderate stability	L	Patches of overhanging bank vegetation	100% Duckweed sp.	18	H	Brown	Clay, Silt, Sand, Gravel	None	Yes	None	None	None	Y	Intermittent	None	Well defined channelized drain with limited instream vegetation. Patches of duckweed present within feature.

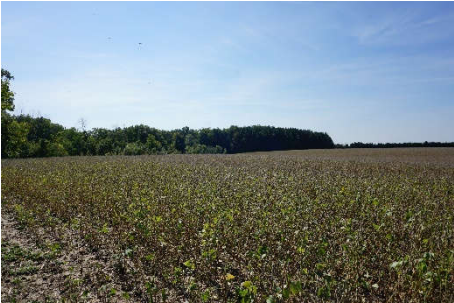
Drainage Feature	Water Body Point	Description	Photographs
Unnamed Drain L	NWB-029	No feature present, looking south

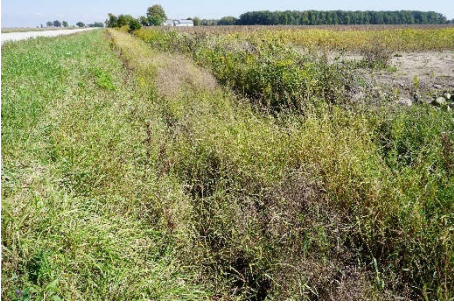
Drainage Feature	Water Body Point	Description	Photographs
Albert E. Metcalf Drain	WB-003	Upstream, looking north-east

Albert E. Metcalf Drain	WB-003	383400	4666247	4-Oct-16	1.2	4	0	22	None	Straight	Defined	L	1.8	2.8	NA	0.1	0.5	Clay, Silt, Sand	Terrestrial grasses and forbs including Aster sp. and Goldenrod sp.	Moderate slope, high stability	L	Terrestrial vegetation	80% terrestrial grasses 20% Phragmites	18	M	Cloudy	Clay, Silt, Sand	None	Saturated Soil	None	None	None	Y	Intermittent	None, Tile Drains With Flow Draining South Field	Channelized roadside drain. Cattails present upstream suggests a degree of permanence, while terrestrial grasses present on streambed suggests periods of dry conditions.
	Coatsworth-Robinson Drain	WB-001	385230	4666935	4-Oct-16	1.2	3	0	22	None	Straight	Defined	L	1.3	4.0	0.4	0.2	1.3	Silt, Sand with some Rip Rap	Terrestrial grasses and forbs including Aster sp. and Goldenrod sp.	Low slope, moderate stability	L	Rip rap, terrestrial vegetation, and Duckweed sp.	80% terrestrial grasseses 20% Duckweed sp.	17	H	Brown	Silt, Sand and Rip Rap	Silt deposits on vegetation in channel only	Saturated Soil	None	None	None	Y	Intermittent	2M Csp Under Road, At Least 3 Tile Drains With Some Flow Upstream And Downstream Of Road	Channelized drain with naturalized riparian corridor. Duckweed within feature and low flow channel present with no instream vegetation suggests a degree of permanence. Terrestrial grasses present within bankfull channel and adjacent to low flow channel suggests periods of dry conditions.

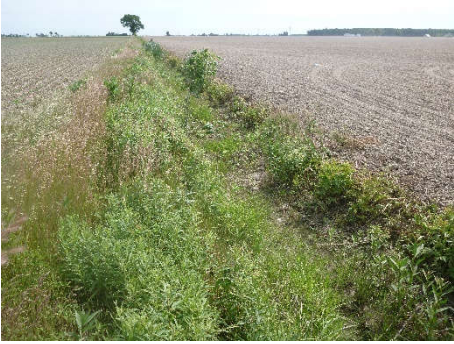
Liddle Drain	NWB-048	382902	4666727	9-Jun-17	0.0	2	40	21	None	Straight	Poorly Defined	Dry	Dry	0.6	Dry	Dry	0.3	Clay, Silt, Sand	Terrestrial grasses	Low slope, low stability	L	Terrestrial vegetation	100% terrestrial grasseses	Dry	Dry	Dry	Clay, Silt, Sand	None	None	None	None	None	N	Ephemeral	None	Dry channelized drain, terrestrial vegetation throughout, evidence of flow is lacking, suggesting long periods of dry conditions.
	Lowe Drain	WB-041	382248	4667057	5-Oct-16	0.4	4	30	25	None	Straight	Poorly Defined	L	Dry	5.5	Dry	Dry	1.2	Silt, Sand with some Gravel	Overhanging bank vegetation, terrestrial grasses and deciduous shrubs	High slope, moderate stability	L	Terrestrial vegetation	80% Broad Leaved Cattail 20% Terrial grasseses	Dry	Dry	Dry	Clay, Silt, Sand	None	Saturated Soil	None	None	None	Y	Intermittent	None	Channelized drain within naturalized corridor. Presence of cattails on streambed suggests a degree of permanence, while terrestrial grasses present on streambed suggests periods of dry conditions. No feature present north of 4th Concession.

Drainage Feature	Water Body Point	Description	Photographs
Liddle Drain	NWB-048	Upstream, looking north-east

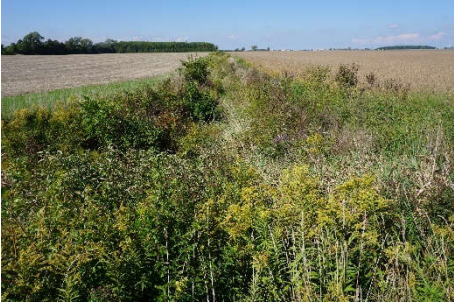
Drainage Feature	Water Body Point	Description	Photographs
Lowe Drain	WB-060	Upstream, looking north-east

Lowe Drain	WB-060	383076	4665991	4-Oct-16	1.2	4	0	22	None	Straight	Defined	L	1.0	3.8	NA	0.2	1.3	Clay, Silt, Sand	Terrestrial grasses and forbs including Aster sp., Goldenrod sp., Red-osier Dogwood, and Sumac sp.	High slope, high stability	L	Terrestrial vegetation	100% terrestrial grasseses	17	M	Cloudy	Clay, Silt, Sand	Silt deposits on vegetation in channel and within bankfull area	Saturated Soil	None	None	None	Y	Intermittent	None, Tile Drain Outlets Observed	Channelized drain within naturalized and well vegetated corridor. Defined low flow channel with no instream vegetation. Presence of terrestrial grasses adjacent to low flow channel suggests periods of dry conditions.
	Nevills Drain	NWB-004	382278	4665261	4-Oct-16	1.2	5	0	22	None	Straight	Poorly Defined	L	Dry	0.5	Dry	Dry	0.2	Clay, Silt, Sand	Terrestrial grasses	High slope, high stability	L	N/A	100% terrestrial grasseses	Dry	Dry	Dry	Clay, Silt, Sand	None	Saturated Soil	None	None	None	N	Ephemeral	None	Terrestrial grass lined roadside drain.

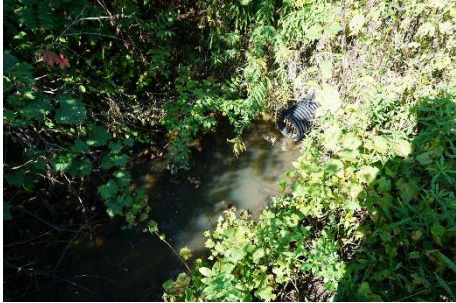
Wright Drain	NWB-041	No feature present	No photographs available
	WB-014	Upstream, looking north-west

Wright Drain	WB-014	381902	4663761	5-Oct-16	0.4	4	25	25	None	Straight	Defined	L	1.5	2.0	0.2	Dry	0.3	Clay, Silt, Sand	Terrestrial grasses, Ash sp., Cedar, Forbs	Moderate slope, moderate stability	L	None	100% terrestrial grasseses	NA	L	Clear	Clay, Silt, Sand	None	Saturated Soil	Yes, recently deposited	None	None	Y	Intermittent	None	Channelized drain begins at surveyed location. Non-WB located immediately upstream. Feature originates at tile drain outlet with low flow channel present downstream. Terrestrial grasses adjacent to low flow channel suggest periods of dry conditions.
		Yellow Creek	WB-004	383037	4665927	4-Oct-16	1.2	5	0	22	None	Meander L	Defined	L	1.5	4.0	0.4	0.3	1.5	Clay, Silt, Sand	Terrestrial grasses and forbs	Low slope, moderate stability	L	Terrestrial vegetation and rip rap around bridge	90% terrestrial grasseses 10% aquatic vegetation	18	H	Cloudy	Clay, Silt, Sand	Silt deposits on vegetation in channel and within bankfull area	Saturated Soil	None	None	School of Yoy Cyprinids (Approx. 20) observed at bridge	Y	Permanent	3.4M Concrete Box Culvert, Smaller Csp And Plastic Culverts Also Observed Directing Ditch Flow To Water Body	Defined channelized drain within a naturalized corridor. Defined low flow channel with no instream vegetation present. Terrestrial grasses present within drain. Fish observed at road crossing.

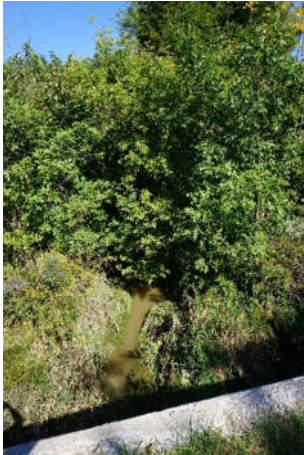
WB-005	Upstream, looking north-east

Yellow Creek	WB-005	382444	4664530	4-Oct-16	1.2	4	0	22	None	Meander L	Defined	L	2.0	4.5	0.5	0.3	1.8	Clay, Silt, Sand, Gravel, Some Cobble	Terrestrial grasses and forbs, Sumac sp., deciduous trees	Moderate slope, low stability - heavy erosion noted	M	Woody debris overhanging bank vegetation	None	18	H	Cloudy	Clay, Silt, Sand	Sediment deposits within bankfull channel	Saturated Soil	None	None	None	Y	Permanent	Approx. 4.3M Concrete Box Culvert, Greatly Undersized Evidenced By Heavy Erosion Upstream And Downstream	Well defined natural watercourse within well vegetated riparian corridor. Meandering feature with riffles and pools. No instream vegetation present.
		Yellow Creek	WB-006	382102	4663284	4-Oct-16	1.2	4	0	22	None	Meander L	Defined	L	1.0	2.5	0.4	0.2	1.3	Clay, Silt, Sand, Gravel, Some Cobble and Rip Rap	Terrestrial grasses and forbs, Sumac sp., Cedar sp. and deciduous trees	Low slope, high stability	M	Overhanging vegetation	None	18	H	Cloudy	Clay, Silt, Sand	Sediment deposits within bankfull channel	Saturated Soil	None	None	None	Y	Permanent	Approx. 4M Csp	Well defined natural watercourse within well vegetated riparian corridor. Meandering feature with riffles and pools. No instream vegetation present.

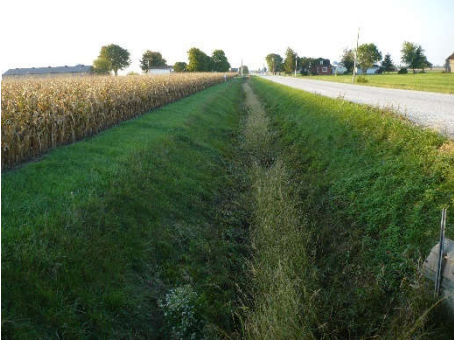
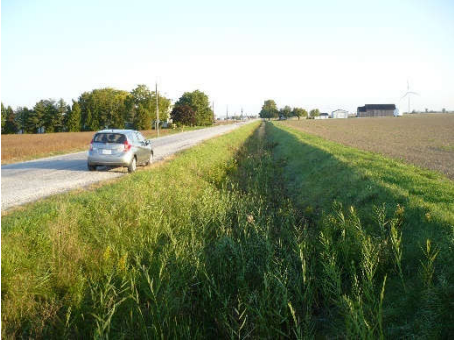
WB-056	Upstream, looking south

18-19 Side Road & Hill Drain	WB-056	378884	4671956	6-Oct-16	0.4	0	0	17	None	Straight	Defined	L	1.2	4.5	0.2	0.1	1.5	Sand, Silt	Overhanging bank vegetation, mostly terrestrial grasses	Moderate slope, high stability	L	Terrestrial grasses and Phragmites	50% Phragmites 30% terrestrial grasseses 20% Duckweed	18	L	Green	Clay, Silt, Sand, Gravel	None	Saturated Soil	None	None	None	Y	Intermittent	4.5M Open Box Culvert	Channelized roadside drain. Duckweed present in feature suggests a degree of permanence, while terrestrial grasses present on streambed suggests periods of dry conditions.
		18-19 Side Road & Hill Drain	WB-057	378923	4672649	6-Oct-16	0.4	0	0	17	None	Straight	Defined	L	0.9	4.0	0.1	0.1	0.9	Sand, Silt	Overhanging bank vegetation, mostly terrestrial grasses	Moderate slope, moderate stability	L	Dense instream Terrestrial vegetation	90% terrestrial grasseses 10% Duckweed	18	L	Green	Clay, Silt, Sand	None	Saturated Soil	None	None	None	Y	Intermittent	None	Channelized roadside drain. Duckweed present in feature suggests a degree of permanence, while terrestrial grasses present on streambed suggests periods of dry conditions. Riprap erosion protection where ephemeral feature connects to roadside drain.

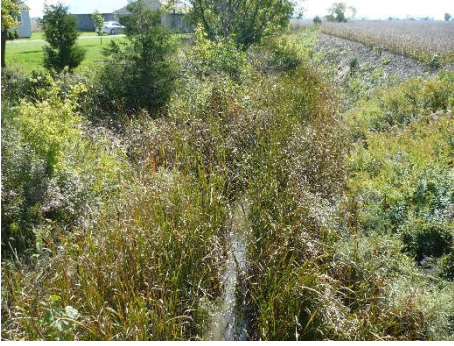
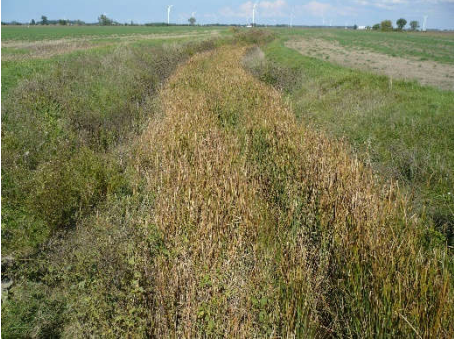
Big Creek	WB-047	Upstream, looking south

Downstream, looking north

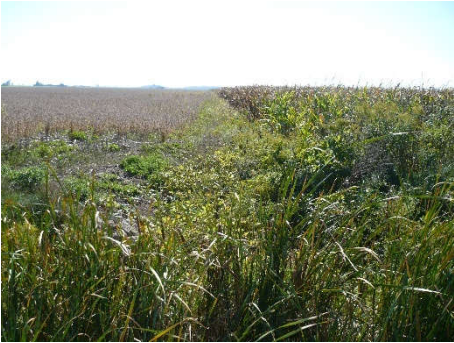
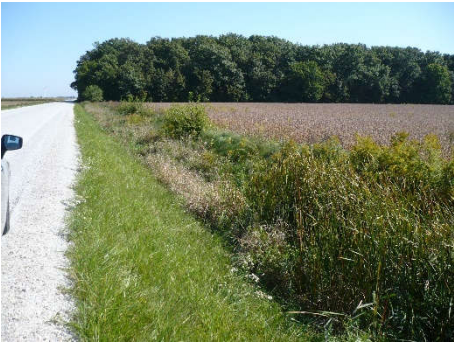
Hill Drain	WB-049	Upstream, looking east

Hill Drain	WB-049	379101	4670566	4-Oct-16	1.2	0	10	20	None	Straight	Poorly Defined	L	Dry	3.3	Dry	Dry	0.5	Silt, Sand with some Gravel	Overhanging bank vegetation, mostly terrestrial grasses	High slope, moderate stability	L	Terrestrial vegetation	90% terrestrial grasseses 10% Narrow Leaved Cattail	Dry	Dry	Dry	Clay, Silt, Sand, Gravel	None	None	None	None	None	Y	Intermittent	None	Channelized roadside drain with cattails present on streambed which suggests a degree of permanence. Terrestrial grasses present on streambed suggests periods of dry conditions. Channel connectivity periodically interrupted by areas of dense terrestrial grasses and raised bed material.
		Hyatt Drain	WB-044	378777	4670584	4-Oct-16	1.2	0	10	20	None	Straight	Poorly Defined	L	Dry	3.0	Dry	Dry	0.8	Silt, Sand with some Cobble	Overhanging bank vegetation, mostly terrestrial grasses	Moderate slope, high stability	L	Terrestrial vegetation	40% terrestrial grasseses, 40% Narrow Leaved Cattail 20% Phragmites	Dry	Dry	Dry	Clay, Silt, Sand, Gravel	None	None	None	None	None	Y	Intermittent	None	Channelized roadside drain. Cattails present on streambed suggests a degree of permanence, while terrestrial grasses present on streambed suggests periods of dry conditions.

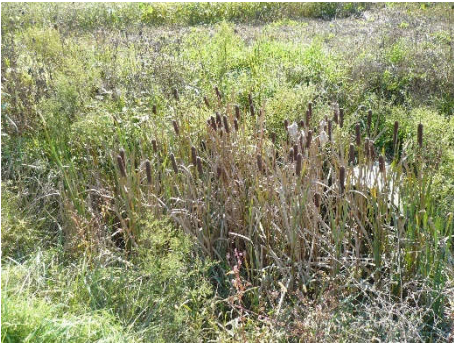
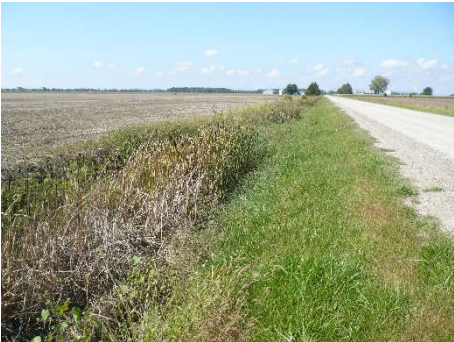
WB-045	Upstream, looking east

Hyatt Drain	WB-045	378472	4670611	4-Oct-16	1.2	0	10	20	None	Straight	Poorly Defined	L	0.7	4.0	0.2	0.1	0.8	Silt, Sand with some Gravel	Overhanging bank vegetation, mostly terrestrial grasses	Moderate slope, high stability	L	Terrestrial vegetation	50% terrestrial grasseses 50% Broad Leaved and Narrow Leaved Cattails (Mixed)	19	L	Brown	Clay, Silt, Sand, Gravel	None	Saturated Soil	None	None	None	Y	Intermittent	None	Channelized roadside drain with dense cattails in the feature. Terrestrial grasses present on streambed suggests periods of dry conditions. Channel connectivity periodically interrupted by areas of dense terrestrial grasses and raised bed material.
		Pond A	NWB-039	379330	4677480	6-Oct-16	0.4	1	0	20	None	N/A	N/A	N/A	NA	NA	NA	NA	NA	Clay, Silt, Sand	Terrestrial grasses and forbs	Moderate slope, moderate stability	N/A	Littoral vegetation	None	19	H	Cloudy	Clay, Silt, Sand	None	Saturated Soil	None	None	Tadpole	N	Permanent	None	Unconnected dug pond

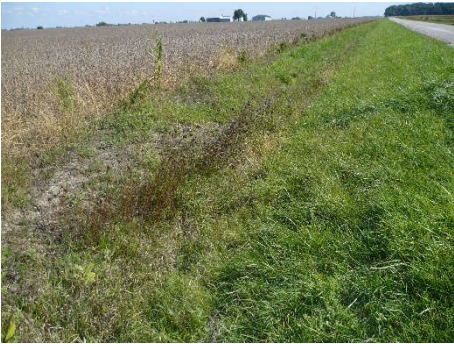
Unnamed Drain G	WB-046	378171	4670636	4-Oct-16	1.2	0	10	20	None	Straight	Poorly Defined	L	Dry	3.5	Dry	Dry	0.5	Silt, Sand with some Cobble	Overhanging bank vegetation, terrestrial grasses and Milkweed sp.	Moderate slope, high stability	L	Terrestrial vegetation	50% terrestrial grasseses 50% Broad Leaved Cattails	Dry	Dry	Dry	Clay, Silt, Sand, Gravel	None	None	None	None	None	Y	Intermittent	None	Channelized roadside drain with cattails present on streambed which suggests a degree of permanence. Terrestrial grasses present on streambed suggests periods of dry conditions. Channel connectivity periodically interrupted by areas of dense terrestrial grasses and raised bed material.
		Unnamed Drain H	NWB-025	379543	4670539	4-Oct-16	1.2	0	10	20	None	Straight	Poorly Defined	L	Dry	1.5	Dry	Dry	0.5	Silt, Sand	Overhanging bank vegetation, terrestrial grasses and deciduous shrubs	Low slope, high stability	L	Terrestrial vegetation	100% terrestrial grasseses	Dry	Dry	Dry	Clay, Silt, Sand, Gravel	None	None	None	None	None	N	Ephemeral	None	Terrestrial grass lined channelized drain. No evidence of channel forming processes. No feature present south of the road.

Unnamed Drain G	WB-046	Upstream, looking south

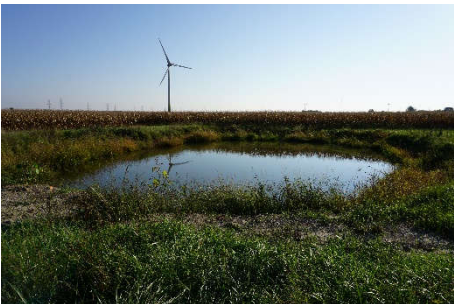
Pond A	NWB-039	Unconnected dug-out pond
