## **APPENDIX C – CULTURAL HERITAGE ASSESSMENT**

<b>Project:</b>	<b>Romney Wind Energy Centre</b>
<b>OPA Reference Number:</b>	<b>L006356-WIN-001-060</b>
<b>Report Title:</b>	<b>Romney Wind Energy Centre: Cultural Heritage Assessment</b>
<b>Applicant:</b>	<b>Romney Energy Centre Limited Partnership</b>
<b>Location:</b>	<b>Geographic Townships of Romney and Tilbury West Municipality of Chatham-Kent, Ontario</b>
<b>MTCS File No.:</b>	<b>0005856</b>

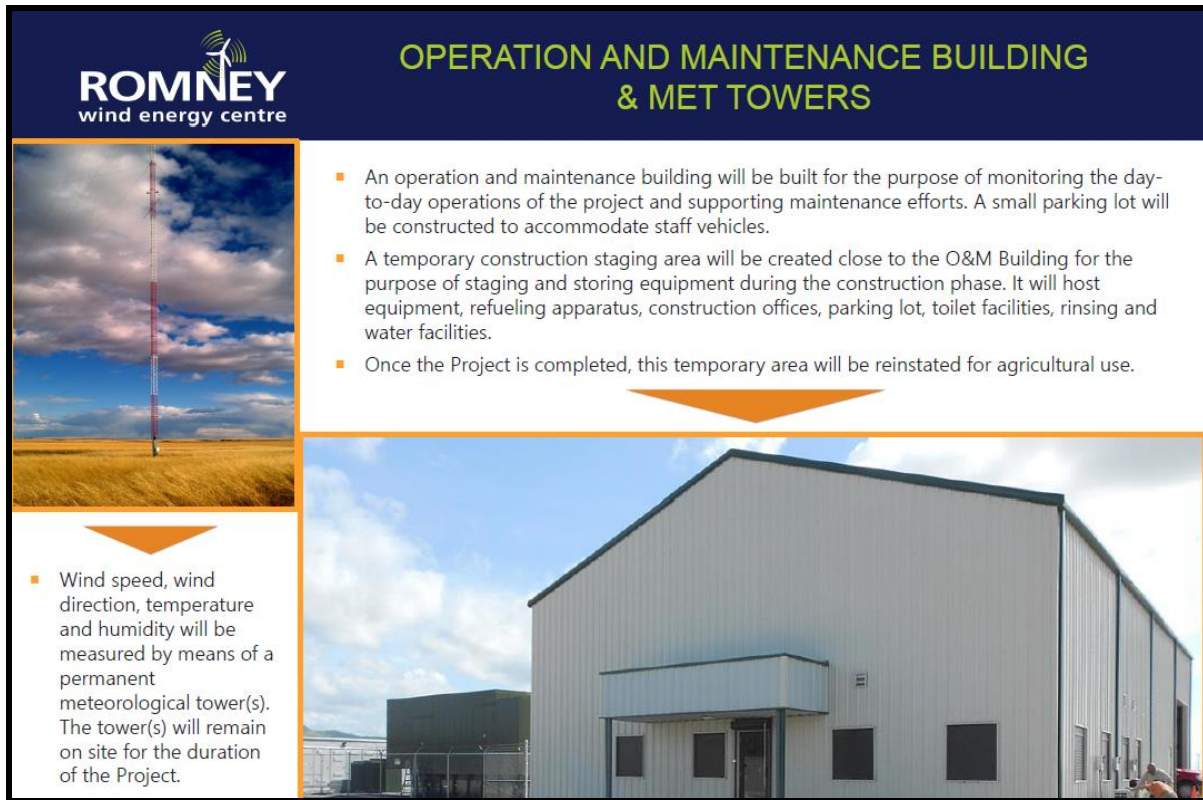
**Image 9: Illustration of the Meteorological Tower & Operations and Maintenance Building**  
(DNV GL 2016b:33)

Additional project infrastructure includes a Meteorological Tower which will be used to monitor wind speed, direction and humidity (DNV GL 2016b). An Operations and Maintenance Building will also be constructed to provide storage and support for ongoing monitoring (DNV GL 2016b).

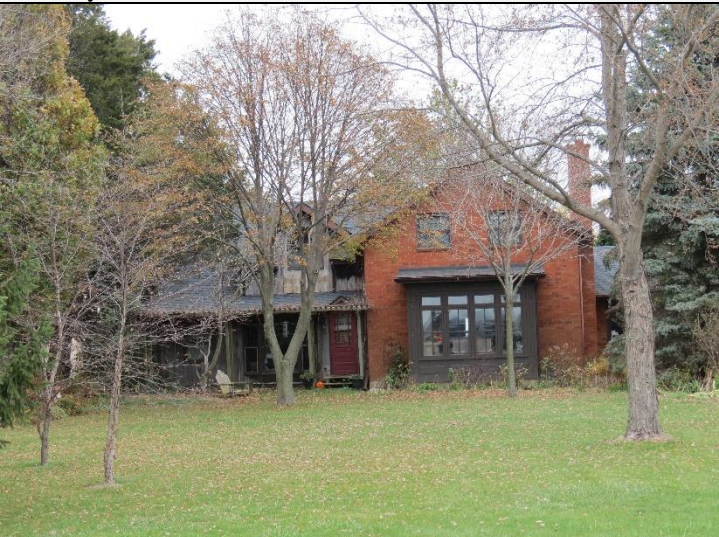
<b>Photo(s)</b>

DESCRIPTION OF PROPERTY	
<b>Street Address</b>	21389 Zion Road
<b>Name</b>	n/a
<b>PIN</b>	8340028
<b>Lot and Concession</b>	Lot 13, Concession 2
<b>Recognition</b>	None
<b>Location</b>	Municipality of Chatham-Kent (formerly Township of Romney)
<b>Participating or Abutting</b>	Participating
<b>Type of Property</b>	Residential
<b>Date(s)</b>	Between 1876 and 1881
<b>Description</b>	<ul style="list-style-type: none"> <li>• Example of an agricultural complex</li> <li>• House is depicted on the 1881 map</li> <li>• Two-storey frame house with a cross gable roof, now partially clad in red brick, and partially clad in board and batten (may have been constructed at different times)</li> <li>• L-shaped plan</li> <li>• Façade exhibits gable dormer with an arched window opening</li> <li>• Shed roof covered porch with an entryway</li> <li>• The front gable (bricked) portion of the house is two -bay, windows appear to have been appear to have been modified</li> <li>• Brick chimney</li> <li>• Situated set back from the road and almost completely screened by trees</li> <li>• Outbuildings and barns on the property</li> <li>• Surrounded by mature trees</li> </ul>

EVALUATION OF PROPERTY			
Criteria	Description	✓	Value Statement(s)
<b>Design or Physical Value</b>	Is a rare, unique, representative or early example of a style, type, expression, material or construction method	✓	Representative example of an agricultural complex including a unique brick and board and batten farmhouse, and outbuildings/barns.
	Displays a high degree of craftsmanship or artistic value		
	Displays a high degree of technical or scientific achievement		
<b>Historical or Associative Value</b>	Has direct associations with a theme, event, belief, person, activity, organization or institution that is significant to a community		
	Yields or has the potential to yield information that contributes to the understanding of a community or culture		
	Demonstrates or reflects the work or ideas of an architect, builder, artist, designer or theorist who is significant to a community		
<b>Contextual Value</b>	Is important in defining, maintaining or supporting the character of an area	✓	Supports the agricultural character of the area.

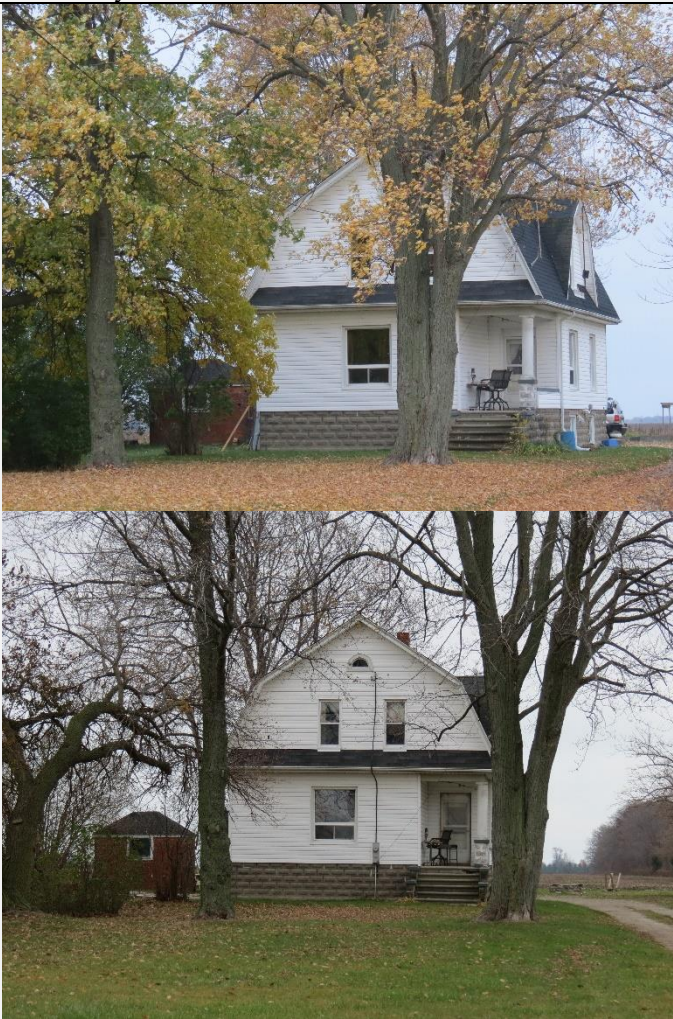
**BUILT HERITAGE RESOURCE NO. 2**

DESCRIPTION OF PROPERTY	
<b>Street Address</b>	1124 4 <sup>th</sup> Concession Line
<b>Name</b>	n/a
<b>PIN</b>	8330045
<b>Lot and Concession</b>	Lot 10, Concession 3
<b>Recognition</b>	None
<b>Location</b>	Municipality of Chatham-Kent (formerly Township of Romney)
<b>Participating or Abutting</b>	Participating
<b>Type of Property</b>	Residential
<b>Date(s)</b>	After 1881
<b>Description</b>	<ul style="list-style-type: none"> <li>• Example of a frame vernacular house</li> <li>• One-and-a-half storey structure with rectangular plan</li> <li>• Side gambrel roof, with a gambrel roof dormer at the front and rear</li> <li>• Clad in siding with cut stone foundation</li> <li>• Red brick chimney</li> </ul>
<b>Photo(s)</b>

EVALUATION OF PROPERTY			
Criteria	Description	✓	Value Statement(s)
<b>Design or Physical Value</b>	Is a rare, unique, representative or early example of a style, type, expression, material or construction method	✓	Unique example of a vernacular house with gambrel roof with two gambrel roof dormers.
	Displays a high degree of craftsmanship or artistic value		
	Displays a high degree of technical or scientific achievement		
<b>Historical or Associative Value</b>	Has direct associations with a theme, event, belief, person, activity, organization or institution that is significant to a community		
	Yields or has the potential to yield information that contributes to the understanding of a community or culture		
	Demonstrates or reflects the work or ideas of an architect, builder, artist, designer or theorist who is significant to a community		
<b>Contextual Value</b>	Is important in defining, maintaining or supporting the character of an area

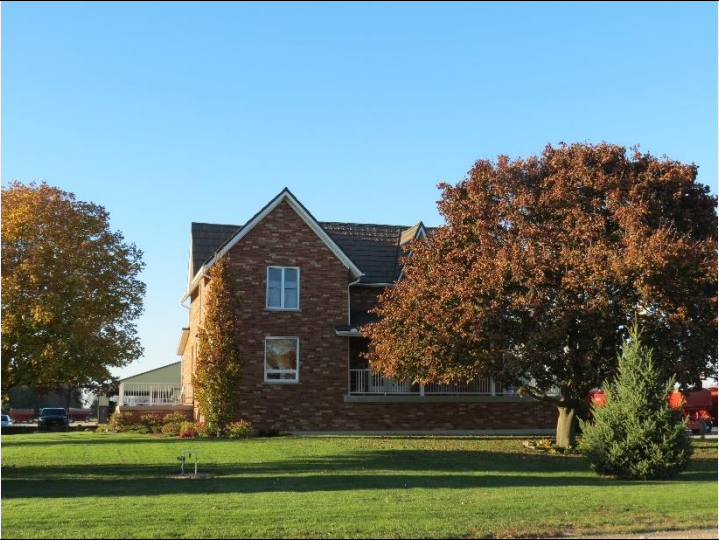
<b>Photo(s)</b>

DESCRIPTION OF PROPERTY	
<b>Street Address</b>	1305 Talbot Trail
<b>Name</b>	n/a
<b>PIN</b>	8470050
<b>Lot and Concession</b>	Lot 11, Concession 2
<b>Recognition</b>	None
<b>Location</b>	Municipality of Chatham-Kent (formerly Township of Romney)
<b>Participating or Abutting</b>	Participating
<b>Type of Property</b>	Residential
<b>Date(s)</b>	After 1881
<b>Description</b>	<ul style="list-style-type: none"> <li>• Example of an agricultural complex</li> <li>• Representative example of the style of Gothic Revival farmhouses found in the study area</li> <li>• Two-storey structure with an L-shaped plan</li> <li>• Cross-gable roof, side gable portion with a central gable</li> <li>• All window openings appear to appear to have been altered</li> <li>• Set back from the road</li> <li>• Cad in brick (may be newer cladding)</li> <li>• Multiple outbuildings at the rear of the house, large farming operation</li> </ul>

EVALUATION OF PROPERTY			
Criteria	Description	✓	Value Statement(s)
<b>Design or Physical Value</b>	Is a rare, unique, representative or early example of a style, type, expression, material or construction method	✓	Representative example of an agricultural complex with a representative example of the style of Gothic Revival farmhouses found in the study area, several outbuildings.
	Displays a high degree of craftsmanship or artistic value		
	Displays a high degree of technical or scientific achievement		
<b>Historical or</b>	Has direct associations with a theme, event, belief, person, activity, organization or

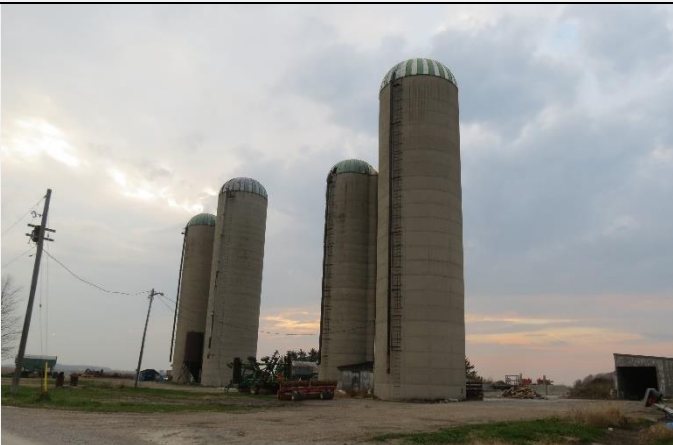
**BUILT HERITAGE RESOURCE NO. 4**

<b>DESCRIPTION OF PROPERTY</b>	
<b>Street Address</b>	North side of 5 <sup>th</sup> Concession Line (across from 1854 5 <sup>th</sup> Concession Line)
<b>Name</b>	n/a
<b>PIN</b>	8310012
<b>Lot and Concession</b>	Lot 16, Concession 5
<b>Recognition</b>	None
<b>Location</b>	Municipality of Chatham-Kent (formerly Township of Romney)
<b>Participating or Abutting</b>	Participating
<b>Type of Property</b>	Agricultural (farm operations buildings only)
<b>Date(s)</b>	Unknown
<b>Description</b>	<ul style="list-style-type: none"> <li>• May be associated with the residence across the road at 1854 5<sup>th</sup> Concession Line</li> <li>• Example of agricultural complex, without a residence</li> <li>• Large barns</li> <li>• Several outbuildings and concrete silos</li> <li>•</li> </ul>
<b>Photo(s)</b>

<b>EVALUATION OF PROPERTY</b>			
<b>Criteria</b>	<b>Description</b>	<b>✓</b>	<b>Value Statement(s)</b>
<b>Design or Physical Value</b>	Is a rare, unique, representative or early example of a style, type, expression, material or construction method		
	Displays a high degree of craftsmanship or artistic value		
	Displays a high degree of technical or scientific achievement		
<b>Historical or Associative Value</b>	Has direct associations with a theme, event, belief, person, activity, organization or institution that is significant to a community		
	Yields or has the potential to yield information that contributes to the understanding of a community or culture		
	Demonstrates or reflects the work or ideas of an architect, builder, artist, designer or theorist who is significant to a community		
<b>Contextual Value</b>	Is important in defining, maintaining or supporting the character of an area	✓	Supports the agricultural character of the area.

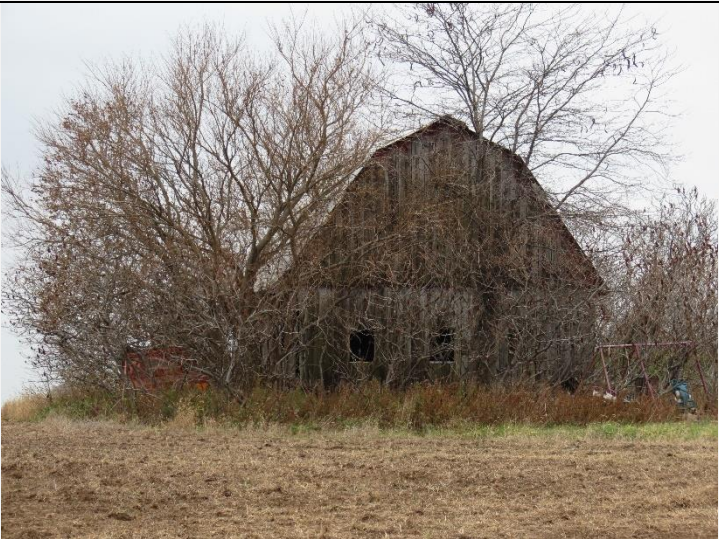
**BUILT HERITAGE RESOURCE NO. 5**

DESCRIPTION OF PROPERTY	
<b>Street Address</b>	2157 Talbot Trail
<b>Name</b>	n/a
<b>PIN</b>	8480104
<b>Lot and Concession</b>	Lot 203, Talbot Road W
<b>Recognition</b>	None
<b>Location</b>	Municipality of Chatham-Kent (formerly Township of Romney)
<b>Participating or Abutting</b>	Participating
<b>Type of Property</b>	Agricultural (farm operations building only)
<b>Date(s)</b>	After 1881
<b>Description</b>	<ul style="list-style-type: none"> <li>• Example of an agricultural complex, without a residence</li> <li>• One large gambrel roof barn</li> <li>• Situated in the middle of an agricultural field</li> <li>•</li> </ul>
<b>Photo(s)</b>

EVALUATION OF PROPERTY			
Criteria	Description	✓	Value Statement(s)
<b>Design or Physical Value</b>	Is a rare, unique, representative or early example of a style, type, expression, material or construction method		
	Displays a high degree of craftsmanship or artistic value		
	Displays a high degree of technical or scientific achievement		
<b>Historical or Associative Value</b>	Has direct associations with a theme, event, belief, person, activity, organization or institution that is significant to a community		
	Yields or has the potential to yield information that contributes to the understanding of a community or culture		
	Demonstrates or reflects the work or ideas of an architect, builder, artist, designer or theorist who is significant to a community

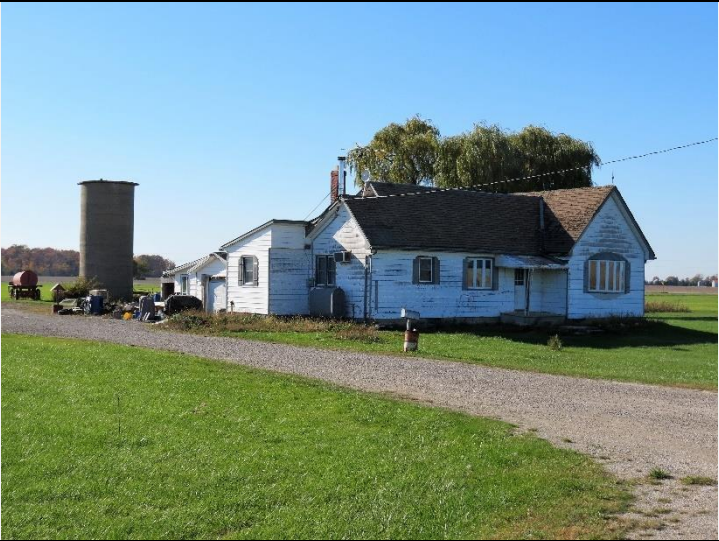
**BUILT HERITAGE RESOURCE NO. 7**

DESCRIPTION OF PROPERTY	
<b>Street Address</b>	22148 Zion Road
<b>Name</b>	n/a
<b>PIN</b>	8330075
<b>Lot and Concession</b>	Lot 12, Concession 5
<b>Recognition</b>	None
<b>Location</b>	Municipality of Chatham-Kent (formerly Township of Romney)
<b>Participating or Abutting</b>	Abutting
<b>Type of Property</b>	Residential
<b>Date(s)</b>	After 1881
<b>Description</b>	<ul style="list-style-type: none"> <li>• Example of an agricultural complex</li> <li>• Example of a vernacular farmhouse</li> <li>• One-storey frame building</li> <li>• Cross gable roof with a shed roof dormer</li> <li>• One-storey rear addition</li> <li>• Situated set back from the road</li> <li>• Several outbuildings/barns/silos on property</li> </ul>
<b>Photo(s)</b>

EVALUATION OF PROPERTY			
Criteria	Description	✓	Value Statement(s)
<b>Design or Physical Value</b>	Is a rare, unique, representative or early example of a style, type, expression, material or construction method	✓	Representative example of an agricultural complex including a representative vernacular farmhouse, at least one barn and one silo.
	Displays a high degree of craftsmanship or artistic value		
	Displays a high degree of technical or scientific achievement		
<b>Historical or Associative Value</b>	Has direct associations with a theme, event, belief, person, activity, organization or institution that is significant to a community		
	Yields or has the potential to yield information that contributes to the understanding of a community or culture

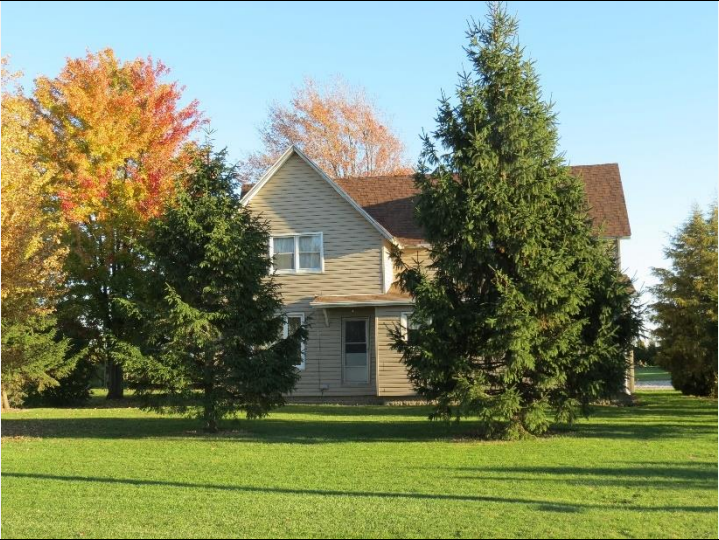
**BUILT HERITAGE RESOURCE NO. 8**

DESCRIPTION OF PROPERTY	
<b>Street Address</b>	1304 Talbot Trail
<b>Name</b>	n/a
<b>PIN</b>	8470156
<b>Lot and Concession</b>	Lot 11, Concession 1
<b>Recognition</b>	None
<b>Location</b>	Municipality of Chatham-Kent (formerly Township of Romney)
<b>Participating or Abutting</b>	Abutting
<b>Type of Property</b>	Residential
<b>Date(s)</b>	After 1881
<b>Description</b>	<ul style="list-style-type: none"> <li>• Example of an agricultural complex</li> <li>• Representative example of the style of Gothic Revival farmhouses found in the study area</li> <li>• Two-storey frame structure with an L-shaped plan</li> <li>• Cross-gable roof, side gable portion with a central gable</li> <li>• All window openings appear to have been altered</li> <li>• Set back from the road</li> <li>• Clad in siding</li> <li>• Multiple outbuildings at the rear of the house</li> </ul>
<b>Photo(s)</b>

EVALUATION OF PROPERTY			
Criteria	Description	✓	Value Statement(s)
<b>Design or Physical Value</b>	Is a rare, unique, representative or early example of a style, type, expression, material or construction method	✓	Representative example of an agricultural complex with a representative example of the style of Gothic Revival farmhouses found in the study area, and several outbuildings.
	Displays a high degree of craftsmanship or artistic value		
	Displays a high degree of technical or scientific achievement		
<b>Historical</b>	Has direct associations with a theme, event,

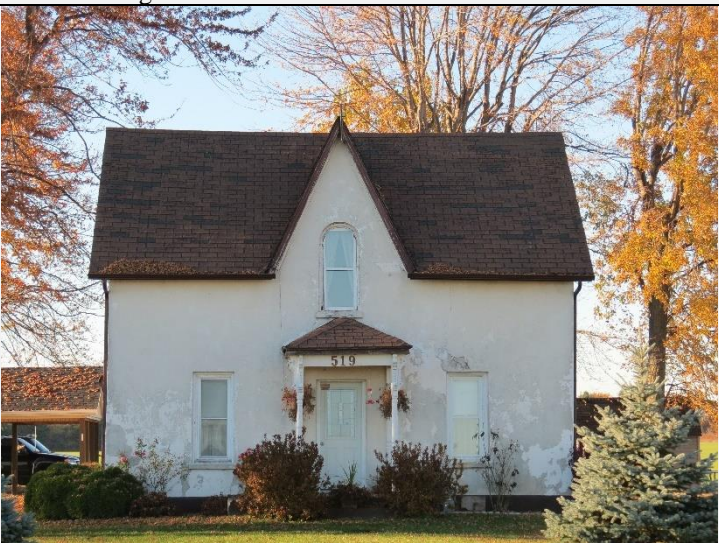
<b>Photo(s)</b>

DESCRIPTION OF PROPERTY	
<b>Street Address</b>	1367 Talbot Trail
<b>Name</b>	n/a
<b>PIN</b>	8470142
<b>Lot and Concession</b>	Lot 12, Concession 2
<b>Recognition</b>	None
<b>Location</b>	Municipality of Chatham-Kent (formerly Township of Romney)
<b>Participating or Abutting</b>	Abutting
<b>Type of Property</b>	Residential
<b>Date(s)</b>	Unknown – house was moved to the property from an unknown location post 2012
<b>Description</b>	<ul style="list-style-type: none"> <li>• Good example of an Gothic Revival farmhouse</li> <li>• One-and-a-half storey frame structure with a side gable roof with one gable</li> <li>• An arched window opening in the gable</li> <li>• Symmetrical façade with central entrance flanked by windows</li> <li>• Entryway with hip roof supported by columns</li> <li>• Situation set far back from the road surrounded by mature trees</li> <li>• Number “519” on the façade - moved to the current property from an unknown location post 2012 (Google Earth Pro 2016)</li> <li>• Rear addition</li> <li>• Several outbuildings</li> </ul>

EVALUATION OF PROPERTY			
Criteria	Description	✓	Value Statement(s)
<b>Design or Physical Value</b>	Is a rare, unique, representative or early example of a style, type, expression, material or construction method	✓	Good example of a Gothic Revival farmhouse.
	Displays a high degree of craftsmanship or artistic value		
	Displays a high degree of technical or scientific achievement		
<b>Historical or</b>	Has direct associations with a theme, event, belief, person, activity, organization or

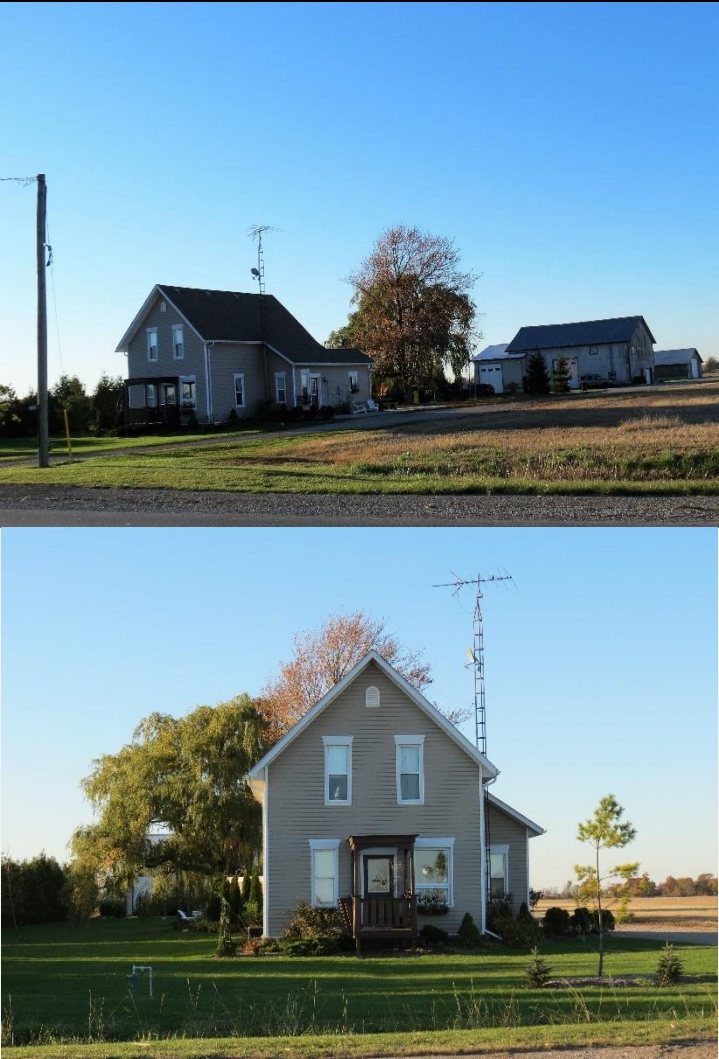
**BUILT HERITAGE RESOURCE NO. 10**

<b>DESCRIPTION OF PROPERTY</b>	
<b>Street Address</b>	1519 Talbot Trail
<b>Name</b>	n/a
<b>PIN</b>	8340059
<b>Lot and Concession</b>	Lot 13, Concession 2
<b>Recognition</b>	None
<b>Location</b>	Municipality of Chatham-Kent (formerly Township of Romney)
<b>Participating or Abutting</b>	Abutting
<b>Type of Property</b>	Residential
<b>Date(s)</b>	After 1881
<b>Description</b>	<ul style="list-style-type: none"> <li>• Example of an agricultural complex</li> <li>• Example of an vernacular farmhouse</li> <li>• Rectangular plan with symmetrical façade</li> <li>• One-and-a-half storey structure with a front gable roof</li> <li>• Frame construction</li> <li>• Clad in new siding</li> <li>• Some gable roof outbuildings/barns</li> </ul>
<b>Photo(s)</b>

<b>EVALUATION OF PROPERTY</b>			
<b>Criteria</b>	<b>Description</b>	<b>✓</b>	<b>Value Statement(s)</b>
<b>Design or Physical Value</b>	Is a rare, unique, representative or early example of a style, type, expression, material or construction method	✓	Representative example of an agricultural complex including a vernacular farmhouse with barns/outbuildings.
	Displays a high degree of craftsmanship or artistic value		
	Displays a high degree of technical or scientific achievement		
<b>Historical or Associative Value</b>	Has direct associations with a theme, event, belief, person, activity, organization or institution that is significant to a community		
	Yields or has the potential to yield information that contributes to the understanding of a community or culture		
	Demonstrates or reflects the work or ideas of an architect, builder, artist, designer or theorist who is significant to a community

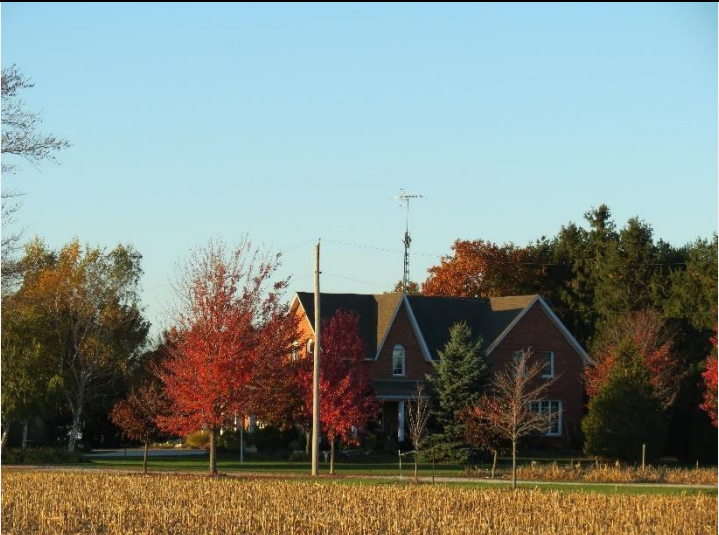
<b>Photo(s)</b>

<b>DESCRIPTION OF PROPERTY</b>	
<b>Street Address</b>	1735 Talbot Trail
<b>Name</b>	n/a
<b>PIN</b>	8340039
<b>Lot and Concession</b>	Lot 15, Concession 2
<b>Recognition</b>	None
<b>Location</b>	Municipality of Chatham-Kent (formerly Township of Romney)
<b>Participating or Abutting</b>	Abutting
<b>Type of Property</b>	Residential
<b>Date(s)</b>	Between 1876 and 1881
<b>Description</b>	<ul style="list-style-type: none"> <li>• Example of an agricultural complex</li> <li>• Good Gothic Revival style building</li> <li>• Two-storey redbrick house with a cross gable roof</li> <li>• L-shaped plan</li> <li>• Façade exhibits steeply pitched gable with an arched window opening with brick voussoirs and stone sill above a shed roof</li> <li>• In the peak of each gable, the brick is laid in basket weave bond while the rest of the house is laid in running bond</li> <li>• Porch supported by pillars that shelters the entryway</li> <li>• The medium pitch front gable portion of the façade is two -bay with rectangular window openings and a large window opening (appear to have been modified)</li> <li>• Situated set back from the road</li> <li>• Outbuildings and barns on the property</li> <li>• Surrounded by mature trees</li> </ul>

EVALUATION OF PROPERTY			
Criteria	Description	✓	Value Statement(s)
<b>Design or Physical Value</b>	Is a rare, unique, representative or early example of a style, type, expression, material or construction method	✓	Representative example of an agricultural complex including a good example of a Gothic Revival farmhouse, and outbuildings/barns.
	Displays a high degree of craftsmanship or artistic value		
	Displays a high degree of technical or scientific achievement		
<b>Historical or Associative Value</b>	Has direct associations with a theme, event, belief, person, activity, organization or institution that is significant to a community		
	Yields or has the potential to yield information that contributes to the understanding of a community or culture		
	Demonstrates or reflects the work or ideas of an architect, builder, artist, designer or theorist who is significant to a community		
<b>Contextual Value</b>	Is important in defining, maintaining or supporting the character of an area	✓	Supports the agricultural character of the area.

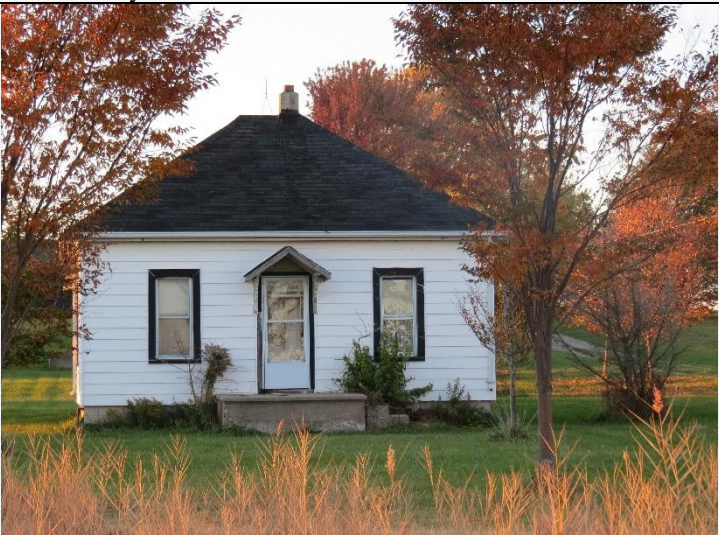
<b>Photo(s)</b>

<b>DESCRIPTION OF PROPERTY</b>	
<b>Street Address</b>	2233 Talbot Trail
<b>Name</b>	n/a
<b>PIN</b>	8490002
<b>Lot and Concession</b>	Lot 202, Talbot Trail W
<b>Recognition</b>	None
<b>Location</b>	Municipality of Chatham-Kent (formerly Township of Romney)
<b>Participating or Abutting</b>	Abutting
<b>Type of Property</b>	Residential
<b>Date(s)</b>	After 1881 (lot owned by the Hetherington Family since at least 1876)
<b>Description</b>	<ul style="list-style-type: none"> <li>• Example of an agricultural complex</li> <li>• Example of a frame vernacular farmhouse</li> <li>• One-storey structure with an square plan</li> <li>• Hip roof, and symmetrical façade</li> <li>• Entryway sheltered by a gable roof supported by brackets</li> <li>• Set back from the road</li> <li>• Clad in siding</li> <li>• Multiple outbuildings at the rear of the house, including one large gambrel roof barn</li> <li>• Barn is large with dressed stone foundation with five rectangular window openings with six-over-six sash windows and three door openings of various sizes</li> <li>• Sign on the barn “Bona Vista Farms, Herb Heatherington”</li> <li>• Lot owned by the Hetherington Family since at least 1876 (Shackleton, J.W. and McIntosh, F.J. 1878)</li> <li>• Heatherington Pioneer Cemetery abuts eastern property boundary with municipal address 2273 Talbot Trail <ul style="list-style-type: none"> <li>○ Romney Township pioneers, including members of the Heatherington family, are buried at the cemetery as well as 20th century burials (rootsweb n.d.),</li> <li>○ Cemetery is closed to further burials</li> </ul> </li> </ul>

RESULTS OF HERITAGE ASSESSMENT	
<b>CHVI Evaluation</b>	Has CHVI.
<b>Heritage Attributes</b>	Key heritage attributes include: one-storey vernacular farmhouse; square floor plan; hip roof; and multiple outbuildings including one large barn; large gambrel roof barn with stone foundation and five six-over-six windows on south elevation.

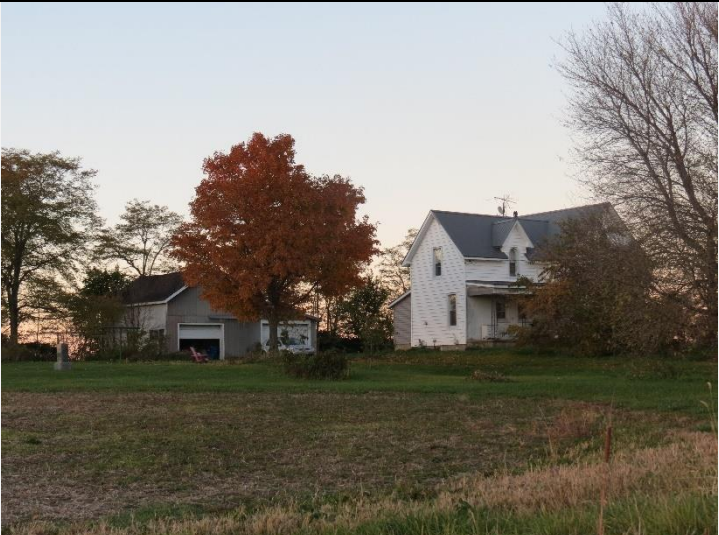
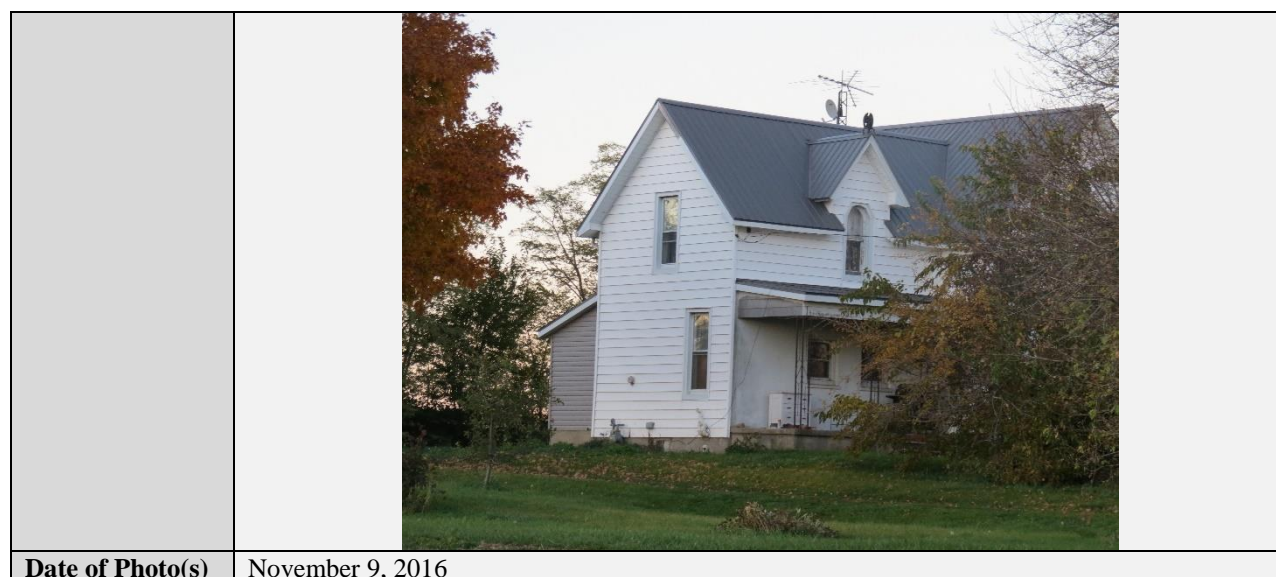
<b>Photo(s)</b>

<b>DESCRIPTION OF PROPERTY</b>	
<b>Street Address</b>	2111 Talbot Trail
<b>Name</b>	n/a
<b>PIN</b>	8480073
<b>Lot and Concession</b>	Lot 203, Talbot Road W
<b>Recognition</b>	None
<b>Location</b>	Municipality of Chatham-Kent (formerly Township of Romney)
<b>Participating or Abutting</b>	Abutting
<b>Type of Property</b>	Residential
<b>Date(s)</b>	After 1881
<b>Description</b>	<ul style="list-style-type: none"> <li>• Example of an agricultural complex</li> <li>• Representative example of the style of Gothic Revival farmhouses found in the study area</li> <li>• Two-storey frame structure with an L-shaped plan</li> <li>• Cross-gable roof, side gable portion with a central gable</li> <li>• Some window openings appear to have been altered</li> <li>• Set back from the road</li> <li>• Clad in siding</li> <li>• House appears to have been heavily altered with a gazebo extending from the covered porch</li> <li>• Multiple outbuildings/barns/silos</li> <li>• Renwick Cemetery abuts western property boundary with municipal address 2107 Talbot Trail               <ul style="list-style-type: none"> <li>○ Family cemetery with members of the Smith and Renwick families interred</li> <li>○ Earliest burial that of Ann Renwick in 1829, latest is George Renwick in 1984 (rootsweb n.d.a.)</li> </ul> </li> </ul>

EVALUATION OF PROPERTY			
Criteria	Description	✓	Value Statement(s)
<b>Design or Physical Value</b>	Is a rare, unique, representative or early example of a style, type, expression, material or construction method	✓	Representative example of an agricultural complex with a representative example of the style of Gothic Revival farmhouses found in the study area, several barns and outbuildings.
	Displays a high degree of craftsmanship or artistic value		
	Displays a high degree of technical or scientific achievement		
<b>Historical or Associative Value</b>	Has direct associations with a theme, event, belief, person, activity, organization or institution that is significant to a community		
	Yields or has the potential to yield information that contributes to the understanding of a community or culture		
	Demonstrates or reflects the work or ideas of an architect, builder, artist, designer or theorist who is significant to a community

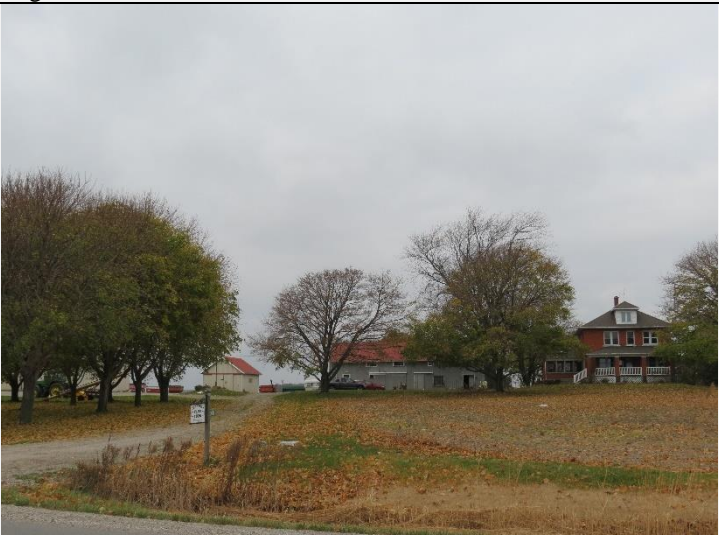
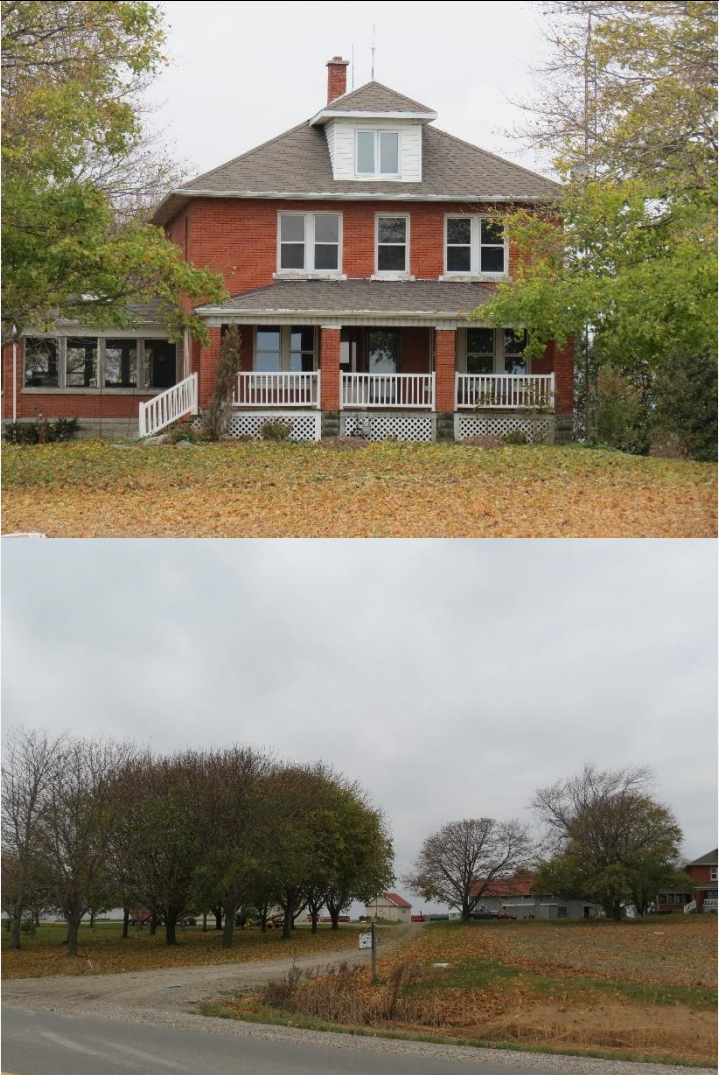
<b>Photo(s)</b>

<b>DESCRIPTION OF PROPERTY</b>	
<b>Street Address</b>	2081 Talbot Trail
<b>Name</b>	n/a
<b>PIN</b>	8480108
<b>Lot and Concession</b>	Lot 204, Talbot Road W
<b>Recognition</b>	None
<b>Location</b>	Municipality of Chatham-Kent (formerly Township of Romney)
<b>Participating or Abutting</b>	Abutting
<b>Type of Property</b>	Residential
<b>Date(s)</b>	After 1881
<b>Description</b>	<ul style="list-style-type: none"> <li>• Example of an agricultural complex</li> <li>• Good example of an Edwardian style building</li> <li>• Two-storey house with a hip roof and central hip roof dormer</li> <li>• Square plan</li> <li>• Red brick construction, bricks laid in stretcher bond</li> <li>• Symmetrical three--bay façade</li> <li>• Centrally placed entryway is flanked by large windows on each side</li> <li>• Hip roof covered porch extends the length of the façade is supported by four brick pillars on stone bases</li> <li>• An addition extends from the east elevation</li> <li>• Central brick chimney set toward the rear</li> <li>• All entryways and window openings are rectangular</li> <li>• Situated set back from the road and surrounded by mature trees</li> <li>• The property is owned by J.C. Renwick according to the 1876 map</li> <li>• Sign out front indicating “Century Farm 1820, Renwick”</li> <li>• Several gable roof barns and newer silos</li> </ul>

EVALUATION OF PROPERTY			
Criteria	Description	✓	Value Statement(s)
<b>Design or Physical Value</b>	Is a rare, unique, representative or early example of a style, type, expression, material or construction method	✓	Representative example of an agricultural complex including a good example of an Edwardian farmhouse and several barns and outbuildings.
	Displays a high degree of craftsmanship or artistic value		
	Displays a high degree of technical or scientific achievement		
<b>Historical or Associative Value</b>	Has direct associations with a theme, event, belief, person, activity, organization or institution that is significant to a community	✓	Is a Century Farm that has been in the Renwick Family since 1820.
	Yields or has the potential to yield information that contributes to the understanding of a community or culture		
	Demonstrates or reflects the work or ideas of an architect, builder, artist, designer or

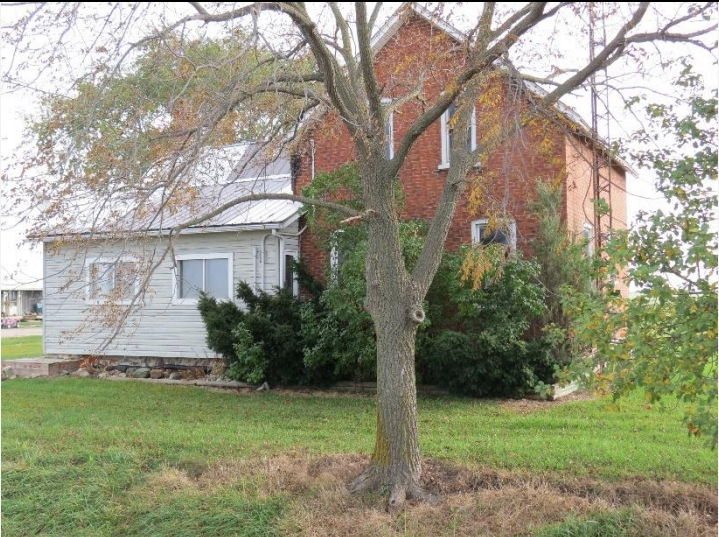
<b>Photo(s)</b>

DESCRIPTION OF PROPERTY	
<b>Street Address</b>	10350 Richardson Side Road
<b>Name</b>	n/a
<b>PIN</b>	750810100
<b>Lot and Concession</b>	Lot 19, Concession 10
<b>Recognition</b>	None
<b>Location</b>	Town of Lakeshore
<b>Participating or Abutting</b>	Abutting
<b>Type of Property</b>	Residential
<b>Date(s)</b>	After 1881
<b>Description</b>	<ul style="list-style-type: none"> <li>• Example of an agricultural complex</li> <li>• Representative front gable vernacular building</li> <li>• Two-storey brick construction</li> <li>• L-shaped plan</li> <li>• Red brick laid in stretcher bond</li> <li>• Cross gable roof, side gable roof portion appears to have been modified</li> <li>• Façade exhibits a two-bay gable and an enclosed porch</li> <li>• At least two barns</li> <li>• Window openings are segmentally arched with brick voussoirs and stone sills</li> <li>• A brick chimney with decorative brickwork remains in the north elevation</li> </ul>

EVALUATION OF PROPERTY			
Criteria	Description	✓	Value Statement(s)
<b>Design or Physical Value</b>	Is a rare, unique, representative or early example of a style, type, expression, material or construction method	✓	Representative example of an agricultural complex including an front gable vernacular building farmhouse and two barns.
	Displays a high degree of craftsmanship or artistic value		
	Displays a high degree of technical or scientific achievement		
<b>Historical or</b>	Has direct associations with a theme, event, belief, person, activity, organization or

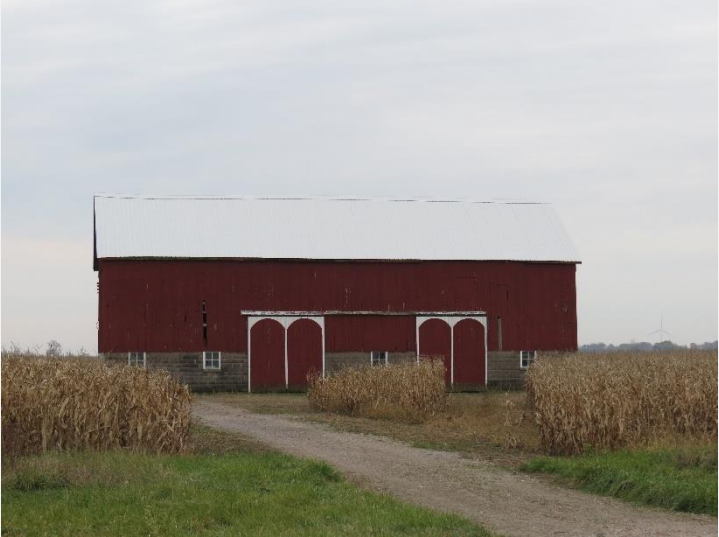
**BUILT HERITAGE RESOURCE NO. 17**

<b>DESCRIPTION OF PROPERTY</b>	
<b>Street Address</b>	No civic address exists
<b>Name</b>	n/a
<b>PIN</b>	750770100
<b>Lot and Concession</b>	Lot 18, Middle Road South Side
<b>Recognition</b>	None
<b>Location</b>	Town of Lakeshore
<b>Participating or Abutting</b>	Abutting
<b>Type of Property</b>	Agricultural (farm operations buildings only)
<b>Date(s)</b>	Unknown
<b>Description</b>	<ul style="list-style-type: none"> <li>• Example of agricultural complex, without a residence</li> <li>• One large barn</li> <li>• L-shaped plan</li> <li>• Cut stone foundation with square window openings</li> <li>• Part of farming complex</li> </ul>
<b>Photo(s)</b>

<b>RESULTS OF HERITAGE ASSESSMENT</b>	
<b>CHVI Evaluation</b>	Has CHVI.
<b>Heritage Attributes</b>	Key heritage attributes include: barn with stone foundation.

<b>EVALUATION OF PROPERTY</b>			
<b>Criteria</b>	<b>Description</b>	<b>✓</b>	<b>Value Statement(s)</b>
<b>Design or Physical Value</b>	Is a rare, unique, representative or early example of a style, type, expression, material or construction method		
	Displays a high degree of craftsmanship or artistic value		
	Displays a high degree of technical or scientific achievement		
<b>Historical or Associative Value</b>	Has direct associations with a theme, event, belief, person, activity, organization or institution that is significant to a community		
	Yields or has the potential to yield information that contributes to the understanding of a community or culture

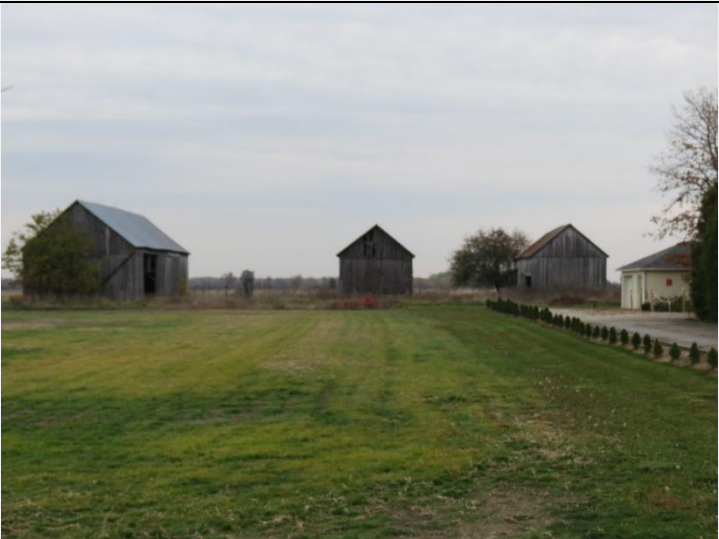
**BUILT HERITAGE RESOURCE NO. 18**

DESCRIPTION OF PROPERTY	
<b>Street Address</b>	No civic address exists
<b>Name</b>	n/a
<b>PIN</b>	750760064
<b>Lot and Concession</b>	Lot 19, Concession 4
<b>Recognition</b>	None
<b>Location</b>	Town of Lakeshore
<b>Participating or Abutting</b>	Abutting
<b>Type of Property</b>	Agricultural (farm operations buildings only)
<b>Date(s)</b>	Unknown
<b>Description</b>	<ul style="list-style-type: none"> <li>• Example of agricultural complex, without a residence</li> <li>• Three large gable roof barns</li> <li>• Maybe associated with 4800 Richardson Sideroad, a separate property parcel</li> <li>•</li> </ul>
<b>Photo(s)</b>

EVALUATION OF PROPERTY			
Criteria	Description	✓	Value Statement(s)
<b>Design or Physical Value</b>	Is a rare, unique, representative or early example of a style, type, expression, material or construction method		
	Displays a high degree of craftsmanship or artistic value		
	Displays a high degree of technical or scientific achievement		
<b>Historical or Associative Value</b>	Has direct associations with a theme, event, belief, person, activity, organization or institution that is significant to a community		
	Yields or has the potential to yield information that contributes to the understanding of a community or culture		
	Demonstrates or reflects the work or ideas of an architect, builder, artist, designer or theorist who is significant to a community

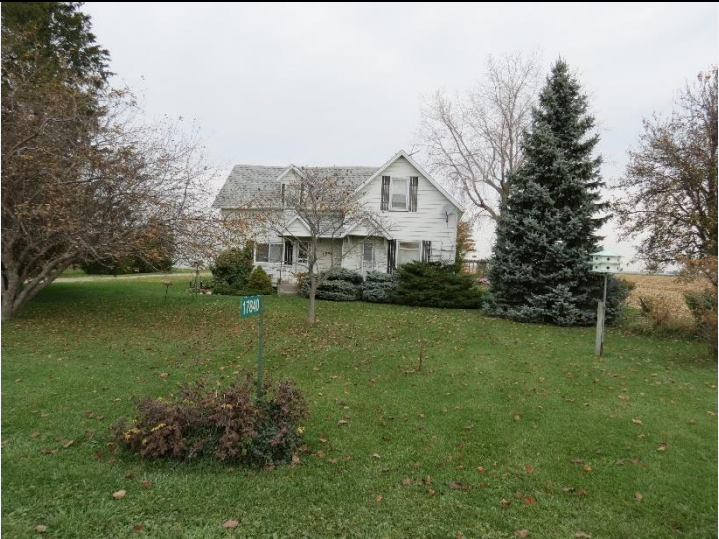
**BUILT HERITAGE RESOURCE NO. 19**

DESCRIPTION OF PROPERTY	
<b>Street Address</b>	17840 Lakeshore Road 311
<b>Name</b>	n/a
<b>PIN</b>	750810065
<b>Lot and Concession</b>	Lot 17, Concession 10
<b>Recognition</b>	None
<b>Location</b>	Town of Lakeshore
<b>Participating or Abutting</b>	Abutting
<b>Type of Property</b>	Residential
<b>Date(s)</b>	After 1881
<b>Description</b>	<ul style="list-style-type: none"> <li>• Example of an agricultural complex</li> <li>• Representative example of the style of Gothic Revival farmhouses found in the study area</li> <li>• Two-storey frame structure with an L-shaped plan</li> <li>• Cross-gable roof, side gable portion with a central gable</li> <li>• Window and door openings appear to have been altered</li> <li>• Set back from the road</li> <li>• Clad in siding</li> <li>• House appears to have been heavily altered</li> <li>• Two barns</li> </ul>
<b>Photo(s)</b>

EVALUATION OF PROPERTY			
Criteria	Description	✓	Value Statement(s)
<b>Design or Physical Value</b>	Is a rare, unique, representative or early example of a style, type, expression, material or construction method	✓	Representative example of an agricultural complex with a representative example of the style of Gothic Revival farmhouses found in the study area, and two barns.
	Displays a high degree of craftsmanship or artistic value		
	Displays a high degree of technical or scientific achievement

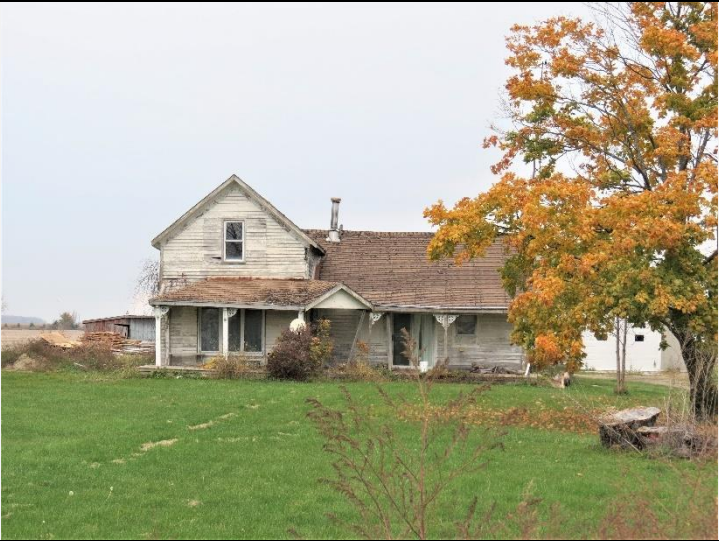
**BUILT HERITAGE RESOURCE NO. 21**

<b>DESCRIPTION OF PROPERTY</b>	
<b>Street Address</b>	15706 Lakeshore Road 311
<b>Name</b>	n/a
<b>PIN</b>	750810043
<b>Lot and Concession</b>	Lot 15, Concession 10
<b>Recognition</b>	None
<b>Location</b>	Town of Lakeshore
<b>Participating or Abutting</b>	Abutting
<b>Type of Property</b>	Residential
<b>Date(s)</b>	After 1881
<b>Description</b>	<ul style="list-style-type: none"> <li>• Example of an agricultural complex</li> <li>• Example of a Gothic Revival farmhouse</li> <li>• One-and-a-half storey structure with an L-shaped plan</li> <li>• Shed roof covered porch supported by columns with decorative brackets</li> <li>• Set back from the road</li> <li>• Wood siding</li> <li>• Multiple outbuildings/barns</li> </ul>
<b>Photo(s)</b>

<b>EVALUATION OF PROPERTY</b>			
<b>Criteria</b>	<b>Description</b>	<b>✓</b>	<b>Value Statement(s)</b>
<b>Design or Physical Value</b>	Is a rare, unique, representative or early example of a style, type, expression, material or construction method	✓	Representative example of an agricultural complex with representative Gothic Revival farmhouse, several barns and outbuildings.
	Displays a high degree of craftsmanship or artistic value		
	Displays a high degree of technical or scientific achievement		
<b>Historical or Associative Value</b>	Has direct associations with a theme, event, belief, person, activity, organization or institution that is significant to a community		
	Yields or has the potential to yield information that contributes to the understanding of a community or culture

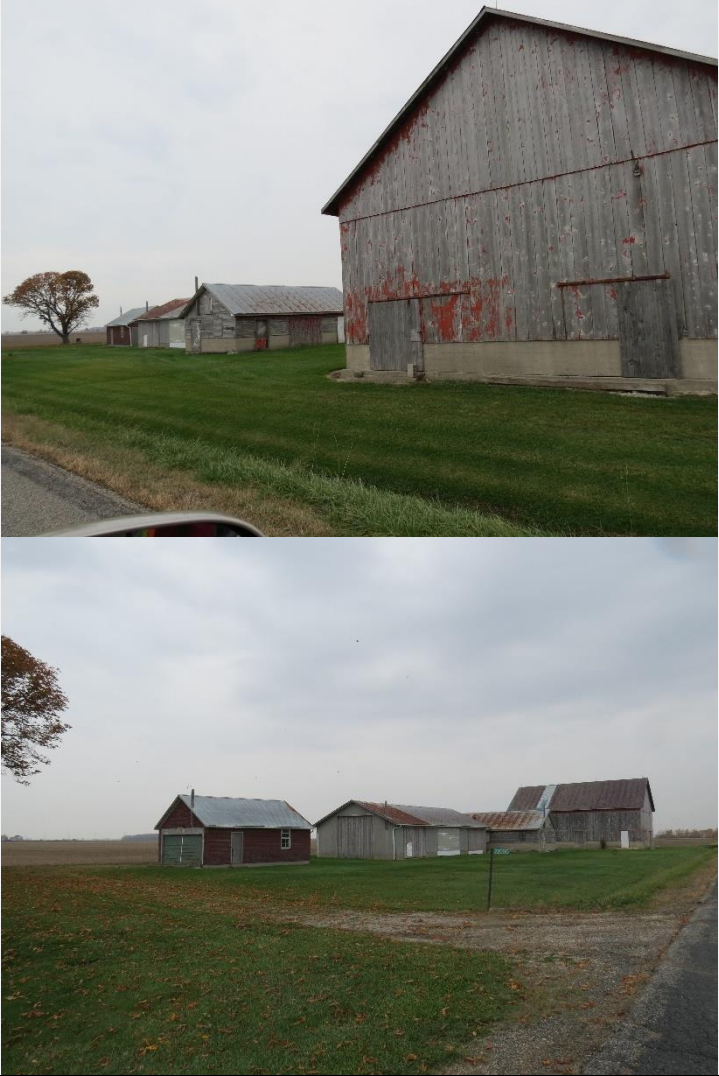
**BUILT HERITAGE RESOURCE NO. 22**

<b>DESCRIPTION OF PROPERTY</b>	
<b>Street Address</b>	22000 Campbell Road
<b>Name</b>	n/a
<b>PIN</b>	8310033
<b>Lot and Concession</b>	Lot 18, Concession 4
<b>Recognition</b>	None
<b>Location</b>	Municipality of Chatham-Kent (formerly Township of Romney)
<b>Participating or Abutting</b>	Abutting
<b>Type of Property</b>	Agricultural (farm operations buildings only)
<b>Date(s)</b>	After 1881
<b>Description</b>	<ul style="list-style-type: none"> <li>• Example of part of an agricultural complex</li> <li>• Four gable roof barns of various sizes</li> <li>• Situated close the road</li> <li>• No residence on the property parcel</li> </ul>
<b>Photo(s)</b>

EVALUATION OF PROPERTY			
Criteria	Description	✓	Value Statement(s)
<b>Design or Physical Value</b>	Is a rare, unique, representative or early example of a style, type, expression, material or construction method		
	Displays a high degree of craftsmanship or artistic value		
	Displays a high degree of technical or scientific achievement		
<b>Historical or Associative Value</b>	Has direct associations with a theme, event, belief, person, activity, organization or institution that is significant to a community		
	Yields or has the potential to yield information that contributes to the understanding of a community or culture		
	Demonstrates or reflects the work or ideas of an architect, builder, artist, designer or theorist who is significant to a community		
<b>Contextual Value</b>	Is important in defining, maintaining or supporting the character of an area	✓	Supports the agricultural character of the area.

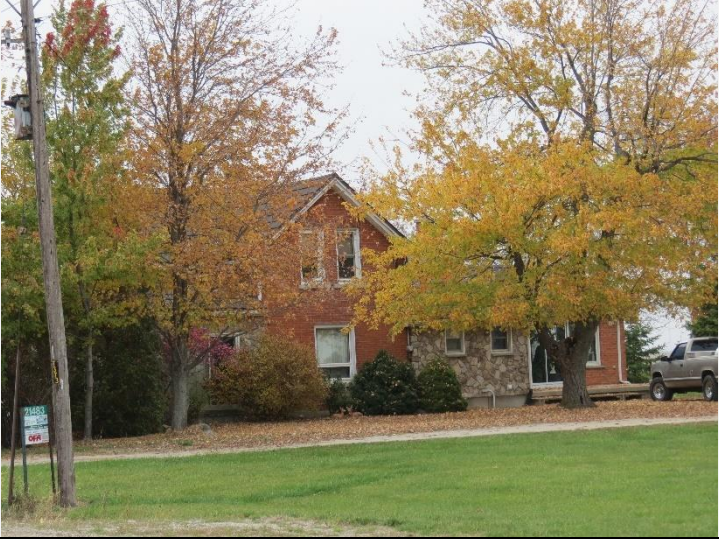
**BUILT HERITAGE RESOURCE NO. 23**

DESCRIPTION OF PROPERTY	
<b>Street Address</b>	21483 Campbell Road
<b>Name</b>	n/a
<b>PIN</b>	8350022
<b>Lot and Concession</b>	Lot 19, Concession 2
<b>Recognition</b>	None
<b>Location</b>	Municipality of Chatham-Kent (formerly Township of Romney)
<b>Participating or Abutting</b>	Abutting
<b>Type of Property</b>	Residential
<b>Date(s)</b>	After 1881
<b>Description</b>	<ul style="list-style-type: none"> <li>• Example of an agricultural complex</li> <li>• Representative Gothic Revival style building</li> <li>• Two-storey with cross gable roof</li> <li>• Red brick construction with some field stone cladding</li> <li>• Rectangular plan</li> <li>• Rectangular window openings</li> <li>• Screened by trees</li> <li>• At least one barn and two silos</li> <li>• House appears to have some additions</li> </ul>
<b>Photo(s)</b>

EVALUATION OF PROPERTY			
Criteria	Description	✓	Value Statement(s)
<b>Design or Physical Value</b>	Is a rare, unique, representative or early example of a style, type, expression, material or construction method	✓	Representative example of an agricultural complex including a Gothic Revival two-storey red brick residence with cross gable roof with a barn and silos.
	Displays a high degree of craftsmanship or artistic value		
	Displays a high degree of technical or scientific achievement		
<b>Historical or</b>	Has direct associations with a theme, event, belief, person, activity, organization or

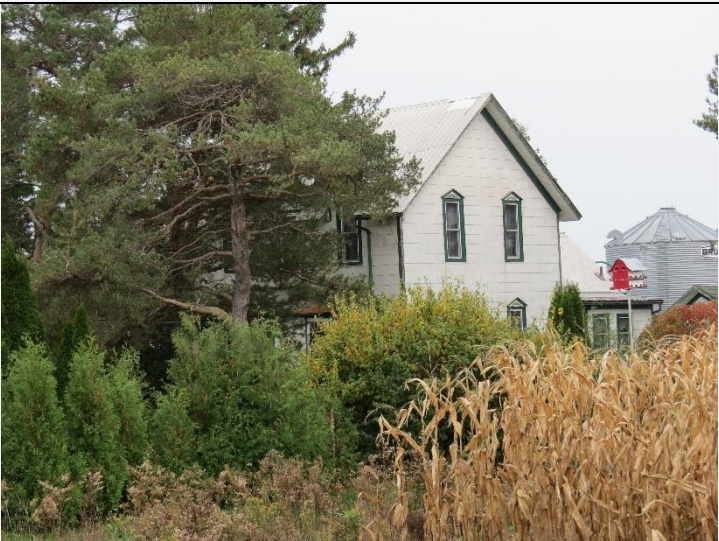
DESCRIPTION OF PROPERTY	
<b>Street Address</b>	21362 Campbell Road
<b>Name</b>	n/a
<b>PIN</b>	8340048
<b>Lot and Concession</b>	Lot 18, Concession 2
<b>Recognition</b>	None
<b>Location</b>	Municipality of Chatham-Kent (formerly Township of Romney)
<b>Participating or Abutting</b>	Abutting
<b>Type of Property</b>	Residential
<b>Date(s)</b>	After 1881
<b>Description</b>	<ul style="list-style-type: none"> <li>• Two-storey frame vernacular house</li> <li>• Rectangular plan</li> <li>• Side gable metal roof</li> <li>• The house is clad in white shingles</li> <li>• A gable roof vestibule on the façade</li> <li>• Three symmetrical gable roof dormers in the façade</li> <li>• Two--bay gable end</li> <li>• Rectangular window openings with decorated pediments</li> <li>• Most of the house is screened by trees and cannot be seen from the road</li> <li>• One outbuilding and several barns/silos are located on the property</li> <li>• Situation set back from the road, surrounded by mature trees</li> </ul>

EVALUATION OF PROPERTY			
Criteria	Description	✓	Value Statement(s)
<b>Design or Physical Value</b>	Is a rare, unique, representative or early example of a style, type, expression, material or construction method	✓	Good example of a two-storey vernacular house with a rectangular plan.
	Displays a high degree of craftsmanship or artistic value		
	Displays a high degree of technical or
