## **APPENDIX C – CULTURAL HERITAGE ASSESSMENT**

<b>Project:</b>	<b>Romney Wind Energy Centre</b>
<b>OPA Reference Number:</b>	<b>L006356-WIN-001-060</b>
<b>Report Title:</b>	<b>Romney Wind Energy Centre: Cultural Heritage Assessment</b>
<b>Applicant:</b>	<b>Romney Energy Centre Limited Partnership</b>
<b>Location:</b>	<b>Geographic Townships of Romney and Tilbury West Municipality of Chatham-Kent, Ontario</b>
<b>MTCS File No.:</b>	<b>0005856</b>

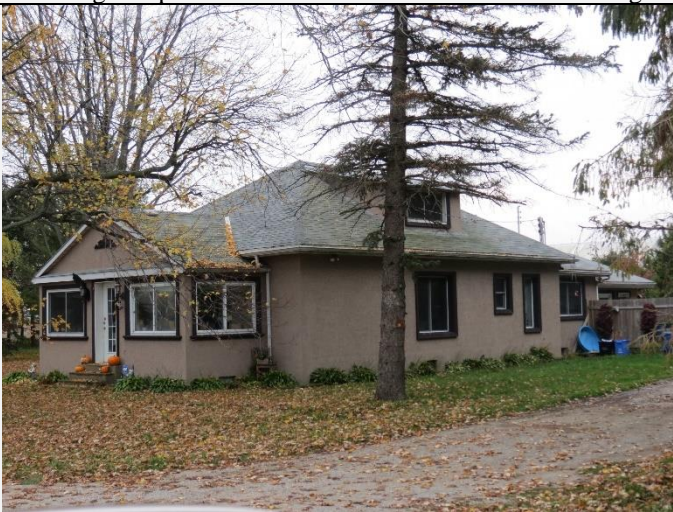
**BUILT HERITAGE RESOURCE NO. 25**

DESCRIPTION OF PROPERTY	
<b>Street Address</b>	2051 3 <sup>rd</sup> Concession Line
<b>Name</b>	n/a
<b>PIN</b>	8340057
<b>Lot and Concession</b>	Lot 17, Concession 2
<b>Location</b>	Municipality of Chatham-Kent (formerly Township of Romney)
<b>Participating or Abutting</b>	Abutting
<b>Type of Property</b>	Residential
<b>Date(s)</b>	After 1881
<b>Description</b>	<ul style="list-style-type: none"> <li>• Vernacular house</li> <li>• One-storey, hip roof frame construction with stucco cladding</li> <li>• Square shaped plan with a gable roof vestibule</li> <li>• Some addition at the rear</li> <li>• Shed roof dormer</li> <li>• Irregular placement and size of windows</li> <li>• Part of a farming complex that includes silos and barns/outbuildings</li> </ul>
<b>Photo(s)</b>

EVALUATION OF PROPERTY			
Criteria	Description	✓	Value Statement(s)
<b>Design or Physical Value</b>	Is a rare, unique, representative or early example of a style, type, expression, material or construction method	✓	Representative example of a vernacular one-storey square-shaped plan house.
	Displays a high degree of craftsmanship or artistic value		
	Displays a high degree of technical or scientific achievement		
<b>Historical or Associative Value</b>	Has direct associations with a theme, event, belief, person, activity, organization or institution that is significant to a community		
	Yields or has the potential to yield information that contributes to the understanding of a community or culture		
	Demonstrates or reflects the work or ideas of

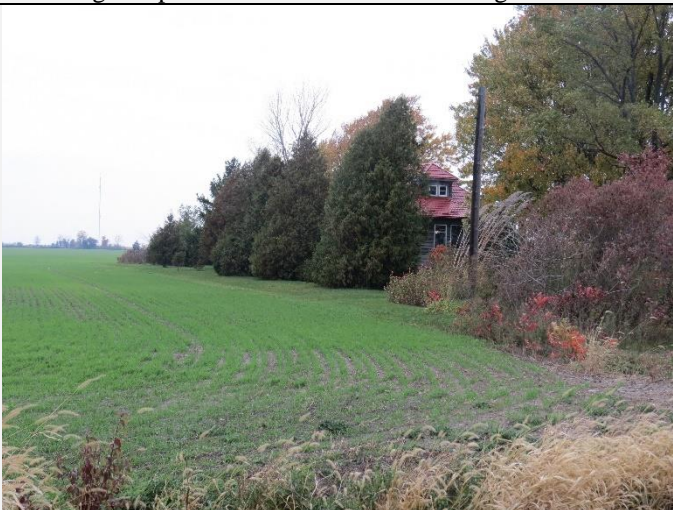
**BUILT HERITAGE RESOURCE NO. 26**

DESCRIPTION OF PROPERTY	
<b>Street Address</b>	1383 3 <sup>rd</sup> Concession Line
<b>Name</b>	n/a
<b>PIN</b>	8330104
<b>Lot and Concession</b>	Lot 12, Concession 3
<b>Location</b>	Municipality of Chatham-Kent (formerly Township of Romney)
<b>Participating or Abutting</b>	Abutting
<b>Type of Property</b>	Residential
<b>Date(s)</b>	After 1881
<b>Description</b>	<ul style="list-style-type: none"> <li>• One-and-a-half storey vernacular house</li> <li>• Hip roof</li> <li>• Frame construction with cedar siding</li> <li>• Hip roof vestibule and hip roof dormer on façade</li> <li>• Difficult to see house from road, screened by trees</li> <li>• Part of a farming complex that includes at least three gable roof barns</li> </ul>
<b>Photo(s)</b>

EVALUATION OF PROPERTY			
Criteria	Description	✓	Value Statement(s)
<b>Design or Physical Value</b>	Is a rare, unique, representative or early example of a style, type, expression, material or construction method	✓	Representative example of a vernacular one-and-a-half storey house with hip roof.
	Displays a high degree of craftsmanship or artistic value		
	Displays a high degree of technical or scientific achievement		
<b>Historical or Associative Value</b>	Has direct associations with a theme, event, belief, person, activity, organization or institution that is significant to a community		
	Yields or has the potential to yield information that contributes to the understanding of a community or culture		
	Demonstrates or reflects the work or ideas of an architect, builder, artist, designer or theorist who is significant to a community

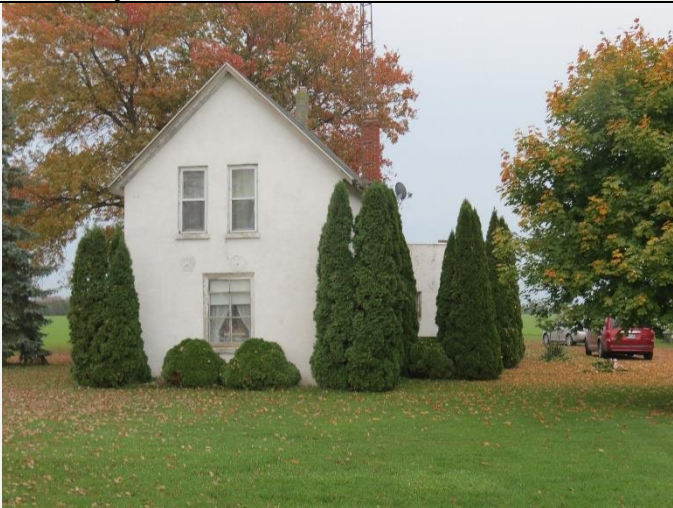
**BUILT HERITAGE RESOURCE NO. 27**

<b>DESCRIPTION OF PROPERTY</b>	
<b>Street Address</b>	1244 3 <sup>rd</sup> Concession Line
<b>Name</b>	n/a
<b>PIN</b>	8470045
<b>Lot and Concession</b>	Lot 11, Concession 2
<b>Recognition</b>	None
<b>Location</b>	Municipality of Chatham-Kent (formerly Township of Romney)
<b>Participating or Abutting</b>	Abutting
<b>Type of Property</b>	Residential
<b>Date(s)</b>	Before 1881
<b>Description</b>	<ul style="list-style-type: none"> <li>• Example of a gable roof vernacular farmhouse</li> <li>• Two-storey frame structure</li> <li>• Originally rectangular plan</li> <li>• Steep pitch side gable roof with centrally place gable</li> <li>• Façade of house faces away from the road</li> <li>• Clad in stucco</li> <li>• Wood window surrounds with stone sills</li> <li>• Addition at rear of property (side elevation)</li> <li>• Red brick chimney at rear of house</li> </ul>
<b>Photo(s)</b>

<b>EVALUATION OF PROPERTY</b>			
<b>Criteria</b>	<b>Description</b>	<b>✓</b>	<b>Value Statement(s)</b>
<b>Design or Physical Value</b>	Is a rare, unique, representative or early example of a style, type, expression, material or construction method	✓	Representative example of an agricultural complex with a gable roof farmhouse, several barns and outbuildings.
	Displays a high degree of craftsmanship or artistic value		
	Displays a high degree of technical or scientific achievement		
<b>Historical or Associative</b>	Has direct associations with a theme, event, belief, person, activity, organization or institution that is significant to a community

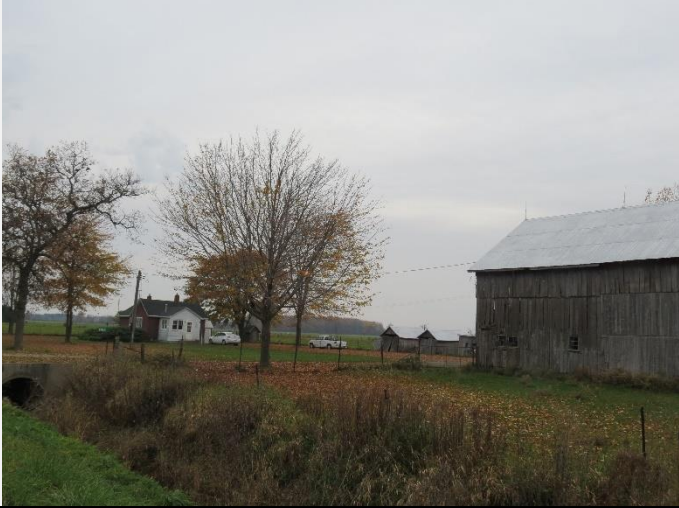
**BUILT HERITAGE RESOURCE NO. 28**

DESCRIPTION OF PROPERTY	
<b>Street Address</b>	1183 3 <sup>rd</sup> Concession Line
<b>Name</b>	n/a
<b>PIN</b>	8330049
<b>Lot and Concession</b>	Lot 10, Concession 3
<b>Location</b>	Municipality of Chatham-Kent (formerly Township of Romney)
<b>Participating or Abutting</b>	Abutting
<b>Type of Property</b>	Residential
<b>Date(s)</b>	After 1881
<b>Description</b>	<ul style="list-style-type: none"> <li>• A vernacular house</li> <li>• One-storey, side gable roof red brick construction with gable roof vestibule</li> <li>• Some additions noted</li> <li>• Two brick chimneys</li> <li>• Part of a farming complex that includes one large barn and several outbuildings</li> </ul>
<b>Photo(s)</b>

EVALUATION OF PROPERTY			
Criteria	Description	✓	Value Statement(s)
<b>Design or Physical Value</b>	Is a rare, unique, representative or early example of a style, type, expression, material or construction method	✓	Representative example of an agricultural complex with vernacular one-storey brick farmhouse and several outbuildings.
	Displays a high degree of craftsmanship or artistic value		
	Displays a high degree of technical or scientific achievement		
<b>Historical or Associative Value</b>	Has direct associations with a theme, event, belief, person, activity, organization or institution that is significant to a community		
	Yields or has the potential to yield information that contributes to the understanding of a community or culture		
	Demonstrates or reflects the work or ideas of an architect, builder, artist, designer or theorist who is significant to a community		
<b>Contextual</b>	Is important in defining, maintaining or	✓	Supports the agricultural character of the area.

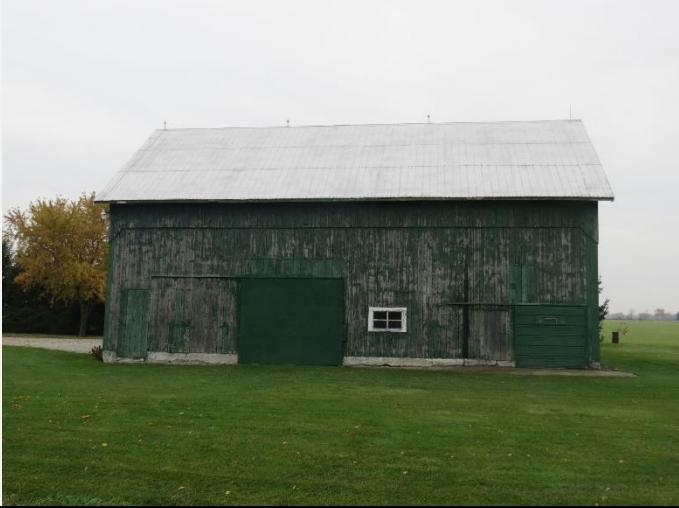
**BUILT HERITAGE RESOURCE NO. 29**

DESCRIPTION OF PROPERTY	
<b>Street Address</b>	1121 3 <sup>rd</sup> Concession Line
<b>Name</b>	n/a
<b>PIN</b>	8330071
<b>Lot and Concession</b>	Lot 10, Concession 3
<b>Location</b>	Municipality of Chatham-Kent (formerly Township of Romney)
<b>Participating or Abutting</b>	Abutting
<b>Type of Property</b>	Agricultural (without a residence)
<b>Date(s)</b>	After 1881
<b>Description</b>	<ul style="list-style-type: none"> <li>• Example of agricultural property, without a residence</li> <li>• One large gable roof barn</li> <li>• Rectangular plan</li> <li>•</li> </ul>
<b>Photo(s)</b>

EVALUATION OF PROPERTY			
Criteria	Description	✓	Value Statement(s)
<b>Design or Physical Value</b>	Is a rare, unique, representative or early example of a style, type, expression, material or construction method		
	Displays a high degree of craftsmanship or artistic value		
	Displays a high degree of technical or scientific achievement		
<b>Historical or Associative Value</b>	Has direct associations with a theme, event, belief, person, activity, organization or institution that is significant to a community		
	Yields or has the potential to yield information that contributes to the understanding of a community or culture		
	Demonstrates or reflects the work or ideas of an architect, builder, artist, designer or theorist who is significant to a community		
<b>Contextual Value</b>	Is important in defining, maintaining or supporting the character of an area	✓	Supports the agricultural character of the area.

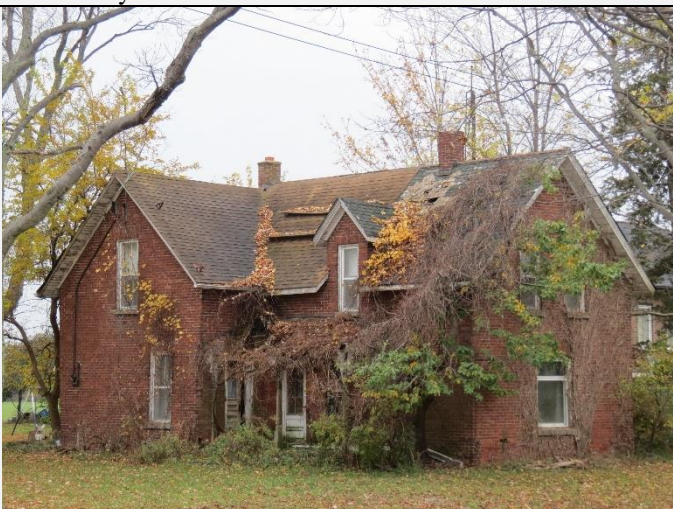
DESCRIPTION OF PROPERTY	
<b>Street Address</b>	1054 3 <sup>rd</sup> Concession Line
<b>Name</b>	n/a
<b>PIN</b>	8470034
<b>Lot and Concession</b>	Lot 9, Concession 2
<b>Recognition</b>	None
<b>Location</b>	Municipality of Chatham-Kent (formerly Township of Romney)
<b>Participating or Abutting</b>	Abutting
<b>Type of Property</b>	Residential
<b>Date(s)</b>	After 1881
<b>Description</b>	<ul style="list-style-type: none"> <li>• Representative example of the style of Gothic Revival farmhouses found in the study area</li> <li>• Two-storey red brick with cross gable roof</li> <li>• Red brick construction</li> <li>• L-shaped plan</li> <li>• Rectangular window openings with radiating brick voussoirs and stone sills</li> <li>• Screened by trees from the road</li> <li>• Façade does not face onto the road</li> <li>• Medium pitch gable with rectangular window opening and off-centre entryway</li> <li>• Appears part of an agricultural complex</li> <li>• Two brick chimneys</li> </ul>

EVALUATION OF PROPERTY			
Criteria	Description	✓	Value Statement(s)
<b>Design or Physical Value</b>	Is a rare, unique, representative or early example of a style, type, expression, material or construction method	✓	Representative example of an agricultural complex including a representative example of the style of Gothic Revival farmhouses found in the study area with barns.
	Displays a high degree of craftsmanship or artistic value		
	Displays a high degree of technical or scientific achievement		
<b>Historical</b>	Has direct associations with a theme, event,

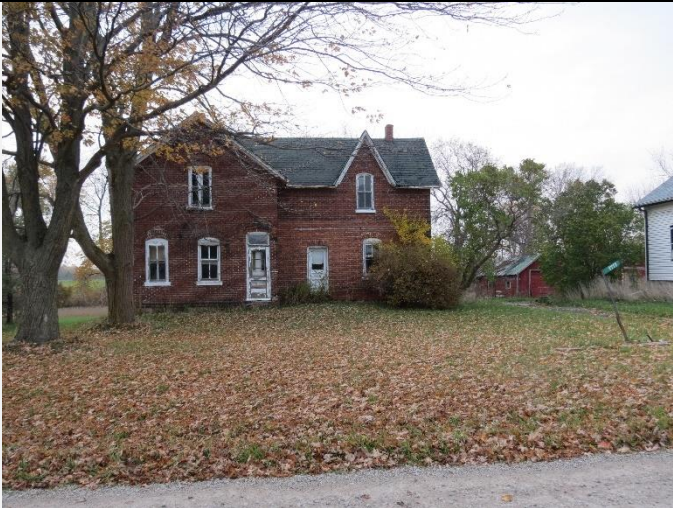
DESCRIPTION OF PROPERTY	
<b>Street Address</b>	1111 4 <sup>th</sup> Concession Line
<b>Name</b>	n/a
<b>PIN</b>	8330016
<b>Lot and Concession</b>	Lot 10, Concession 4
<b>Recognition</b>	None
<b>Location</b>	Municipality of Chatham-Kent (formerly Township of Romney)
<b>Participating or Abutting</b>	Abutting
<b>Type of Property</b>	Residential
<b>Date(s)</b>	After 1881
<b>Description</b>	<ul style="list-style-type: none"> <li>• Example of an agricultural complex</li> <li>• Good example of a Gothic Revival farmhouse</li> <li>• Two-storey red-brick house with a cross gable roof</li> <li>• L-shaped plan</li> <li>• Addition on the rear</li> <li>• Almost mirror image of the red brick (now painted white) house at 1116 4<sup>th</sup> Concession Line on the same lot to the east</li> <li>• Façade exhibits a medium pitched gable with a segmentally arched window opening above a similar first storey window openings beside the entryway, all of which are segmentally arched</li> <li>• The medium pitch front gable portion of the façade is three-bay with segmentally arched window opening and a second entryway on the first storeys, all segmentally arched with a three-layer header voussoirs, the second storey exhibits a paired arched windows</li> <li>• Decorative brickwork follows along the roofline of the façade gable</li> <li>• Many barns and outbuildings are extant on the property</li> </ul>

EVALUATION OF PROPERTY			
Criteria	Description	✓	Value Statement(s)
<b>Design or Physical Value</b>	Is a rare, unique, representative or early example of a style, type, expression, material or construction method	✓	Representative example of an agricultural complex including a good example of an L-shaped Gothic Revival residence and barns.
	Displays a high degree of craftsmanship or

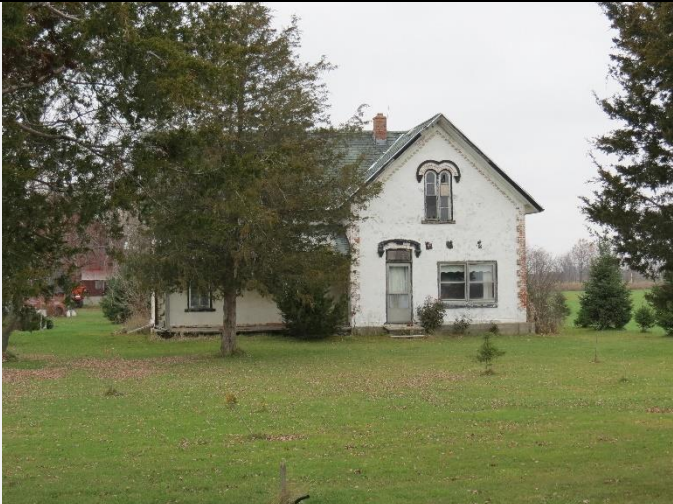
<b>DESCRIPTION OF PROPERTY</b>	
<b>Street Address</b>	1161 4 <sup>th</sup> Concession Line
<b>Name</b>	n/a
<b>PIN</b>	8330015
<b>Lot and Concession</b>	Lot 10, Concession 4
<b>Recognition</b>	None
<b>Location</b>	Municipality of Chatham-Kent (formerly Township of Romney)
<b>Participating or Abutting</b>	Abutting
<b>Type of Property</b>	Residential
<b>Date(s)</b>	After 1881
<b>Description</b>	<ul style="list-style-type: none"> <li>• Example of an agricultural complex</li> <li>• Excellent example of a Gothic Revival farmhouse</li> <li>• Two-storey red-brick house with a cross gable roof</li> <li>• L-shaped plan</li> <li>• Addition on the rear</li> <li>• Almost mirror image of the red brick house at 1111 4<sup>th</sup> Concession Line on the same lot to the west</li> <li>• Façade exhibits a medium pitched gable with an arched window opening above a shed roof covered porch that shelters an entryway and window</li> <li>• The medium pitch front gable portion of the façade is two -bay with a appear to have been modified window opening on the first storey beside an entryway, the second storey has paired arched windows with a hoodmould</li> <li>• The front door has a hoodmould</li> <li>• The decorative brickwork has been partially hidden by white paint, but the quoining and some dentil details are visible</li> <li>• Many barns and outbuildings are extant on the property</li> <li>•</li> </ul>

EVALUATION OF PROPERTY			
Criteria	Description	✓	Value Statement(s)
<b>Design or Physical Value</b>	Is a rare, unique, representative or early example of a style, type, expression, material or construction method	✓	Representative example of an agricultural complex including an excellent example of an L-shaped Gothic Revival residence and barns.
	Displays a high degree of craftsmanship or artistic value		
	Displays a high degree of technical or scientific achievement		
<b>Historical or Associative Value</b>	Has direct associations with a theme, event, belief, person, activity, organization or institution that is significant to a community		
	Yields or has the potential to yield information that contributes to the understanding of a community or culture		
	Demonstrates or reflects the work or ideas of an architect, builder, artist, designer or theorist who is significant to a community		
<b>Contextual Value</b>	Is important in defining, maintaining or supporting the character of an area	✓	Supports the agricultural character of the area.

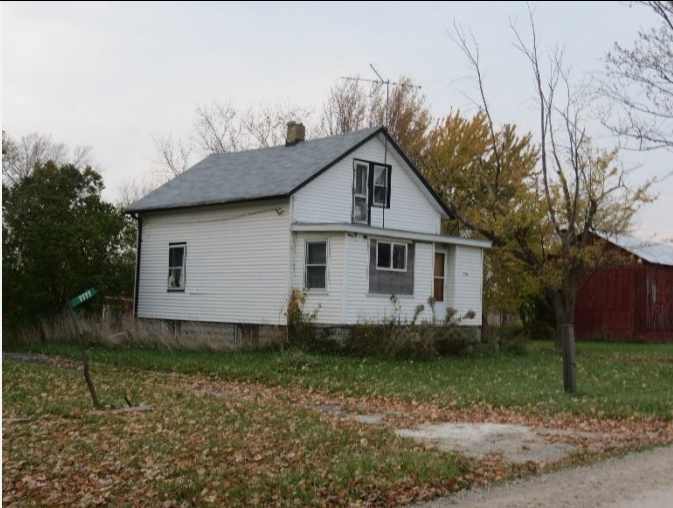
**BUILT HERITAGE RESOURCE NO. 33**

<b>DESCRIPTION OF PROPERTY</b>	
<b>Street Address</b>	1113 4 <sup>th</sup> Concession Line
<b>Name</b>	n/a
<b>PIN</b>	8330016
<b>Lot and Concession</b>	Lot 10, Concession 4
<b>Recognition</b>	None
<b>Location</b>	Municipality of Chatham-Kent (formerly Township of Romney)
<b>Participating or Abutting</b>	Abutting
<b>Type of Property</b>	Residential
<b>Date(s)</b>	After 1881
<b>Description</b>	<ul style="list-style-type: none"> <li>• Example of an agricultural complex</li> <li>• Example of a frame vernacular farmhouse</li> <li>• One-and-a-half storey structure with rectangular plan</li> <li>• Front gable roof, and shed roof covered vestibule</li> <li>• entryway sheltered by a gable roof supported by brackets</li> <li>• Clad in siding</li> <li>• One centrally placed yellow brick chimney</li> <li>• Multiple outbuildings at the rear of the house, including one large gable roof barn</li> </ul>
<b>Photo(s)</b>

<b>EVALUATION OF PROPERTY</b>			
<b>Criteria</b>	<b>Description</b>	<b>✓</b>	<b>Value Statement(s)</b>
<b>Design or Physical Value</b>	Is a rare, unique, representative or early example of a style, type, expression, material or construction method	✓	Representative example of an agricultural complex with a small vernacular farmhouse, several outbuildings including a large barn.
	Displays a high degree of craftsmanship or artistic value		
	Displays a high degree of technical or scientific achievement		
<b>Historical or Associative</b>	Has direct associations with a theme, event, belief, person, activity, organization or institution that is significant to a community

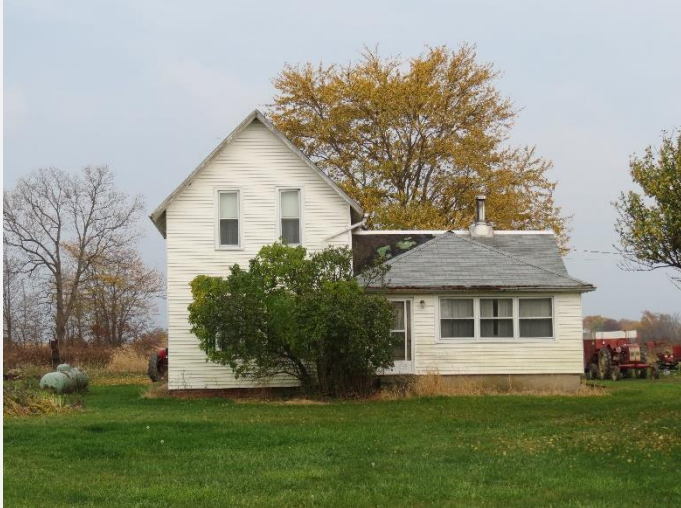
**BUILT HERITAGE RESOURCE NO. 34**

DESCRIPTION OF PROPERTY	
<b>Street Address</b>	1242 4 <sup>th</sup> Concession Line
<b>Name</b>	n/a
<b>PIN</b>	8330050
<b>Lot and Concession</b>	Lot 11, Concession 3
<b>Recognition</b>	None
<b>Location</b>	Municipality of Chatham-Kent (formerly Township of Romney)
<b>Participating or Abutting</b>	Abutting
<b>Type of Property</b>	Residential
<b>Date(s)</b>	Before 1881
<b>Description</b>	<ul style="list-style-type: none"> <li>• Example of an agricultural complex</li> <li>• Example of a Gothic Revival farmhouse</li> <li>• Two-storey structure with an L-shaped plan</li> <li>• Set back from the road</li> <li>• Clad in siding</li> <li>• House appears to have been heavily altered</li> <li>• Multiple outbuildings/barns</li> <li>•</li> </ul>
<b>Photo(s)</b>

EVALUATION OF PROPERTY			
Criteria	Description	✓	Value Statement(s)
<b>Design or Physical Value</b>	Is a rare, unique, representative or early example of a style, type, expression, material or construction method	✓	Representative example of an agricultural complex with a Gothic Revival farmhouse, several barns and outbuildings.
	Displays a high degree of craftsmanship or artistic value		
	Displays a high degree of technical or scientific achievement		
<b>Historical or Associative Value</b>	Has direct associations with a theme, event, belief, person, activity, organization or institution that is significant to a community		
	Yields or has the potential to yield

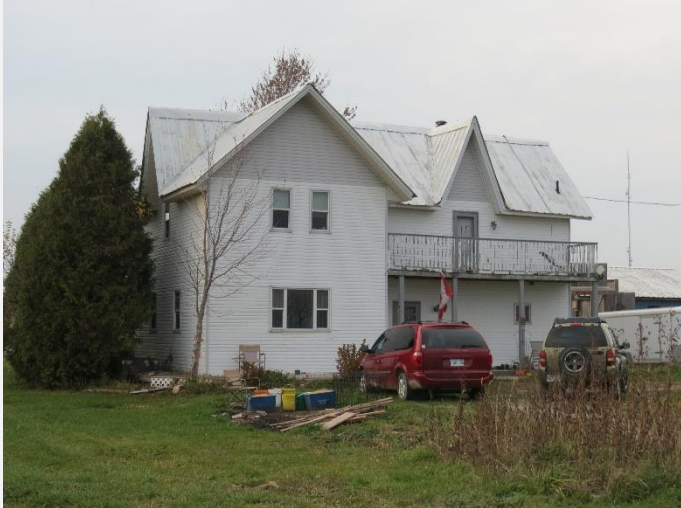
**BUILT HERITAGE RESOURCE NO. 35**

<b>DESCRIPTION OF PROPERTY</b>	
<b>Street Address</b>	1293 4 <sup>th</sup> Concession Line
<b>Name</b>	n/a
<b>PIN</b>	8330073
<b>Lot and Concession</b>	Lot 11, Concession 4
<b>Recognition</b>	None
<b>Location</b>	Municipality of Chatham-Kent (formerly Township of Romney)
<b>Participating or Abutting</b>	Abutting
<b>Type of Property</b>	Residential
<b>Date(s)</b>	After 1881
<b>Description</b>	<ul style="list-style-type: none"> <li>• Example of an agricultural complex</li> <li>• Representative Gothic Revival farmhouse</li> <li>• Two-storey frame house with a cross gable roof</li> <li>• L-shaped plan</li> <li>• Façade exhibits steeply pitched gable with an rectangular entryway to a balcony over the main entryway and a small square window</li> <li>• The medium pitch front gable portion of the façade is two -bay with rectangular window openings and a large window opening (appear to have been modified)</li> <li>• Outbuildings and barns on the property</li> </ul>

<b>EVALUATION OF PROPERTY</b>			
<b>Criteria</b>	<b>Description</b>	<b>✓</b>	<b>Value Statement(s)</b>
<b>Design or Physical Value</b>	Is a rare, unique, representative or early example of a style, type, expression, material or construction method	✓	Representative example of an agricultural complex including a Gothic Revival farmhouse, and outbuildings/barns.
	Displays a high degree of craftsmanship or artistic value		
	Displays a high degree of technical or scientific achievement		
<b>Historical or</b>	Has direct associations with a theme, event, belief, person, activity, organization or

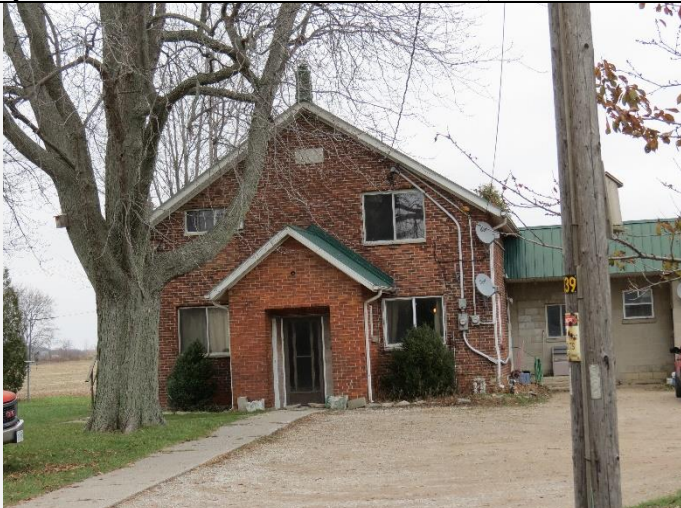
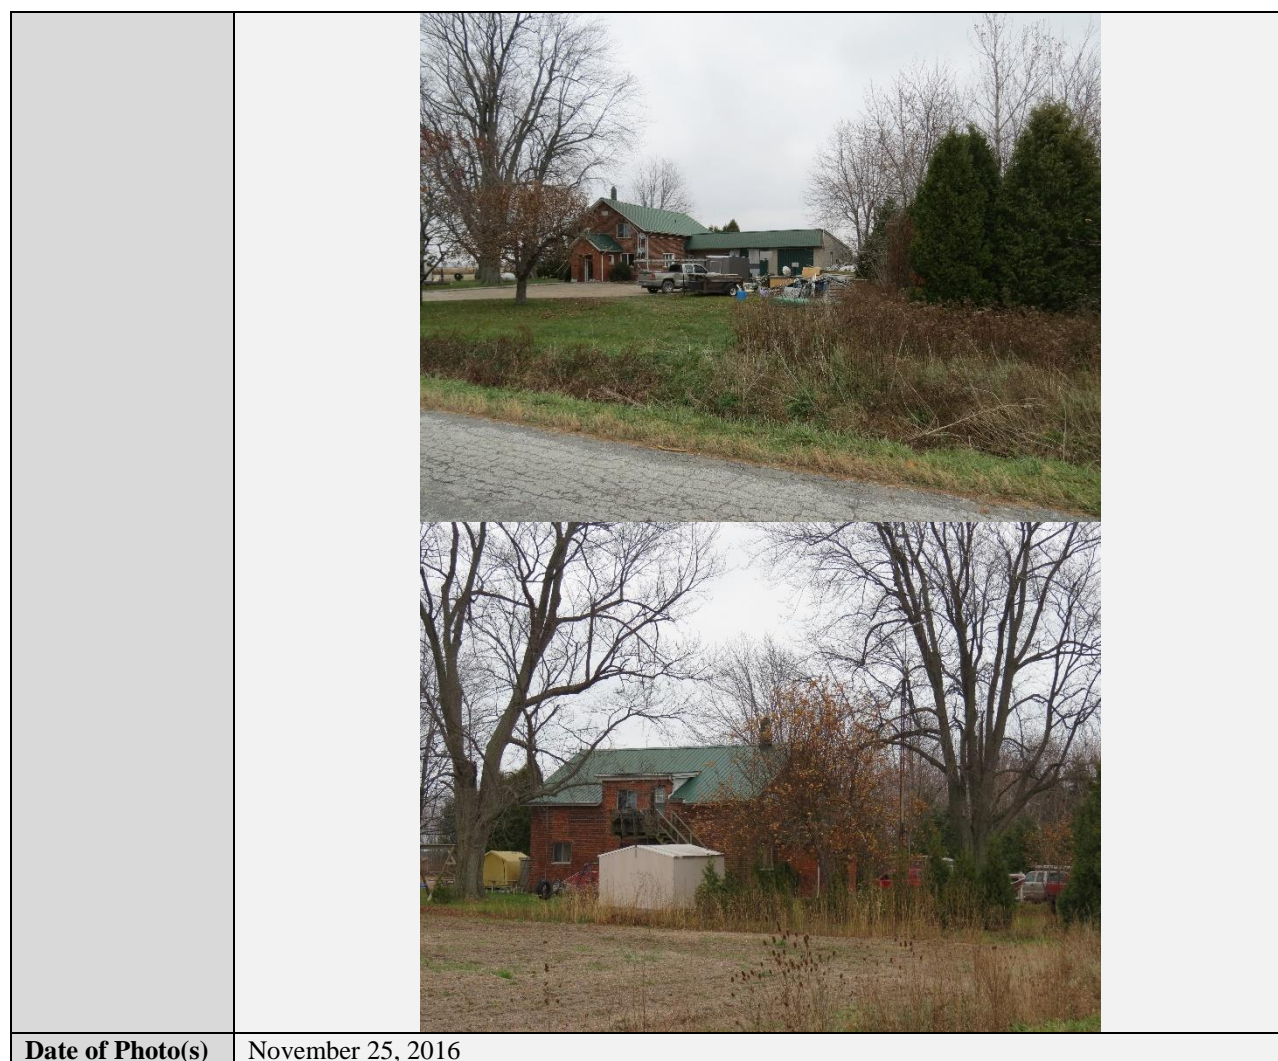
**BUILT HERITAGE RESOURCE NO. 36**

<b>DESCRIPTION OF PROPERTY</b>	
<b>Street Address</b>	21413 Zion Road
<b>Name</b>	n/a
<b>PIN</b>	8340030
<b>Lot and Concession</b>	Lot 13, Concession 2
<b>Recognition</b>	None
<b>Location</b>	Municipality of Chatham-Kent (formerly Township of Romney)
<b>Participating or Abutting</b>	Abutting
<b>Type of Property</b>	Residential
<b>Date(s)</b>	1904
<b>Description</b>	<ul style="list-style-type: none"> <li>• A good example of a one-and-a-half storey schoolhouse</li> <li>• Front gable roof</li> <li>• Red brick construction</li> <li>• Gable roof vestibule with entryway</li> <li>• Centrally placed date stone that reads “S.S. No. 3, 1904”</li> <li>• Window openings appear to have been modified</li> <li>• Cinderblock and frame addition</li> <li>• Shed roof dormer, addition</li> <li>• Formerly functioned as School Section 3 (S.S. No. 3)</li> </ul>
<b>Photo(s)</b>

EVALUATION OF PROPERTY			
Criteria	Description	✓	Value Statement(s)
<b>Design or Physical Value</b>	Is a rare, unique, representative or early example of a style, type, expression, material or construction method	✓	Good example of an early 20 <sup>th</sup> century one-and-a-half brick schoolhouse.
	Displays a high degree of craftsmanship or artistic value		
	Displays a high degree of technical or scientific achievement		
<b>Historical or Associative Value</b>	Has direct associations with a theme, event, belief, person, activity, organization or institution that is significant to a community	✓	Associated with rural education in the Geographic Township of Romney as it functioned as S.S. No. 3.
	Yields or has the potential to yield information that contributes to the understanding of a community or culture		
	Demonstrates or reflects the work or ideas of an architect, builder, artist, designer or theorist who is significant to a community

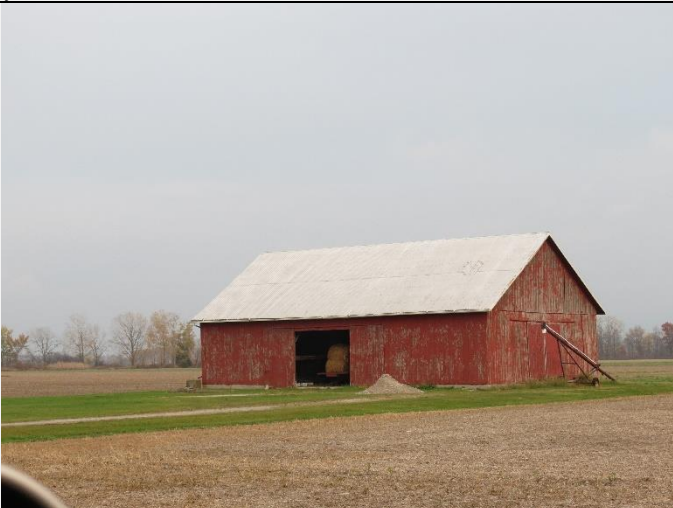
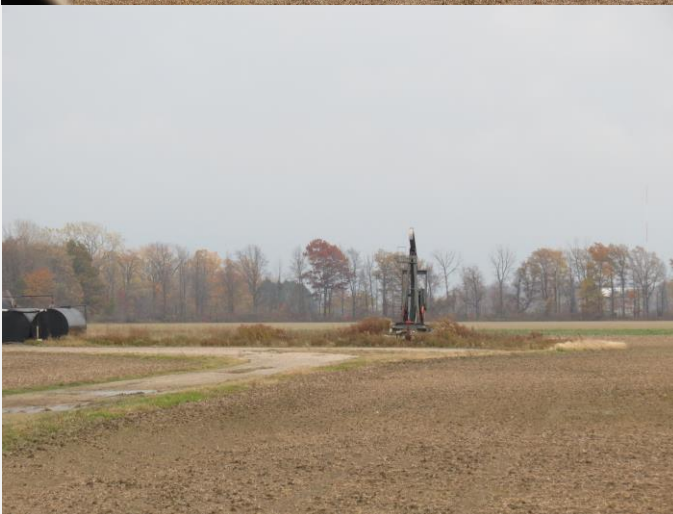
**BUILT HERITAGE RESOURCE NO. 37**

<b>DESCRIPTION OF PROPERTY</b>	
<b>Street Address</b>	1640 4 <sup>th</sup> Concession Line
<b>Name</b>	n/a
<b>PIN</b>	8340010
<b>Lot and Concession</b>	Lot 14, Concession 3
<b>Recognition</b>	None
<b>Location</b>	Municipality of Chatham-Kent (formerly Township of Romney)
<b>Participating or Abutting</b>	Abutting
<b>Type of Property</b>	Agricultural (farm operations buildings only), oil production
<b>Date(s)</b>	Unknown
<b>Description</b>	<ul style="list-style-type: none"> <li>• Example of agricultural building, without a residence</li> <li>• One large barn</li> <li>• Rectangular plan</li> <li>• Property also contains an oil derrick</li> </ul>
<b>Photo(s)</b>

EVALUATION OF PROPERTY			
Criteria	Description	✓	Value Statement(s)
<b>Design or Physical Value</b>	Is a rare, unique, representative or early example of a style, type, expression, material or construction method		
	Displays a high degree of craftsmanship or artistic value		
	Displays a high degree of technical or scientific achievement		
<b>Historical or Associative Value</b>	Has direct associations with a theme, event, belief, person, activity, organization or institution that is significant to a community	✓	Representative of natural resource extraction in Ontario.
	Yields or has the potential to yield information that contributes to the understanding of a community or culture		
	Demonstrates or reflects the work or ideas of an architect, builder, artist, designer or theorist who is significant to a community		
<b>Contextual Value</b>	Is important in defining, maintaining or supporting the character of an area	✓	Supports the agricultural character of the area.

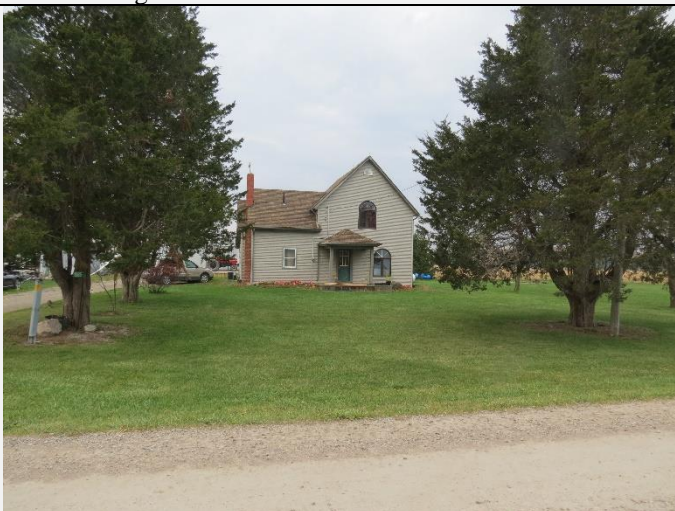
**BUILT HERITAGE RESOURCE NO. 38**

DESCRIPTION OF PROPERTY	
<b>Street Address</b>	1885 4 <sup>th</sup> Concession Line
<b>Name</b>	n/a
<b>PIN</b>	8310065
<b>Lot and Concession</b>	Lot 16, Concession 4
<b>Recognition</b>	None
<b>Location</b>	Municipality of Chatham-Kent (formerly Township of Romney)
<b>Participating or Abutting</b>	Abutting
<b>Type of Property</b>	Residential
<b>Date(s)</b>	After 1881
<b>Description</b>	<ul style="list-style-type: none"> <li>• Example of an agricultural complex</li> <li>• Example of a L-shaped farmhouse</li> <li>• One-and-a-half storey structure with an L-shaped plan</li> <li>• Set back from the road</li> <li>• Clad in siding</li> <li>• House appears to have been heavily altered</li> <li>• Multiple outbuildings/barns</li> </ul>
<b>Photo(s)</b>

EVALUATION OF PROPERTY			
Criteria	Description	✓	Value Statement(s)
<b>Design or Physical Value</b>	Is a rare, unique, representative or early example of a style, type, expression, material or construction method	✓	Representative example of an agricultural complex with a L-shaped farmhouse, several barns and outbuildings.
	Displays a high degree of craftsmanship or artistic value		
	Displays a high degree of technical or scientific achievement		
<b>Historical or Associative Value</b>	Has direct associations with a theme, event, belief, person, activity, organization or institution that is significant to a community		
	Yields or has the potential to yield information that contributes to the

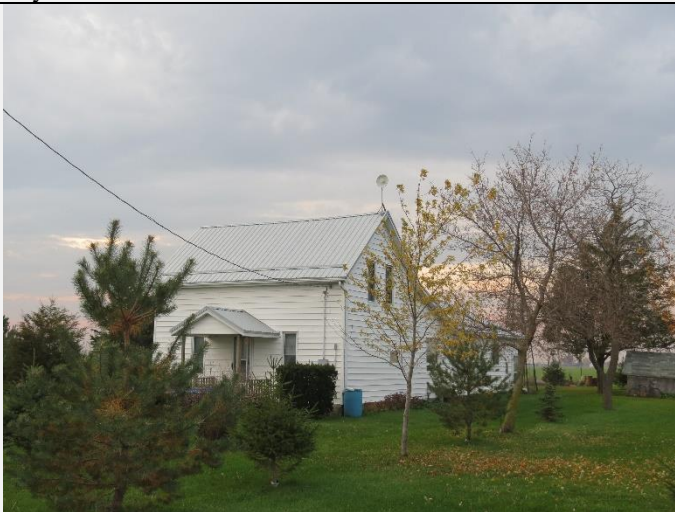
**BUILT HERITAGE RESOURCE NO. 39**

<b>DESCRIPTION OF PROPERTY</b>	
<b>Street Address</b>	1673 5 <sup>th</sup> Concession Line
<b>Name</b>	n/a
<b>PIN</b>	8310044
<b>Lot and Concession</b>	Lot 14, Concession 5
<b>Recognition</b>	None
<b>Location</b>	Municipality of Chatham-Kent (formerly Township of Romney)
<b>Participating or Abutting</b>	Abutting
<b>Type of Property</b>	Residential
<b>Date(s)</b>	After 1881
<b>Description</b>	<ul style="list-style-type: none"> <li>• Example of a frame vernacular farmhouse</li> <li>• One-and-a-half storey structure with an rectangular plan</li> <li>• Side gable roof</li> <li>• Symmetrical façade with central entryway covered by a gable roof portico</li> <li>• Clad in siding</li> <li>• One outbuilding, garage</li> <li>• One-storey rear addition</li> </ul>
<b>Photo(s)</b>

<b>EVALUATION OF PROPERTY</b>			
<b>Criteria</b>	<b>Description</b>	<b>✓</b>	<b>Value Statement(s)</b>
<b>Design or Physical Value</b>	Is a rare, unique, representative or early example of a style, type, expression, material or construction method	✓	Representative example of a vernacular house with a side gable roof and symmetrical façade.
	Displays a high degree of craftsmanship or artistic value		
	Displays a high degree of technical or scientific achievement		
<b>Historical or Associative Value</b>	Has direct associations with a theme, event, belief, person, activity, organization or institution that is significant to a community		
	Yields or has the potential to yield

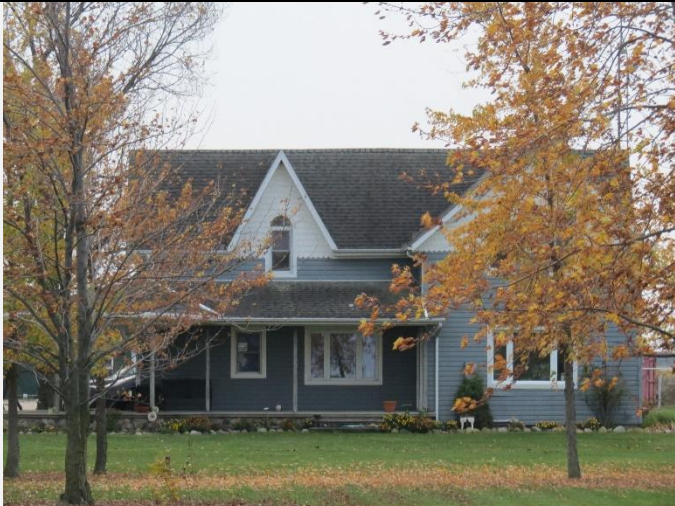
**BUILT HERITAGE RESOURCE NO. 40**

<b>DESCRIPTION OF PROPERTY</b>	
<b>Street Address</b>	1426 5 <sup>th</sup> Concession Line
<b>Name</b>	n/a
<b>PIN</b>	8330004
<b>Lot and Concession</b>	Lot 12, Concession 4
<b>Recognition</b>	None
<b>Location</b>	Municipality of Chatham-Kent (formerly Township of Romney)
<b>Participating or Abutting</b>	Abutting
<b>Type of Property</b>	Residential
<b>Date(s)</b>	After 1881
<b>Description</b>	<ul style="list-style-type: none"> <li>• Example of an agricultural complex</li> <li>• Representative example of a Gothic Revival house</li> <li>• Two-storey frame house with a cross gable roof</li> <li>• L-shaped plan</li> <li>• Frame structure Clad in siding with fish scale detailing in the gables</li> <li>• Addition of a round covered gazebo-like porch addition on the facade</li> <li>• Façade exhibits a medium pitched gable with an arched window opening above a shed roof covered porch that shelters an entryway and window openings (window openings were likely appear to have been modified)</li> <li>• The medium pitch front gable portion of the façade is two -bay with a two-arched window opening on the second storey and one large window opening below</li> <li>• One large barn at the rear of the property</li> <li>• Set far back from the road</li> </ul>

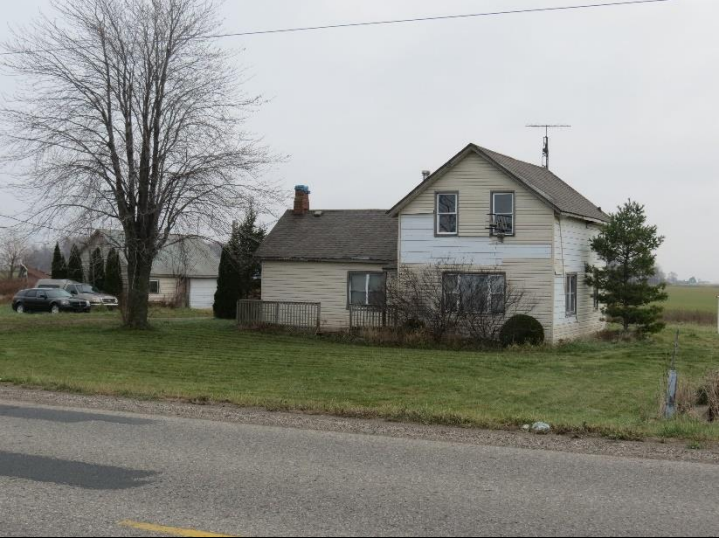
**BUILT HERITAGE RESOURCE NO. 41**

<b>DESCRIPTION OF PROPERTY</b>	
<b>Street Address</b>	22510 Wheatley Road
<b>Name</b>	n/a
<b>PIN</b>	8300047
<b>Lot and Concession</b>	Lot 15, Concession 6
<b>Recognition</b>	None
<b>Location</b>	Municipality of Chatham-Kent (formerly Township of Romney)
<b>Participating or Abutting</b>	Abutting
<b>Type of Property</b>	Residential
<b>Date(s)</b>	After 1881
<b>Description</b>	<ul style="list-style-type: none"> <li>• Example of an agricultural complex</li> <li>• Example of a gable roof farmhouse</li> <li>• One-and-a-half storey structure with an L-shaped plan</li> <li>• Clad in siding</li> <li>• Multiple outbuildings/barns</li> </ul>
<b>Photo(s)</b>

<b>EVALUATION OF PROPERTY</b>			
<b>Criteria</b>	<b>Description</b>	<b>✓</b>	<b>Value Statement(s)</b>
<b>Design or Physical Value</b>	Is a rare, unique, representative or early example of a style, type, expression, material or construction method	✓	Representative example of an agricultural complex with a gable roof farmhouse, several barns/ outbuildings.
	Displays a high degree of craftsmanship or artistic value		
	Displays a high degree of technical or scientific achievement		
<b>Historical or Associative Value</b>	Has direct associations with a theme, event, belief, person, activity, organization or institution that is significant to a community		
	Yields or has the potential to yield information that contributes to the understanding of a community or culture

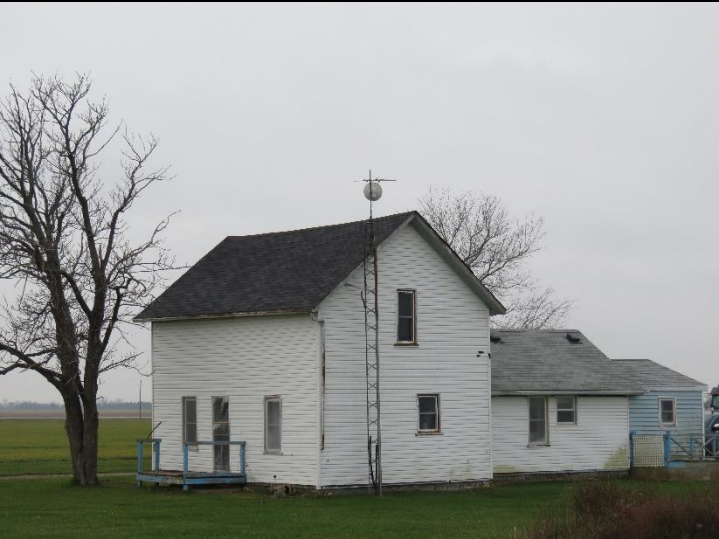
**BUILT HERITAGE RESOURCE NO. 42**

DESCRIPTION OF PROPERTY	
<b>Street Address</b>	11705 Wheatley Road
<b>Name</b>	n/a
<b>PIN</b>	750810084
<b>Lot and Concession</b>	Lot 20, Concession 11
<b>Recognition</b>	None
<b>Location</b>	Town of Lakeshore
<b>Participating or Abutting</b>	Abutting
<b>Type of Property</b>	Residential
<b>Date(s)</b>	After 1881
<b>Description</b>	<ul style="list-style-type: none"> <li>• Example of an agricultural complex</li> <li>• Example of two-storey farmhouse</li> <li>• Façade with two rectangular first storey window openings and one entryway</li> <li>• At least two additions to the rear of the house</li> <li>• Side gable roof</li> <li>• Clad in siding</li> <li>• Multiple outbuildings/barns</li> </ul>
<b>Photo(s)</b>

EVALUATION OF PROPERTY			
Criteria	Description	✓	Value Statement(s)
<b>Design or Physical Value</b>	Is a rare, unique, representative or early example of a style, type, expression, material or construction method	✓	Representative example of an agricultural complex with a gable roof farmhouse, with barns and outbuildings.
	Displays a high degree of craftsmanship or artistic value		
	Displays a high degree of technical or scientific achievement		
<b>Historical or Associative Value</b>	Has direct associations with a theme, event, belief, person, activity, organization or institution that is significant to a community		
	Yields or has the potential to yield information that contributes to the understanding of a community or culture

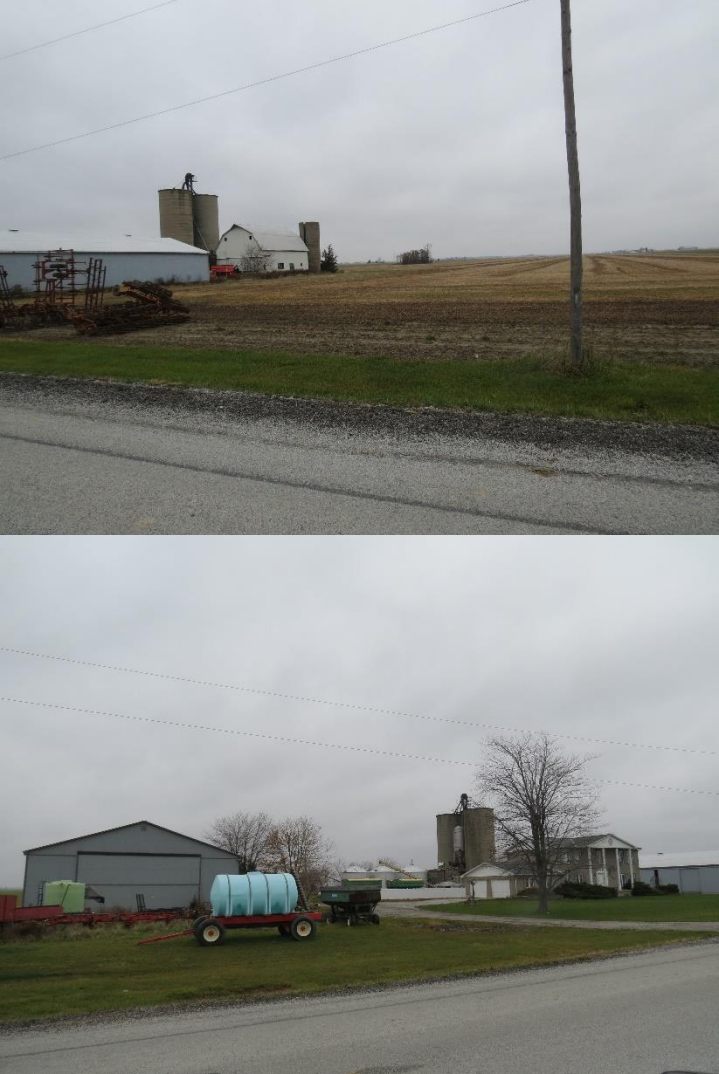
**BUILT HERITAGE RESOURCE NO. 43**

DESCRIPTION OF PROPERTY	
<b>Street Address</b>	15704 County Road 8
<b>Name</b>	n/a
<b>PIN</b>	750810080
<b>Lot and Concession</b>	Lot 18, Concession 11
<b>Recognition</b>	None
<b>Location</b>	Town of Lakeshore
<b>Participating or Abutting</b>	Abutting
<b>Type of Property</b>	Agricultural (farm operations buildings only)
<b>Date(s)</b>	Unknown
<b>Description</b>	<ul style="list-style-type: none"> <li>• Example of agricultural complex, with a newer residence</li> <li>• One large gambrel roof barn with other newer infrastructure and a newer house</li> <li>• Rectangular plan</li> <li>•</li> </ul>
<b>Photo(s)</b>

EVALUATION OF PROPERTY			
Criteria	Description	✓	Value Statement(s)
<b>Design or Physical Value</b>	Is a rare, unique, representative or early example of a style, type, expression, material or construction method		
	Displays a high degree of craftsmanship or artistic value		
	Displays a high degree of technical or scientific achievement		
<b>Historical or Associative Value</b>	Has direct associations with a theme, event, belief, person, activity, organization or institution that is significant to a community		
	Yields or has the potential to yield information that contributes to the understanding of a community or culture		
	Demonstrates or reflects the work or ideas of an architect, builder, artist, designer or theorist who is significant to a community		
<b>Contextual Value</b>	Is important in defining, maintaining or supporting the character of an area	✓	Supports the agricultural character of the area.

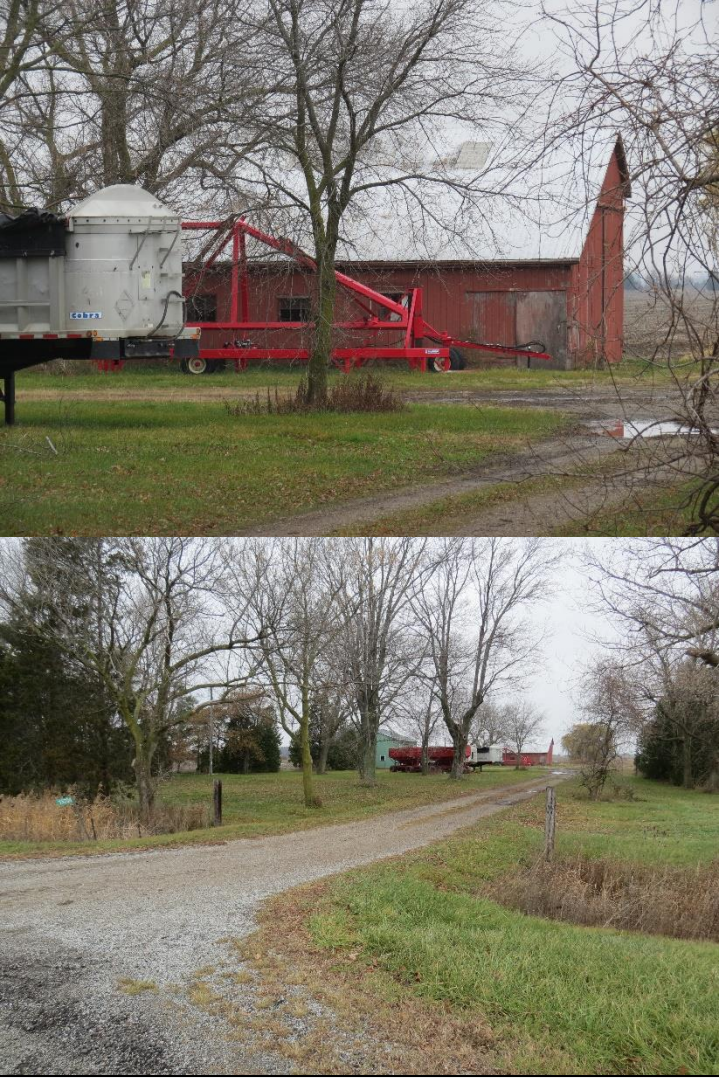
**BUILT HERITAGE RESOURCE NO. 44**

DESCRIPTION OF PROPERTY	
<b>Street Address</b>	15704 County Road 8
<b>Name</b>	n/a
<b>PIN</b>	750810056
<b>Lot and Concession</b>	Lot 15, Concession 11
<b>Recognition</b>	None
<b>Location</b>	Town of Lakeshore
<b>Participating or Abutting</b>	Abutting
<b>Type of Property</b>	Agricultural (farm operations buildings only)
<b>Date(s)</b>	Unknown
<b>Description</b>	<ul style="list-style-type: none"> <li>• Example of agricultural complex, without a residence</li> <li>• One large gable roof barn and other newer infrastructure</li> <li>• Rectangular plan</li> <li>• Six pane windows</li> <li>•</li> </ul>
<b>Photo(s)</b>

EVALUATION OF PROPERTY			
Criteria	Description	✓	Value Statement(s)
<b>Design or Physical Value</b>	Is a rare, unique, representative or early example of a style, type, expression, material or construction method		
	Displays a high degree of craftsmanship or artistic value		
	Displays a high degree of technical or scientific achievement		
<b>Historical or Associative Value</b>	Has direct associations with a theme, event, belief, person, activity, organization or institution that is significant to a community		
	Yields or has the potential to yield information that contributes to the understanding of a community or culture		
	Demonstrates or reflects the work or ideas of an architect, builder, artist, designer or theorist who is significant to a community		
<b>Contextual Value</b>	Is important in defining, maintaining or supporting the character of an area	✓	Supports the agricultural character of the area.

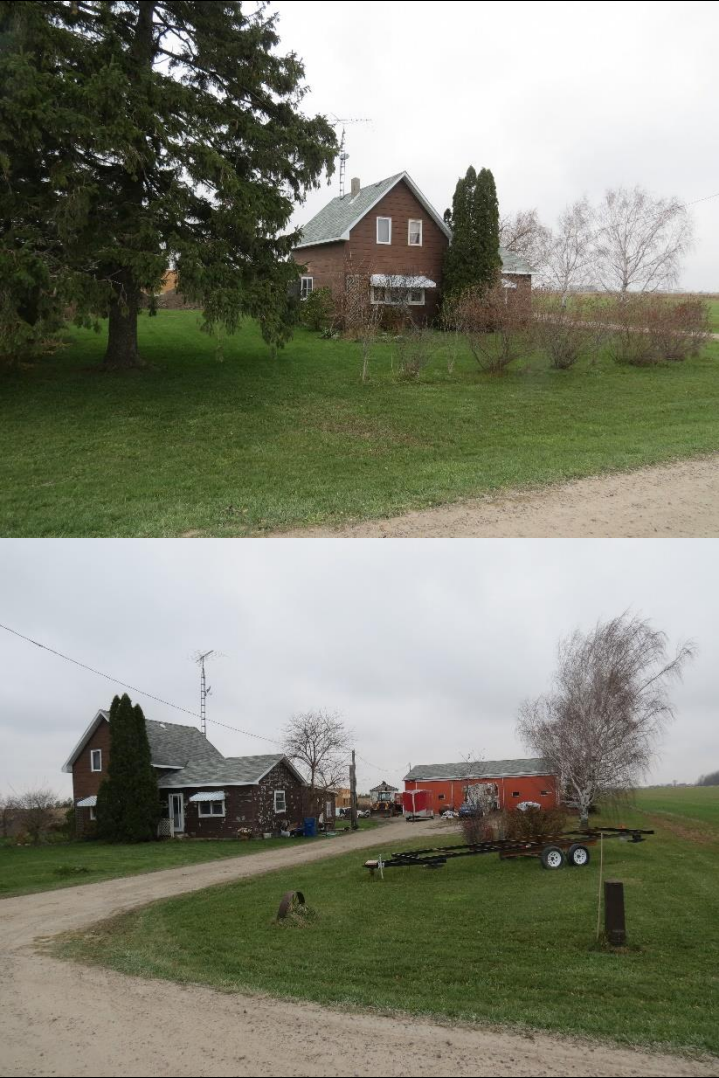
**BUILT HERITAGE RESOURCE NO. 45**

DESCRIPTION OF PROPERTY	
<b>Street Address</b>	1795 6 <sup>th</sup> Concession Line
<b>Name</b>	n/a
<b>PIN</b>	8300011
<b>Lot and Concession</b>	Lot 15, Concession 6
<b>Location</b>	Municipality of Chatham-Kent (formerly Township of Romney)
<b>Participating or Abutting</b>	Abutting
<b>Type of Property</b>	Residential
<b>Date(s)</b>	After 1881
<b>Description</b>	<ul style="list-style-type: none"> <li>• Example of a gable roof farmhouse</li> <li>• One-and-a-half storey frame structure with a cross gable roof</li> <li>• The front gable portion exhibits two rectangular second storey window openings over one large window opening (appears to have been modified)</li> <li>• Some farming outbuildings associated with the house</li> </ul>
<b>Photo(s)</b>

EVALUATION OF PROPERTY			
Criteria	Description	✓	Value Statement(s)
<b>Design or Physical Value</b>	Is a rare, unique, representative or early example of a style, type, expression, material or construction method	✓	Representative example of a gable roof farmhouse.
	Displays a high degree of craftsmanship or artistic value		
	Displays a high degree of technical or scientific achievement		
<b>Historical or Associative Value</b>	Has direct associations with a theme, event, belief, person, activity, organization or institution that is significant to a community		
	Yields or has the potential to yield information that contributes to the understanding of a community or culture		
	Demonstrates or reflects the work or ideas of an architect, builder, artist, designer or theorist who is significant to a community		
<b>Contextual Value</b>	Is important in defining, maintaining or supporting the character of an area	✓	Supports the agricultural character of the area.

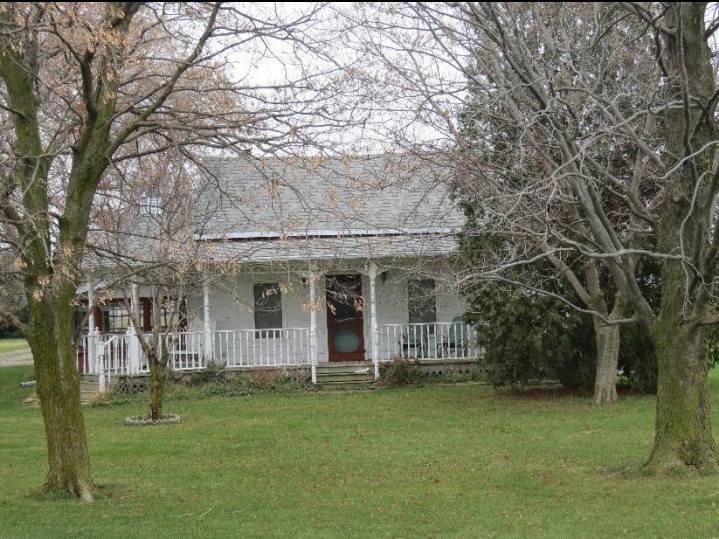
**BUILT HERITAGE RESOURCE NO. 46**

DESCRIPTION OF PROPERTY	
<b>Street Address</b>	1975 6 <sup>th</sup> Concession Line
<b>Name</b>	n/a
<b>PIN</b>	8300020
<b>Lot and Concession</b>	Lot 17, Concession 6
<b>Recognition</b>	None
<b>Location</b>	Municipality of Chatham-Kent (formerly Township of Romney)
<b>Participating or Abutting</b>	Abutting
<b>Type of Property</b>	Residential
<b>Date(s)</b>	After 1881
<b>Description</b>	<ul style="list-style-type: none"> <li>• Example of an agricultural complex</li> <li>• Example of One-storey farmhouse</li> <li>• Side gable frame house with a shed roof covered porch</li> <li>• Addition on side elevation</li> <li>• Porch appears to have been modified with a covered gazebo in front of the addition</li> <li>• Clad in siding</li> <li>• Two barns</li> </ul>
<b>Photo(s)</b>

EVALUATION OF PROPERTY			
Criteria	Description	✓	Value Statement(s)
<b>Design or Physical Value</b>	Is a rare, unique, representative or early example of a style, type, expression, material or construction method	✓	Representative example of an agricultural complex with a farmhouse and two barns.
	Displays a high degree of craftsmanship or artistic value		
	Displays a high degree of technical or scientific achievement		
<b>Historical or Associative Value</b>	Has direct associations with a theme, event, belief, person, activity, organization or institution that is significant to a community		
	Yields or has the potential to yield information that contributes to the understanding of a community or culture

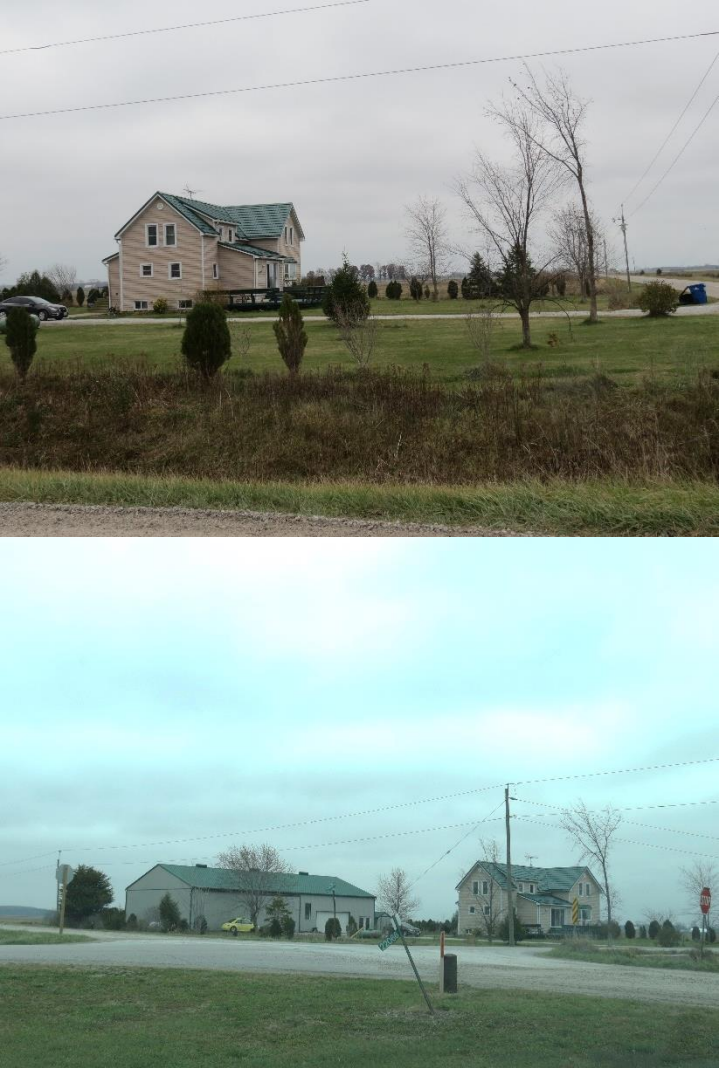
**BUILT HERITAGE RESOURCE NO. 47**

DESCRIPTION OF PROPERTY	
<b>Street Address</b>	22051 Zion Road
<b>Name</b>	n/a
<b>PIN</b>	8310050
<b>Lot and Concession</b>	Lot 13, Concession 4
<b>Recognition</b>	None
<b>Location</b>	Municipality of Chatham-Kent (formerly Township of Romney)
<b>Participating or Abutting</b>	Abutting
<b>Type of Property</b>	Residential
<b>Date(s)</b>	After 1881
<b>Description</b>	<ul style="list-style-type: none"> <li>• Example of an agricultural complex</li> <li>• Representative L-shaped farmhouse</li> <li>• Two-storey frame house with a cross gable roof</li> <li>• L-shaped plan</li> <li>• Appear to have been heavily modified with a shed roof dormer and shed roof enclosed porch</li> <li>• One barn on the property</li> </ul>
<b>Photo(s)</b>

<b>EVALUATION OF PROPERTY</b>			
<b>Criteria</b>	<b>Description</b>	<b>✓</b>	<b>Value Statement(s)</b>
<b>Design or Physical Value</b>	Is a rare, unique, representative or early example of a style, type, expression, material or construction method	✓	Representative example of an agricultural complex including a L-shaped farmhouse.
	Displays a high degree of craftsmanship or artistic value		
	Displays a high degree of technical or scientific achievement		
<b>Historical or Associative Value</b>	Has direct associations with a theme, event, belief, person, activity, organization or institution that is significant to a community		
	Yields or has the potential to yield information that contributes to the understanding of a community or culture		
	Demonstrates or reflects the work or ideas of an architect, builder, artist, designer or theorist who is significant to a community		
<b>Contextual Value</b>	Is important in defining, maintaining or supporting the character of an area	✓	Supports the agricultural character of the area
