## **APPENDIX C – CULTURAL HERITAGE ASSESSMENT**

<b>Project:</b>	<b>Romney Wind Energy Centre</b>
<b>OPA Reference Number:</b>	<b>L006356-WIN-001-060</b>
<b>Report Title:</b>	<b>Romney Wind Energy Centre: Cultural Heritage Assessment</b>
<b>Applicant:</b>	<b>Romney Energy Centre Limited Partnership</b>
<b>Location:</b>	<b>Geographic Townships of Romney and Tilbury West Municipality of Chatham-Kent, Ontario</b>
<b>MTCS File No.:</b>	<b>0005856</b>

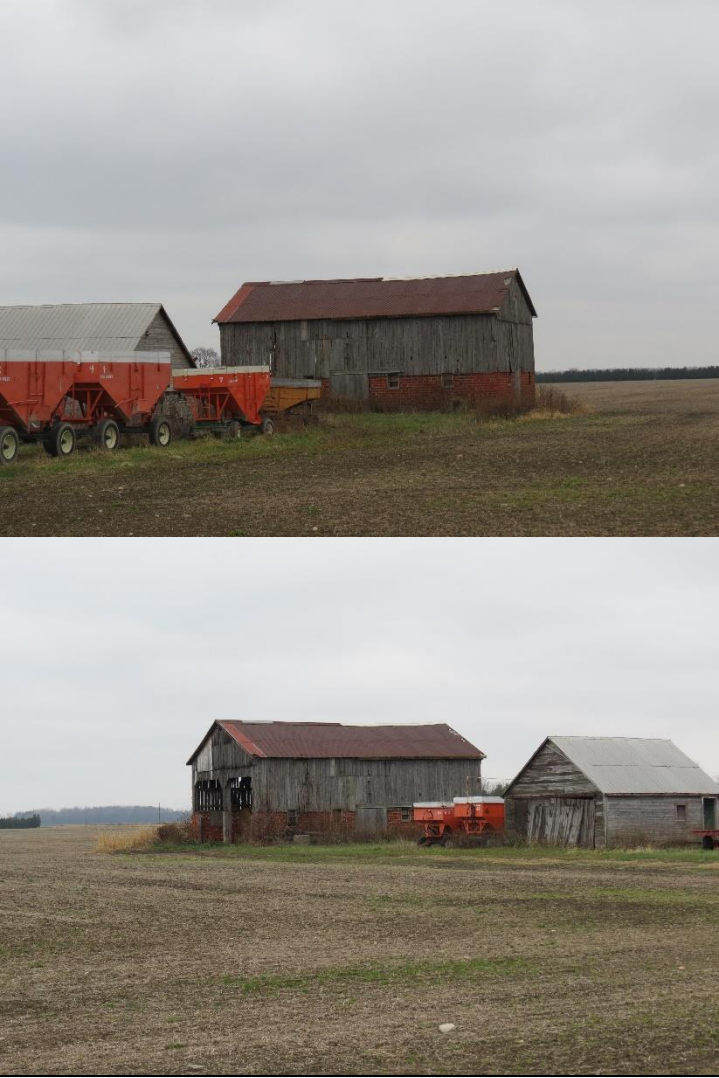
**BUILT HERITAGE RESOURCE NO. 48**

<b>DESCRIPTION OF PROPERTY</b>	
<b>Street Address</b>	No civic address exists (Southwest corner of Zion Road and 3 <sup>rd</sup> Concession)
<b>Name</b>	Zion Acres
<b>PIN</b>	8470149
<b>Lot and Concession</b>	Lot 12, Concession 2
<b>Recognition</b>	None
<b>Location</b>	Municipality of Chatham-Kent (formerly Township of Romney)
<b>Participating or Abutting</b>	Abutting
<b>Type of Property</b>	Agricultural (farm operations buildings only)
<b>Date(s)</b>	Unknown
<b>Description</b>	<ul style="list-style-type: none"> <li>• Example of agricultural complex, without a residence</li> <li>• One large barn</li> <li>• Rectangular plan, gable roof with foundation constructed with large red bricks</li> <li>• Wood frame sash windows</li> <li>•</li> </ul>
<b>Photo(s)</b>

EVALUATION OF PROPERTY			
Criteria	Description	✓	Value Statement(s)
<b>Design or Physical Value</b>	Is a rare, unique, representative or early example of a style, type, expression, material or construction method		
	Displays a high degree of craftsmanship or artistic value		
	Displays a high degree of technical or scientific achievement		
<b>Historical or Associative Value</b>	Has direct associations with a theme, event, belief, person, activity, organization or institution that is significant to a community		
	Yields or has the potential to yield information that contributes to the understanding of a community or culture		
	Demonstrates or reflects the work or ideas of an architect, builder, artist, designer or theorist who is significant to a community		
<b>Contextual Value</b>	Is important in defining, maintaining or supporting the character of an area	✓	Supports the agricultural character of the area.

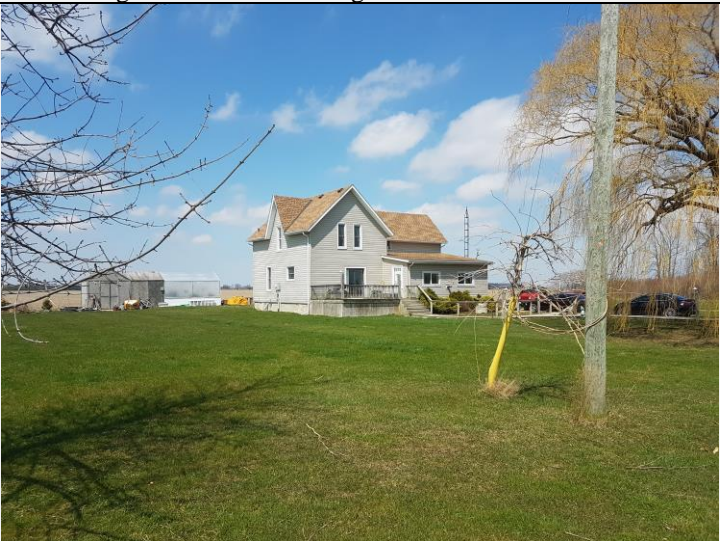
**BUILT HERITAGE RESOURCE NO. 49**

<b>DESCRIPTION OF PROPERTY</b>	
<b>Street Address</b>	Unknown (Bluff Line)
<b>Name</b>	n/a
<b>PIN</b>	8470099
<b>Lot and Concession</b>	Lot 11, Concession 1
<b>Recognition</b>	None
<b>Location</b>	Municipality of Chatham-Kent (formerly Township of Romney)
<b>Participating or Abutting</b>	Abutting
<b>Type of Property</b>	Residential
<b>Date(s)</b>	After 1880
<b>Description</b>	<p>Example Gothic Revival house with front gable</p> <p>One-and-a-half storey structure with an L-shaped plan</p> <p>Clad in siding</p> <p>House appears to have been heavily altered with a wood front deck and enclosed porch</p> <p>Rectangular window openings</p> <p>Outbuildings include a shed and greenhouse</p>
<b>Photo(s)</b>

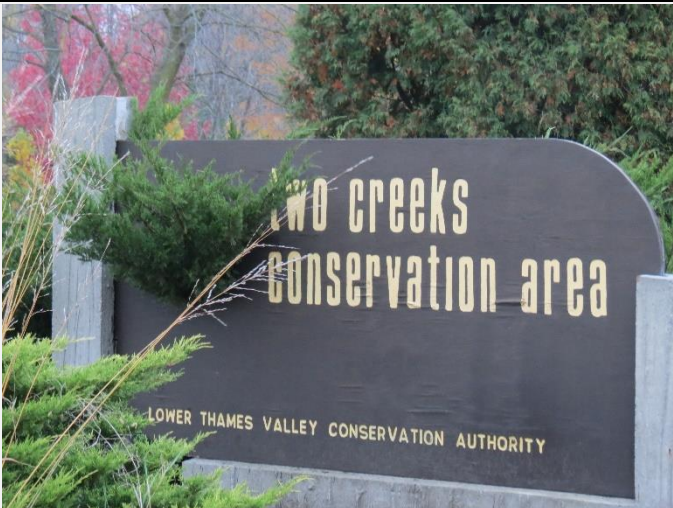
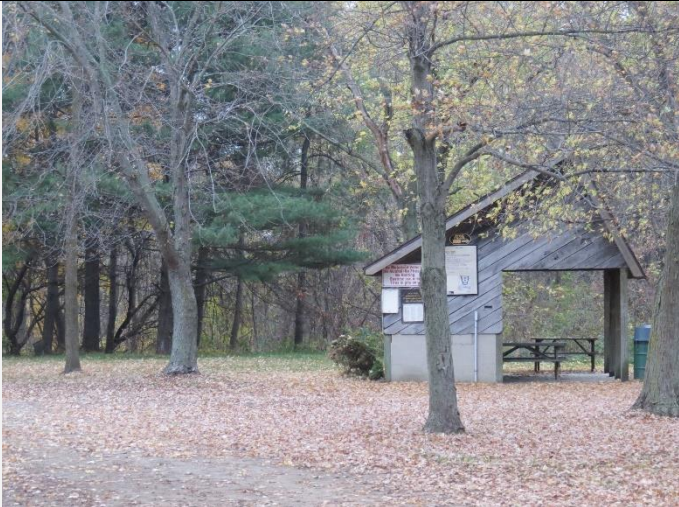
DESCRIPTION OF PROPERTY	
<b>Street Address</b>	100 Thames Street
<b>Name</b>	Two Creeks Conservation Area (Lower Thames Valley Conservation Authority)
<b>PIN</b>	8330026
<b>Lot and Concession</b>	Lots 7–8, Concession 3
<b>Recognition</b>	None
<b>Location</b>	Municipality of Chatham-Kent (formerly Township of Romney)
<b>Participating or Abutting</b>	Abutting
<b>Type of Property</b>	Conservation Authority Lands
<b>Date(s)</b>	Opened in 1992
<b>Description</b>	<ul style="list-style-type: none"> <li>• Friends of Two Creeks was established in 1992 and renamed Wheatley Two Creeks Association in 2012</li> <li>• Conservation area opened in 1992</li> <li>• The Wheatley Two Creeks Conservation Area provides many facilities to accommodate families and large groups. There is an extensive picnic area with tables, restroom and a barbecue. A 4,000 square foot pavilion was added in 2005 to provide shelter for up to 200 people. The Weil Stage, in the natural amphitheatre, is home to the annual summer concert series and other events.</li> <li>• During winter, snowboarding and tobogganing have become popular local pastimes on the only lighted hill in the area. Cross-country skiing is also permitted.</li> </ul>

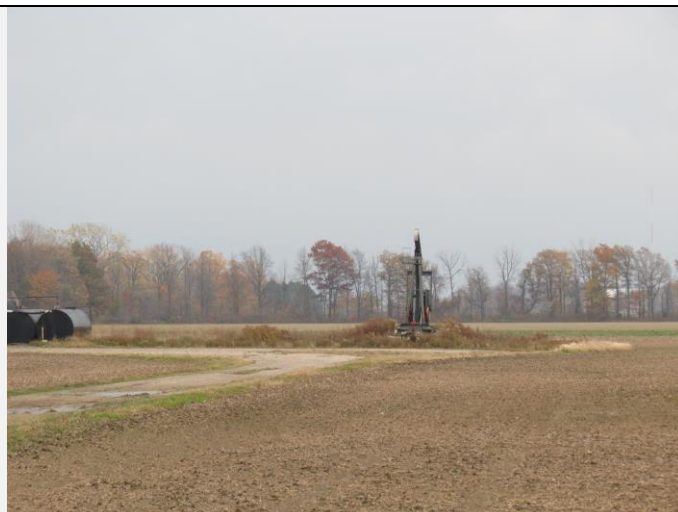
PIN 8340010

<b>DESCRIPTION OF PROPERTY</b>	
<b>Street Address</b>	Various places throughout Township of Romney
<b>Name</b>	Oil Extraction Area
<b>PIN</b>	8340010, 8340043, 8480071, 8480105, 8340099, 8340024, 8470072, 8480105
<b>Lot and Concession</b>	Multiple lots and Concessions
<b>Recognition</b>	None
<b>Location</b>	Municipality of Chatham-Kent (formerly Township of Romney)
<b>Participating or Abutting</b>	Participating
<b>Type of Property</b>	Oil Extraction Lands
<b>Date(s)</b>	Circa 1902
<b>Description</b>	<ul style="list-style-type: none"> <li>• During the site visit, oil derricks were noted as common across the landscape of the area. As such, photos were taken of oil derricks as they were encountered in the vicinity of the heritage assessed area</li> <li>• Oil derricks were noted on 8 properties</li> <li>• It is an industrial landscape that evolved over time, some oil derricks are still in operation, as such the landscape can be considered evolved and continuing</li> <li>• According to the 1958 map, there is one oil field (7 - Wheatley Field) located within the study area. Discovered in 1902 in the “Guelph Producing Formation”</li> <li>• The 1970 map shows the same oil field, this time, numbered 53 and is still named Wheatley. It should be noted that the field is listed as “inactive” at this time</li> <li>• Another formation of the Wheatley oil pool discovered in 1985 in “linear fields that have fracture-related reservoir development” (Colquhoun 2004:16)</li> <li>• Oil Springs Heritage Conservation District (HCD) in Lambton County is a good landscape comparison. The Oil Springs HCD is the first oil field in Canada and it is recognized as a National Historic Site. A HCD Study led by MHBC, outlines the heritage values and attributes for protection of the landscape at a location level. CHL 2: Oil Extraction Area was discovered in 1902, and like the Oil Springs HCD, this CHL 2: Oil Extraction Area is a working industrial landscape. Therefore, in the absence of any formal recognition of CHL 2, the Oil Springs HCD provides a comparative landscape. Specifically, the Oil Springs values and attributes were used to inform those identified for CHL 2: Oil Extraction Area (with Oil Derricks). The heritage values of the Oil Springs HCD are summarized as: natural resource utilization, inventiveness, continuous operation, family continuity, traditional extraction methods, use of new technology, cyclical nature of industry, sounds and smells of the oil fields, the hard oilers (people who help develop the oil fields), and contribution to the physical development of the county such as the lot layouts and transportation network (MHBC 2010).</li> </ul> <p>The heritage features and attributes of the Oil Springs HCD are listed as: a preserved comprehensive production system, ownership by a number of individuals; collection of all key equipment that are need for the operation of oil fields, a transportation network that links the oil field with refineries, lot pattern including fence rows and vegetation lines; Black Creek Corridor (MHBC 2010).</p>

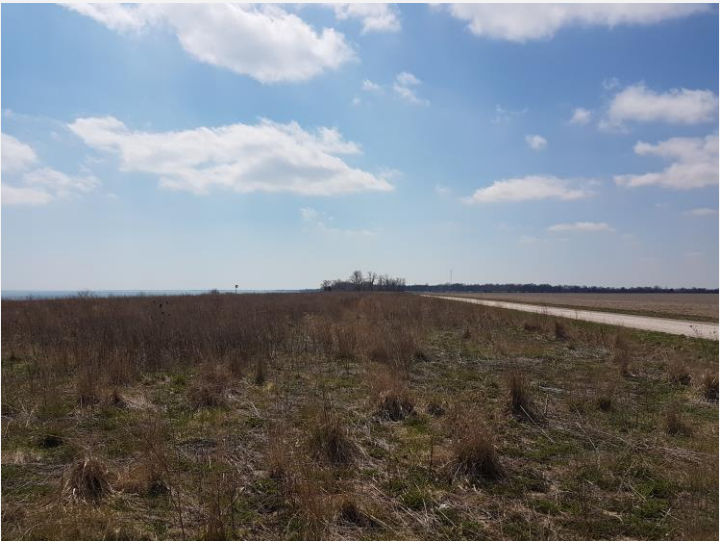
Description of Property	
<b>Street Address</b>	Bluff Line
<b>Name</b>	Bluffs
<b>PIN</b>	8470077 and 8470078
<b>Lot and Concession</b>	Lot 12, Concession 1
<b>Recognition</b>	None
<b>Location</b>	Municipality of Chatham-Kent (formerly Township of Romney)
<b>Participating or Abutting</b>	Abutting
<b>Type of Property</b>	Critically Regulated Area
<b>Date(s)</b>	n/a
<b>Description</b>	<p>Part of the bluffs located northeast of Wheatley Provincial Park in the Lower Thames Valley Conservation Authority</p> <p>Physical shoreline characteristics, including the bluffs, resulted directly from the forces of the last ice age (Brown 2009)</p> <p>Historically, sand eroded from the bluffs northeast of Wheatley and would have moved south bypassing the entrances of Muddy Creek at Wheatley and Hillman Creek until it was deposited off the tip of Point Pelee in a shoal (Stephenson 2006)</p> <p>Ontario Regulation 152/06 sets out the regulations for development along Lake Erie in Chatham-Kent</p> <p>The Lake Erie bluff along the Talbot Trail from Charing Cross Road to Wheatley is now regulated to allow for 100 years of erosion and a stable slope. The Conservation Authority considers this to be the ‘critically’ regulated area.</p>

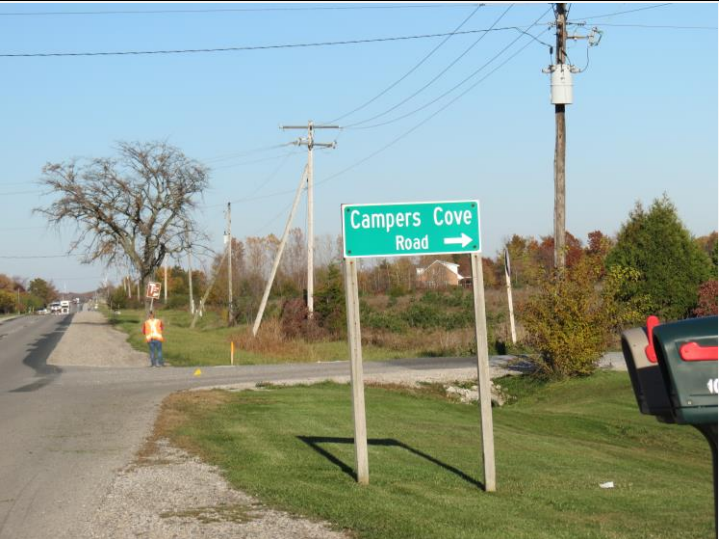
DESCRIPTION OF PROPERTY	
<b>Street Address</b>	Talbot Road
<b>Name</b>	Talbot Road
<b>PIN</b>	
<b>Lot and Concession</b>	Multiple
<b>Recognition</b>	None
<b>Location</b>	Municipality of Chatham-Kent (formerly Township of Romney)
<b>Participating or Abutting</b>	Participating
<b>Type of Property</b>	Historic Thoroughfare
<b>Date(s)</b>	Opened through Chatham-Kent in 1825
<b>Description</b>	<ul style="list-style-type: none"> <li>• Thomas Talbot required a road linking his lands in Sandwich to Fort Erie and Niagara</li> <li>• Talbot Road was installed along the Lake Erie shoreline</li> <li>• Installation and survey of the Talbot Road followed the alignment of an existing Indigenous trail as of 1809</li> <li>• Road work was halted during the War of 1812, resumed in 1816</li> <li>• Eventually the Talbot Road linked the Detroit River with Lake Ontario</li> <li>• Road was corduroyed until 1826 when the road-bed was improved</li> <li>• Was once considered one of the best roads in Upper Canada</li> <li>• Talbot Road is an historic thoroughfare that facilitated colonization along the Lake Erie shoreline (Bradford 2015:40–41)</li> </ul>

<p>View of Talbot road looking east from Campers Cove Road</p>
<b>Date of Photo(s)</b>	November 9, 2016
